POWER LOSS VERSUS ENGINE FAILURE

BY TOM CLEMENTS • APRIL 5, 2019

Ask the Expert

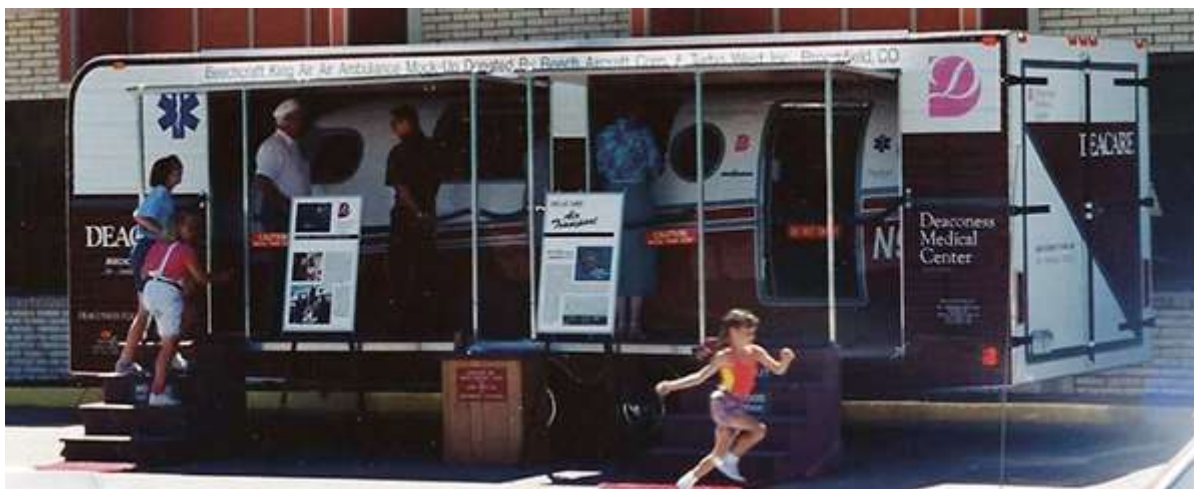
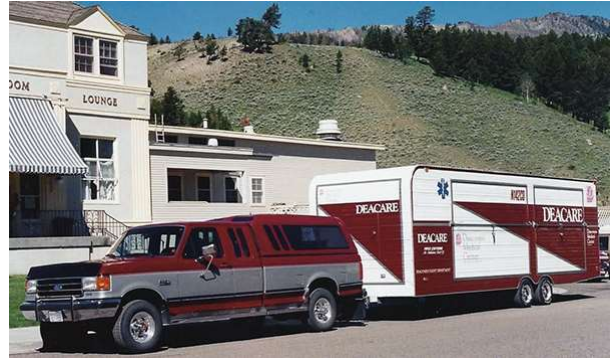
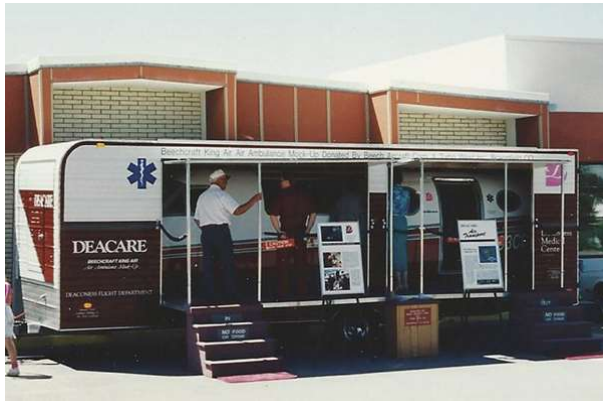
In his quest to find a 200 fuselage to make into a mock-up, Mobley contacted Beech – from whom he had just purchased two B200s to use in this program – and convinced them to give him BB-1. The wings and tail were removed, the left side of the fuselage was cut away and it was housed in a specially designed trailer that traveled to rural clinics and hospitals as well as health fairs. Mobley reported that the program was quite successful in alleviating the public's concerns."

The article entitled “The Amazing History of BB-1” that appeared in the January 2019 issue included mention of when she was used as an air ambulance mock-up. Gerald Mobley – whom I had tried to contact, without success, while writing the report – read the article and was thoughtful enough to offer a more accurate history of this phase of BB-1’s life. Here is what I should have written:
