Maintenance-of-Way-Related Accidents and Incidents Analysis, Findings, and Recommendations

Prepared By
LTK Engineering Services

Project Number:	C4565.3.06.P1

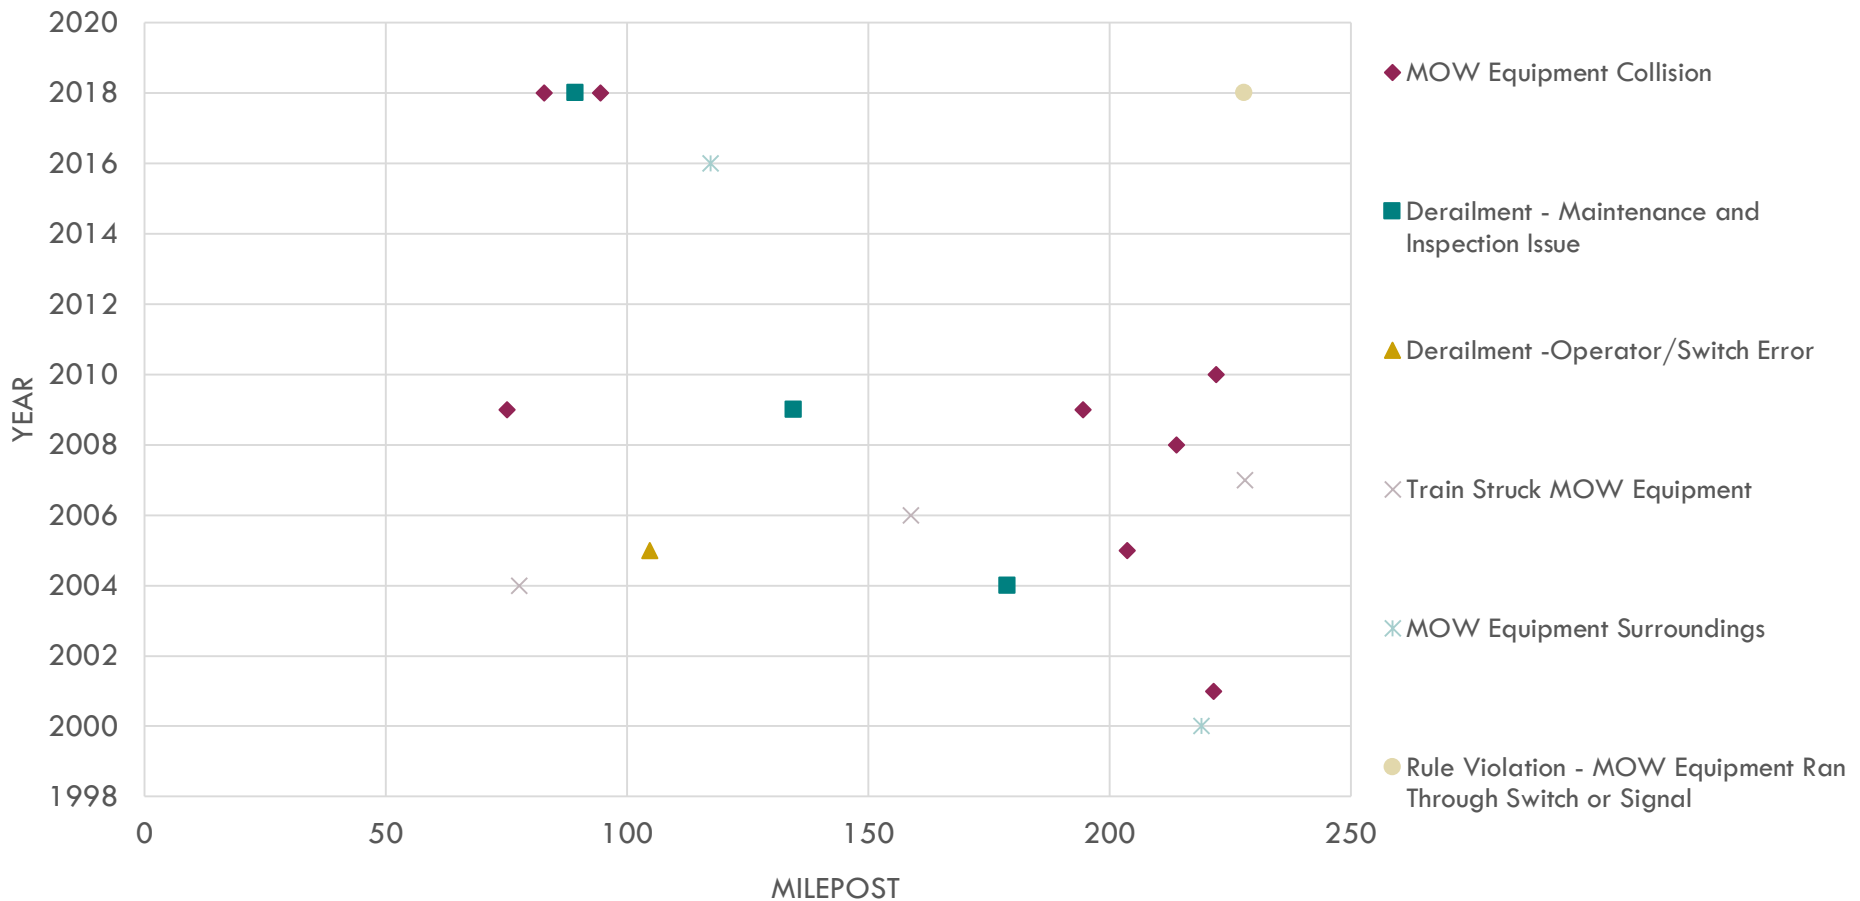
AB Line Incident Activity Scatter Plot

AB-SHORE LINE MOW ACTIVITY INCIDENT TRENDS

First Glance AB Line Data Trends

- The majority of incidents occurred between the years 2004 and 2010.
- Additionally, incident activity is heightened towards the extremities of the AB line portion of the NEC (MP 72 & MP 229).

- For initial evaluation, scatter plot graphs were produced to analyze potential patterns relating to position (Mile Post - MP) on the NEC, or time (Year of Occurrence).
- These graphs appear in the following slides.

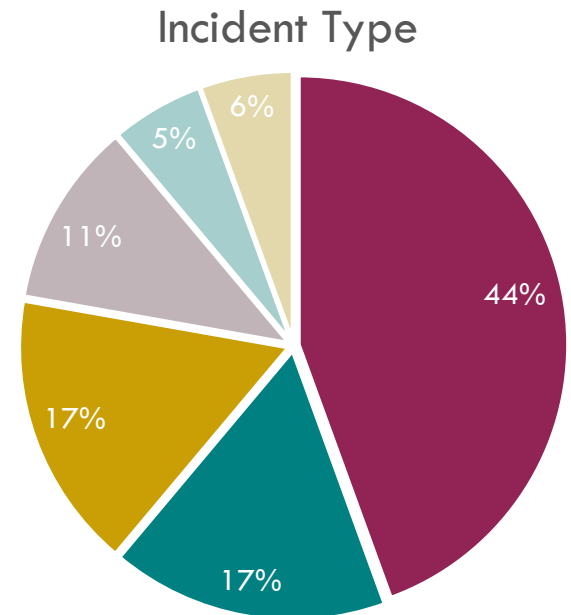
- In regards to incident type: Total 18

- MOW Equipment Collision
- Derailments - Maintenance & Inspection Issues
- Train Struck MOW Equipment
- MOW Equipment Struck Surroundings
- Derailments - Switch or Operator Error
- Rule Violation - MOW Equipment Ran Through Switch/Signal

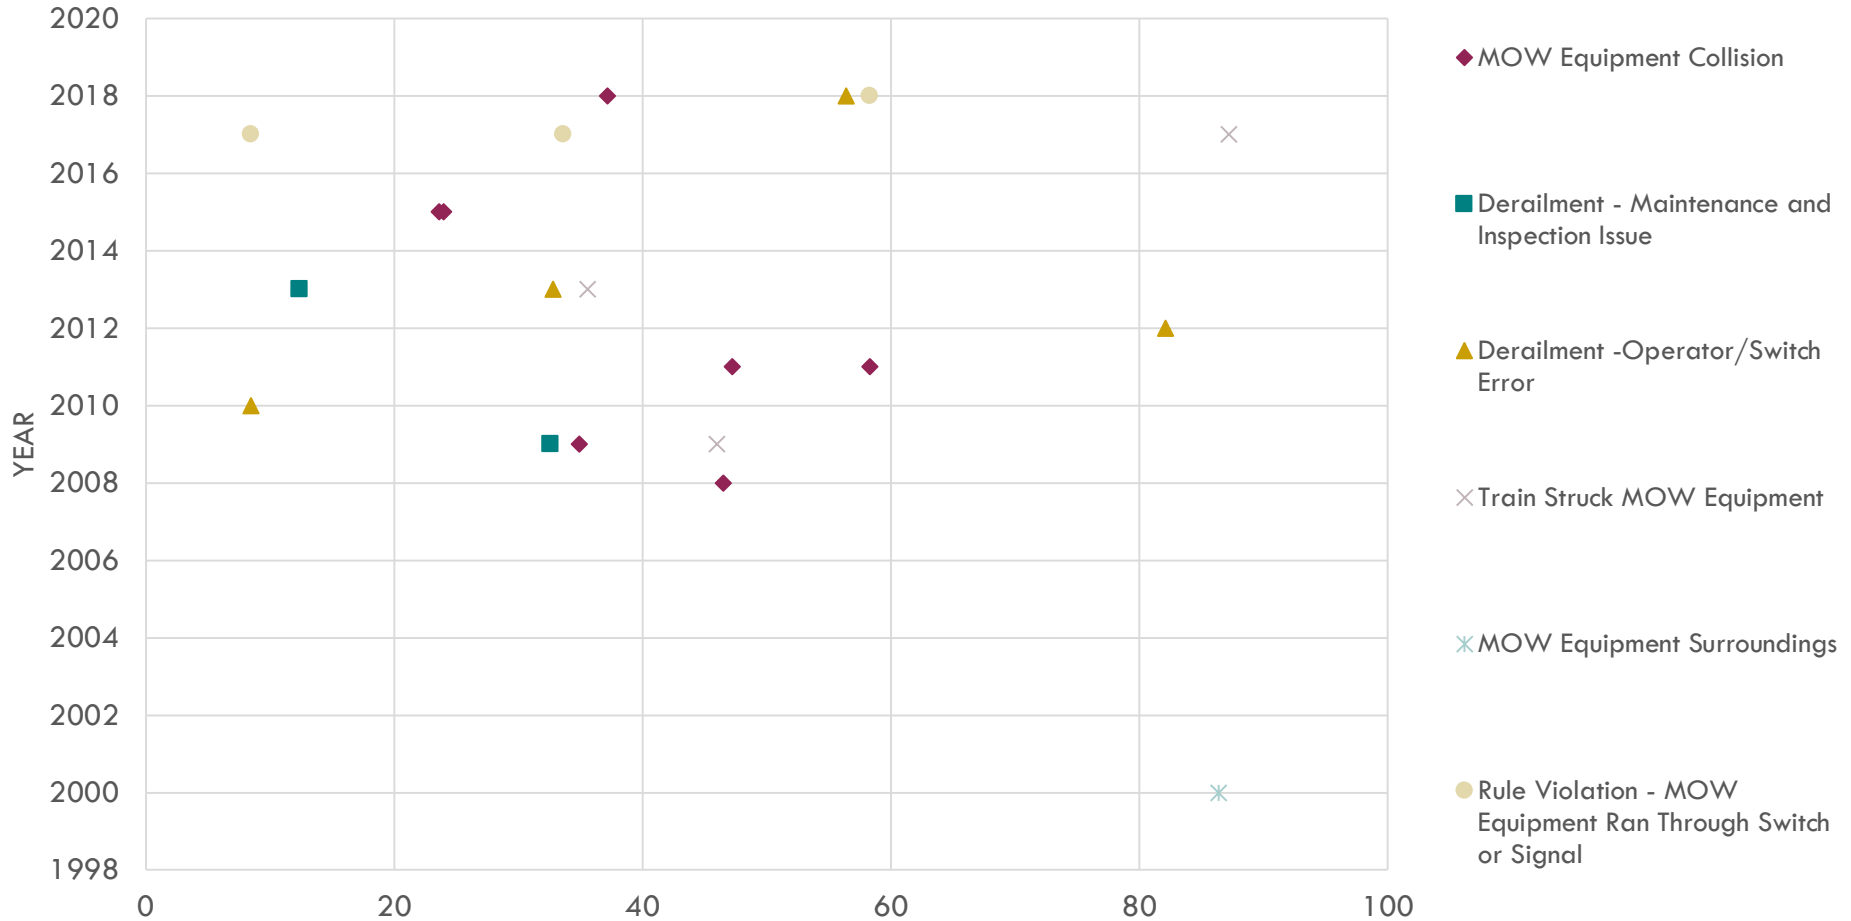
AN Line Incident Activity Scatter Plot

AN- NEW JERSEY LINE MOW ACTIVITY INCIDENT TRENDS

First Glance AN Line Data Trends

- There was an increase in incidents starting in the year 2008.
- Additionally, incident activity is widely distributed throughout this segment of the NEC, having a small gap (between MP 60 & MP 80)

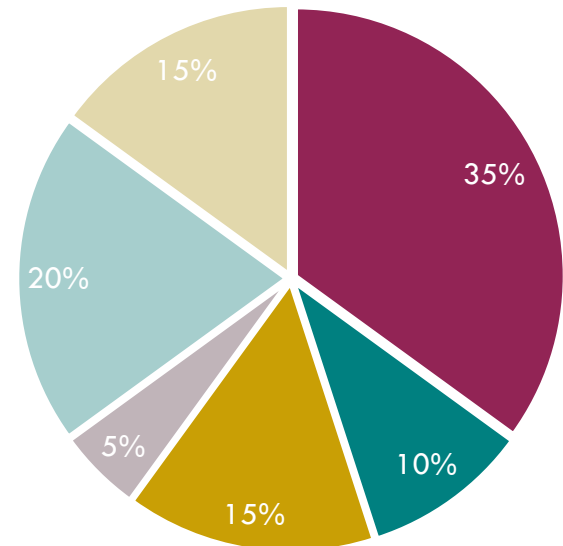
Incident Type

- MOW Equipment Collision
- Derailments - Maintenance & Inspection Issues
- Train Struck MOW Equipment
- MOW Equipment Struck Surroundings
- Derailments - Switch or Operator Error
- Rule Violation - MOW Equipment Ran Through Switch/Signal

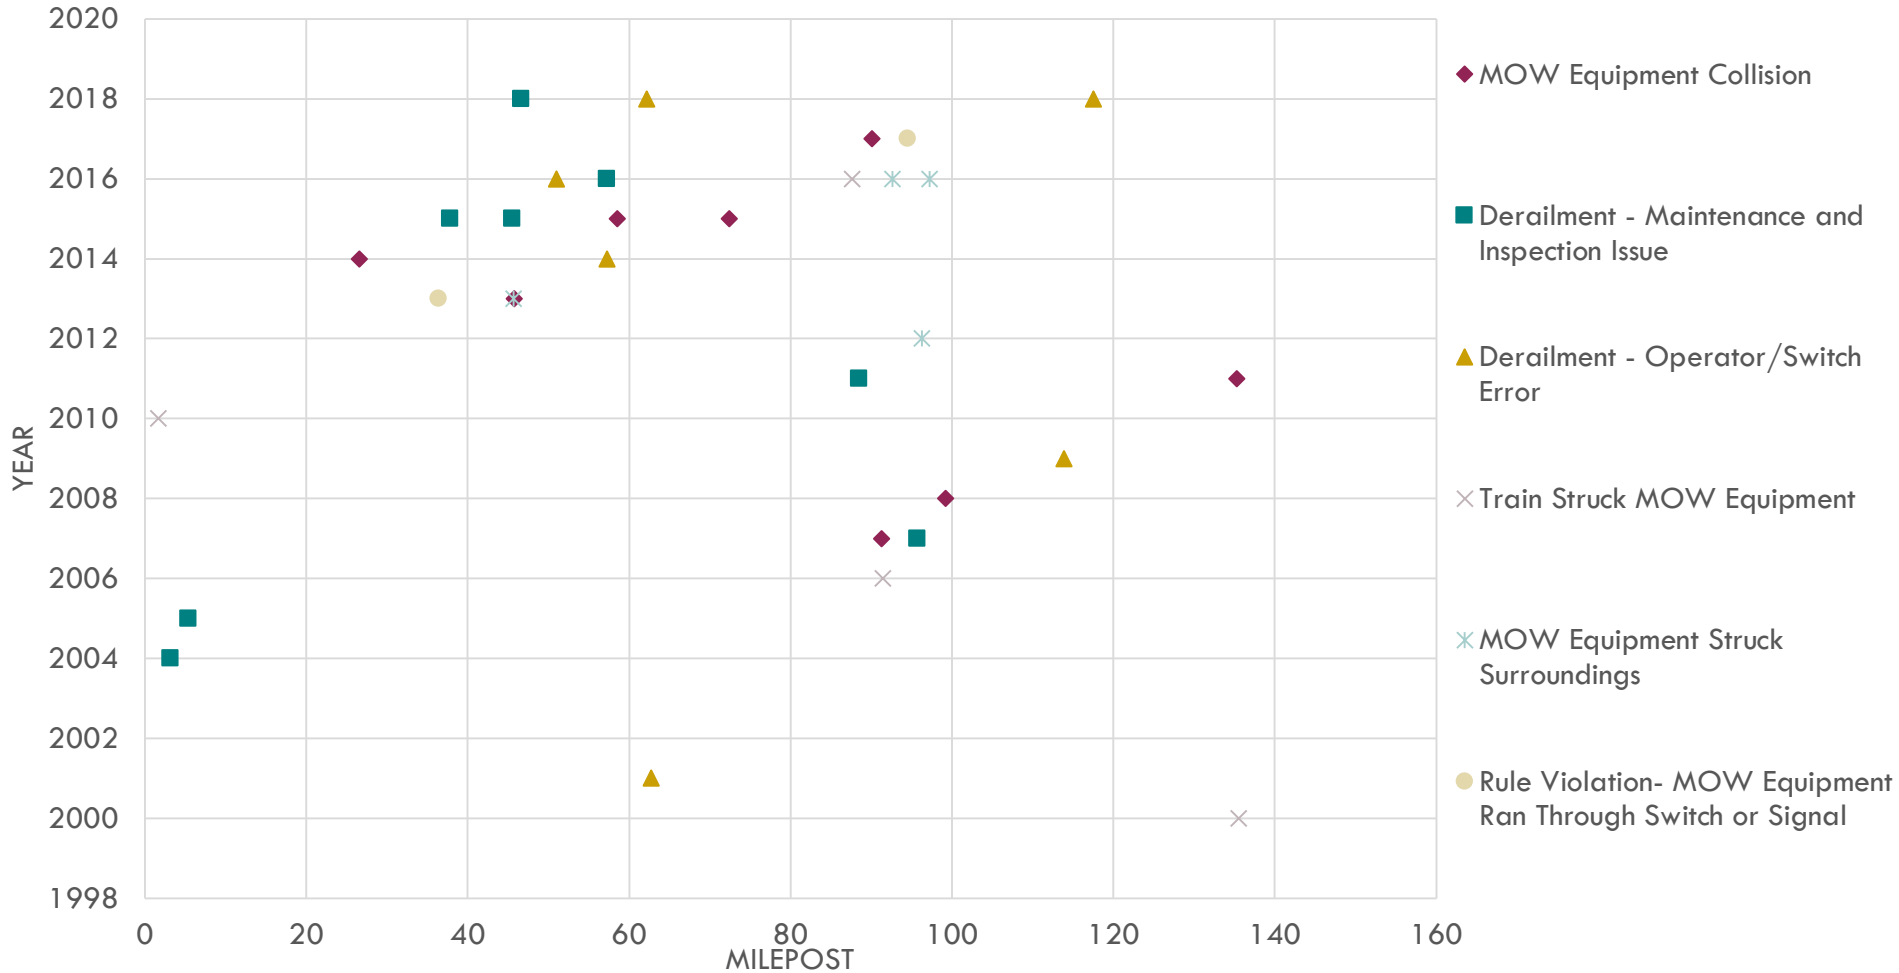
AP Line Incident Activity Scatter Plot

AP-PHILADELPHIA LINE MOW ACTIVITY INCIDENT TRENDS

First Glance AP Line Data Trends

- There was an increase in incidents starting in the year 2006, with another dramatic increase starting in the year 2012.
- Additionally, incident activity is widely distributed throughout this segment of the NEC.

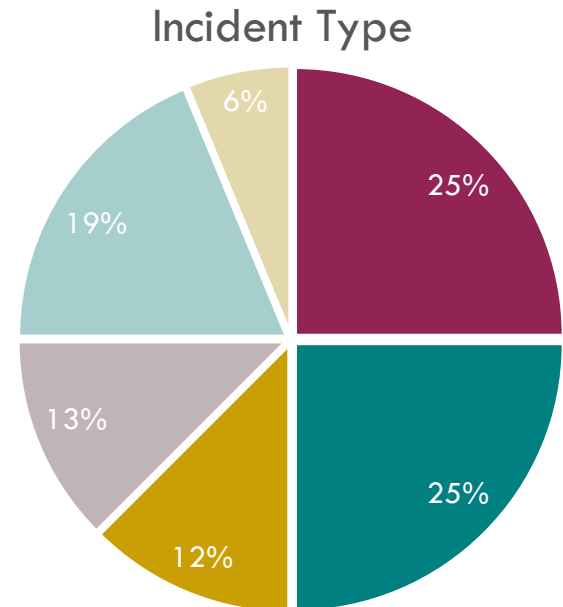
- In regards to incident type: Total 32

- MOW Equipment Collisions
- Derailments - Maintenance & Inspection Issues
- Train Struck MOW Equipment
- MOW Equipment Struck Surroundings
- Derailments - Switch or Operator Error
- Rule Violation - MOW Equipment Ran Through Switch/Signal

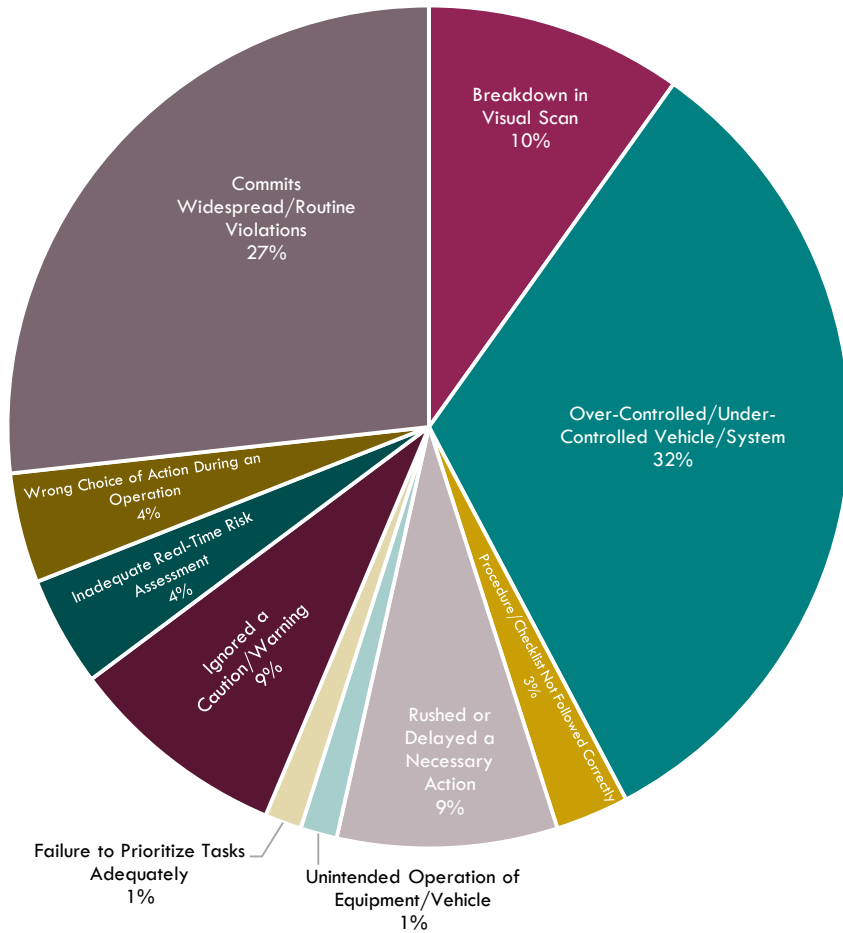
Active Failures

Collision Incidents: 23

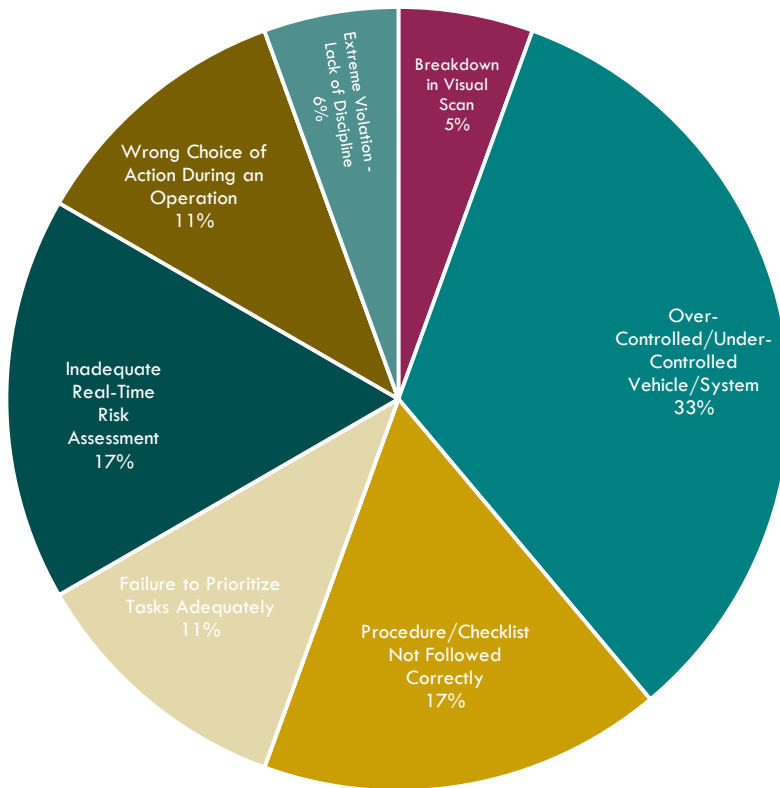
Active Failures

Train Struck MOW Equipment: 9

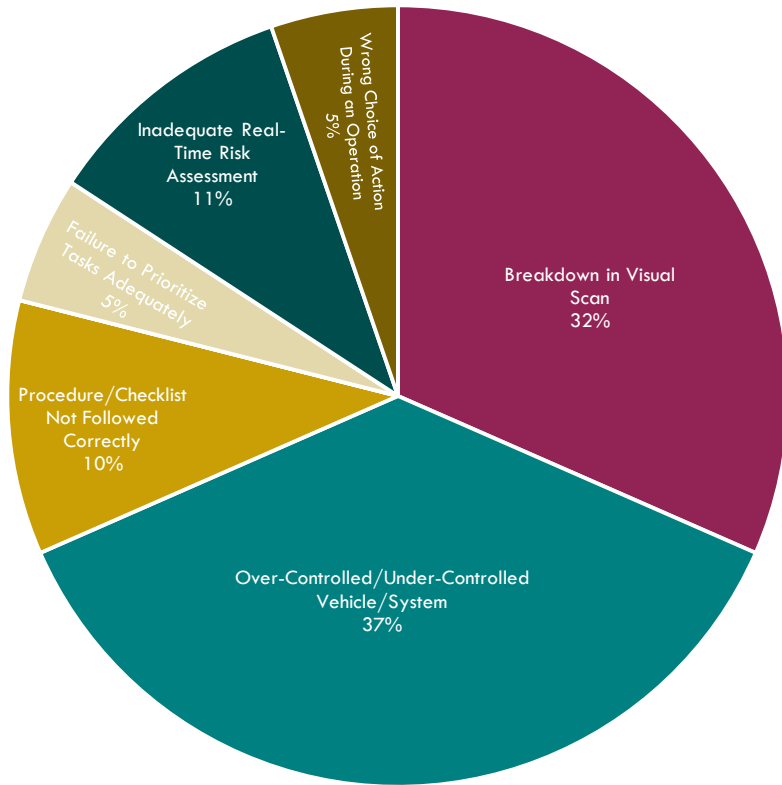
Active Failures

Train Struck Object: 8

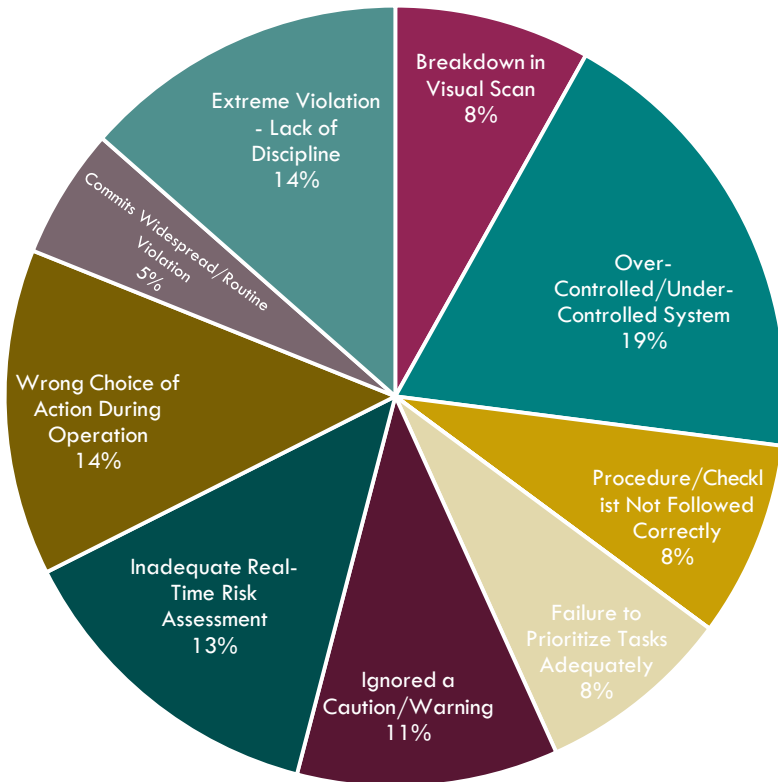
Active Failures

Rule Violation: 8

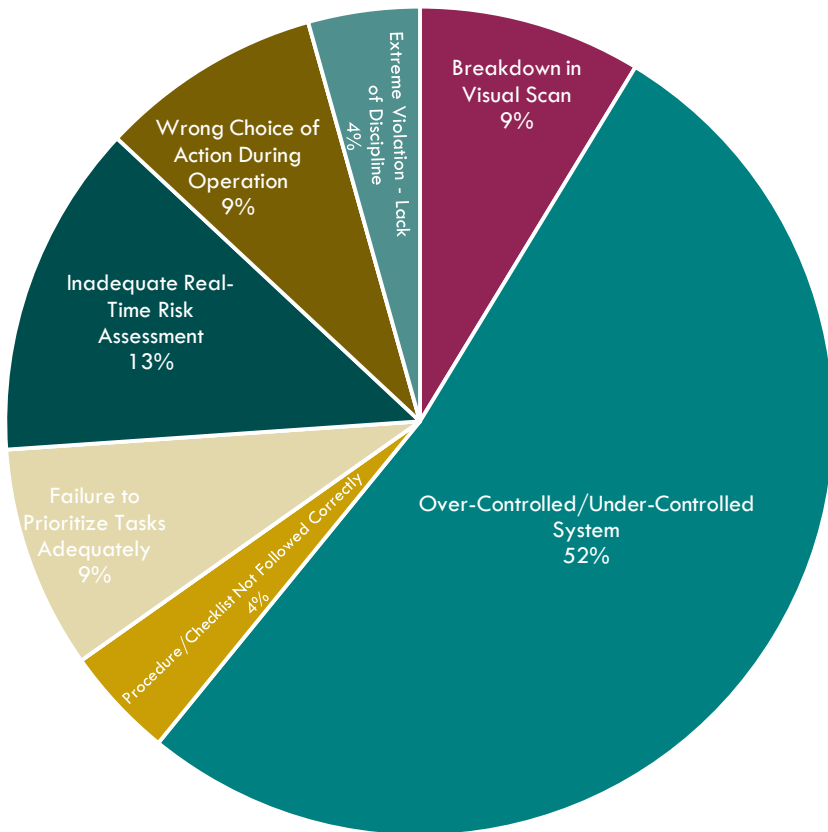
Active Failures

Derailment – Operator/Switch Error: 12

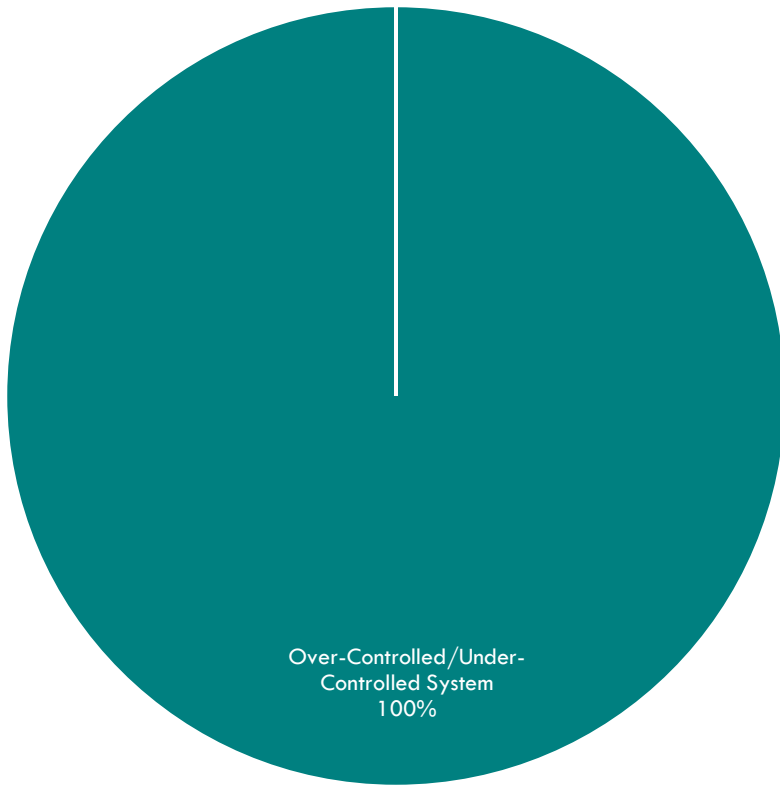
Active Failures

Derailment – Maintenance & Inspection

Issue: 10

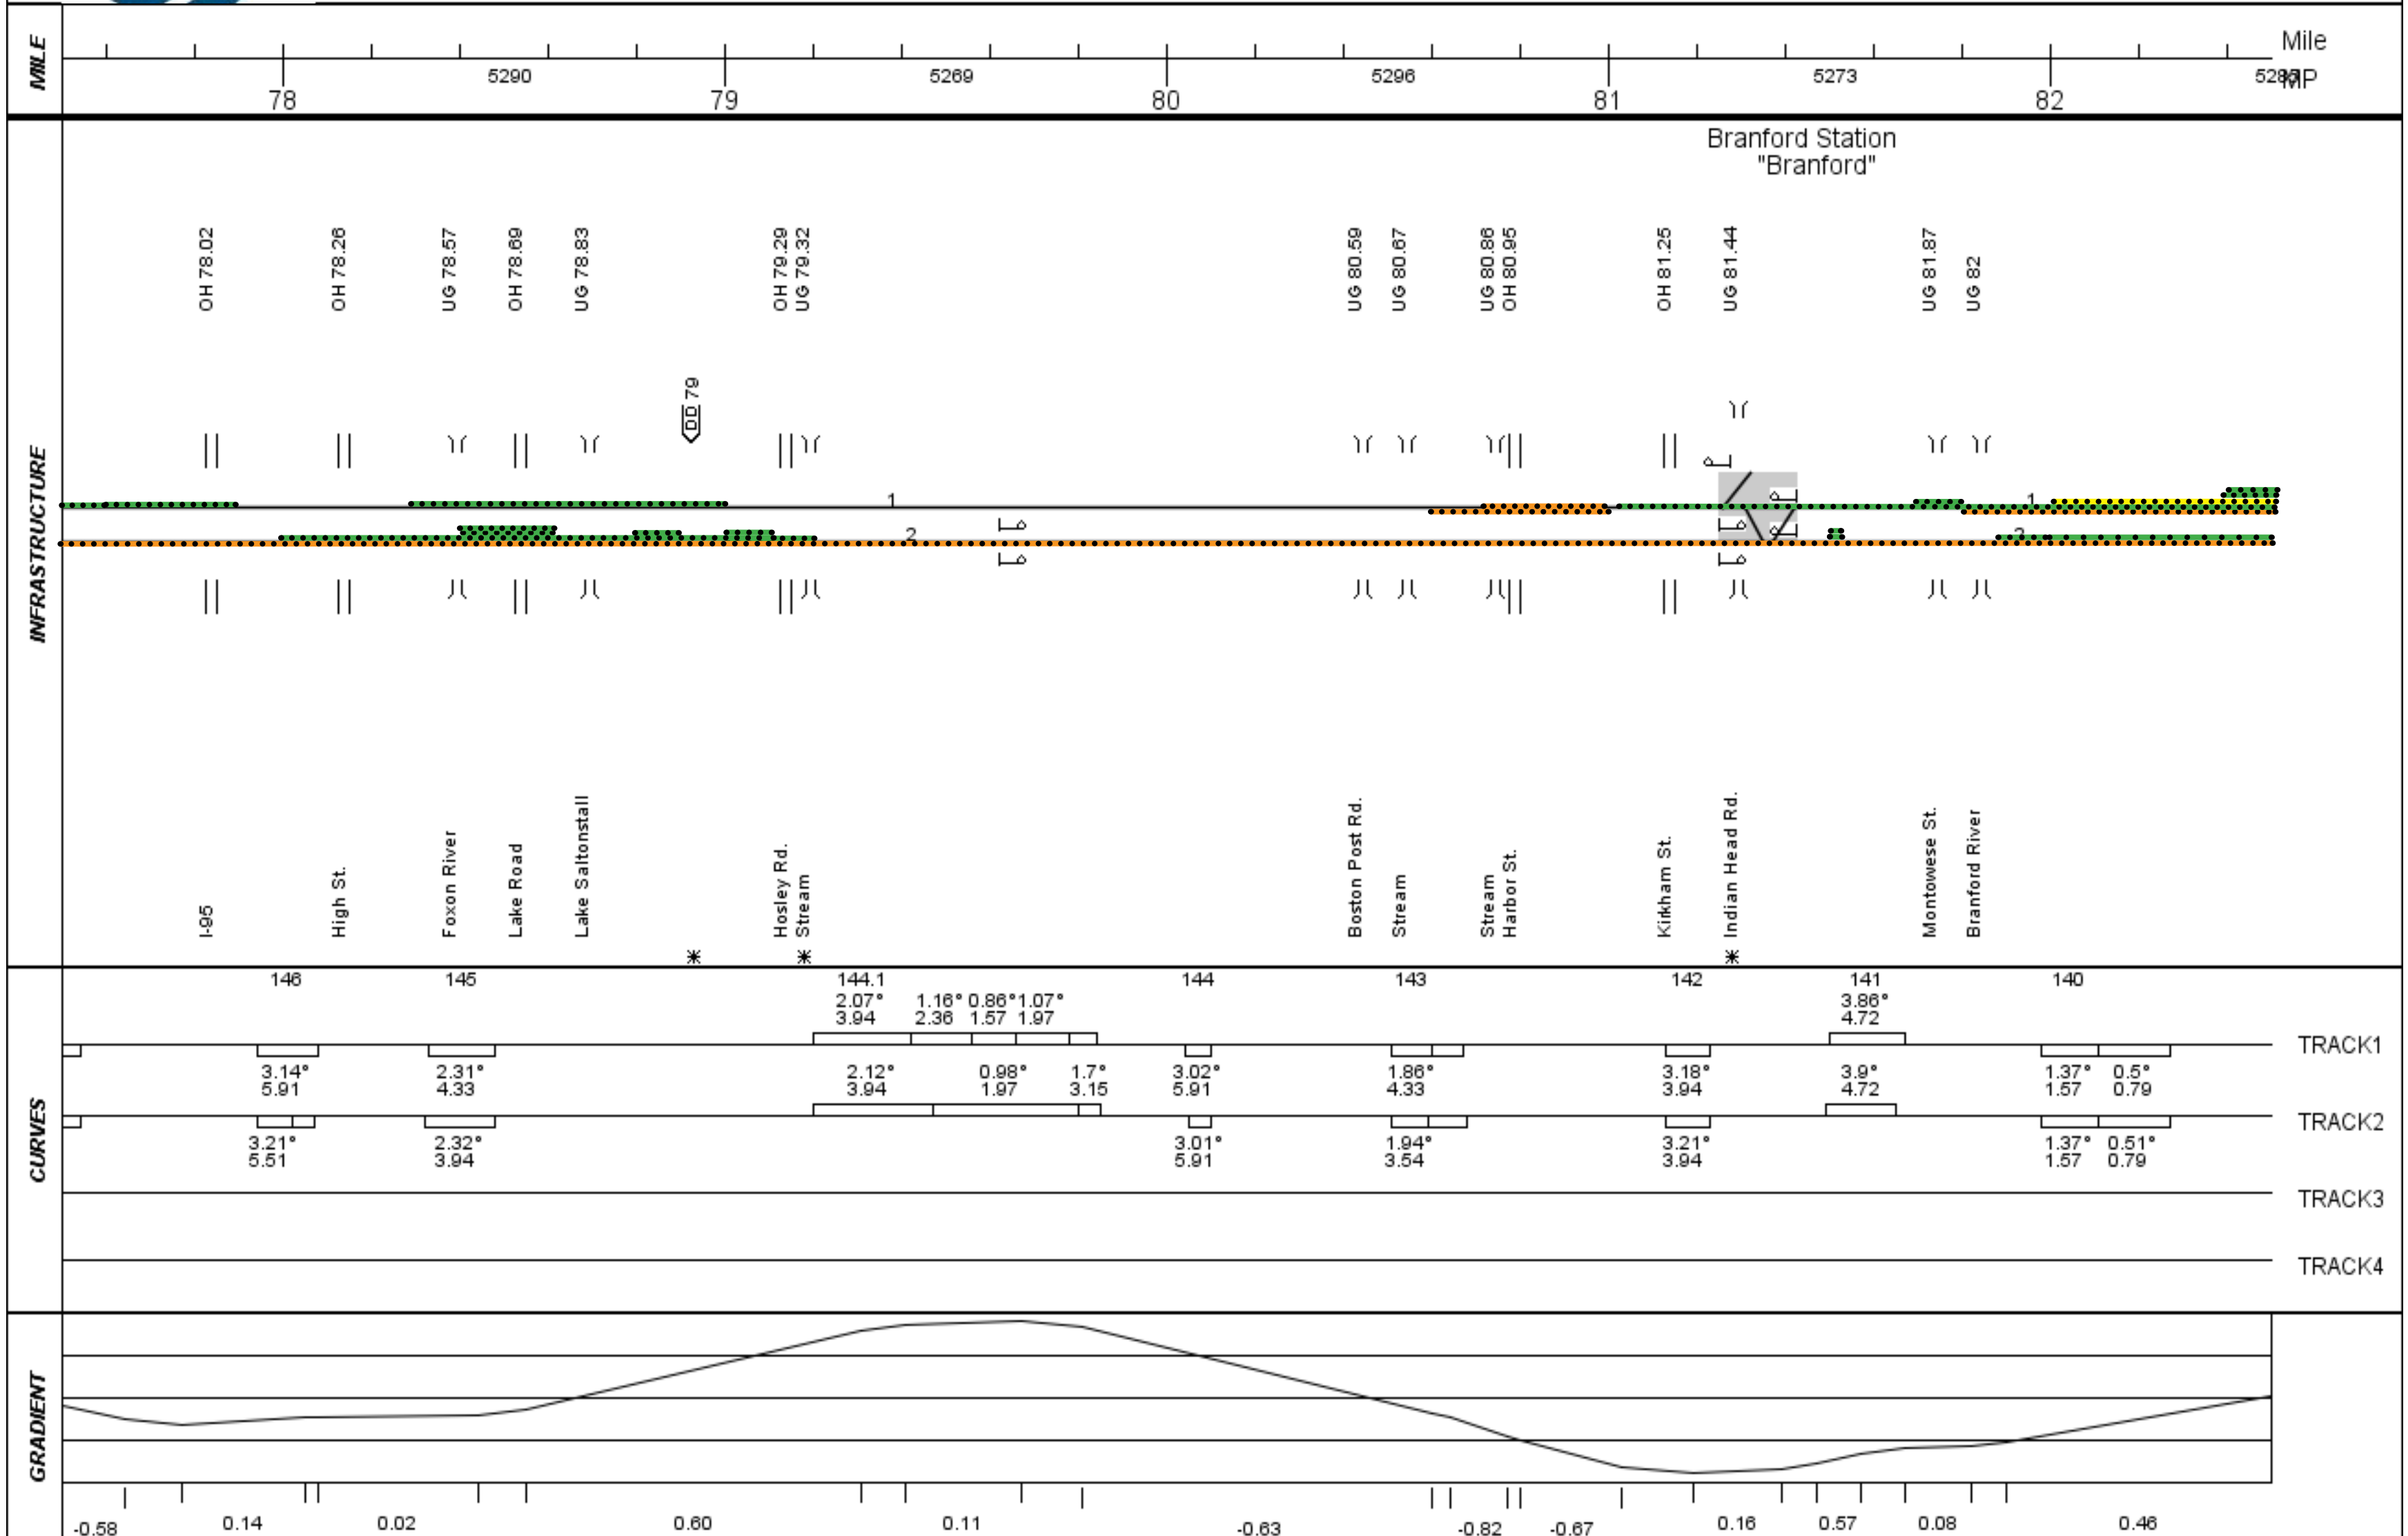
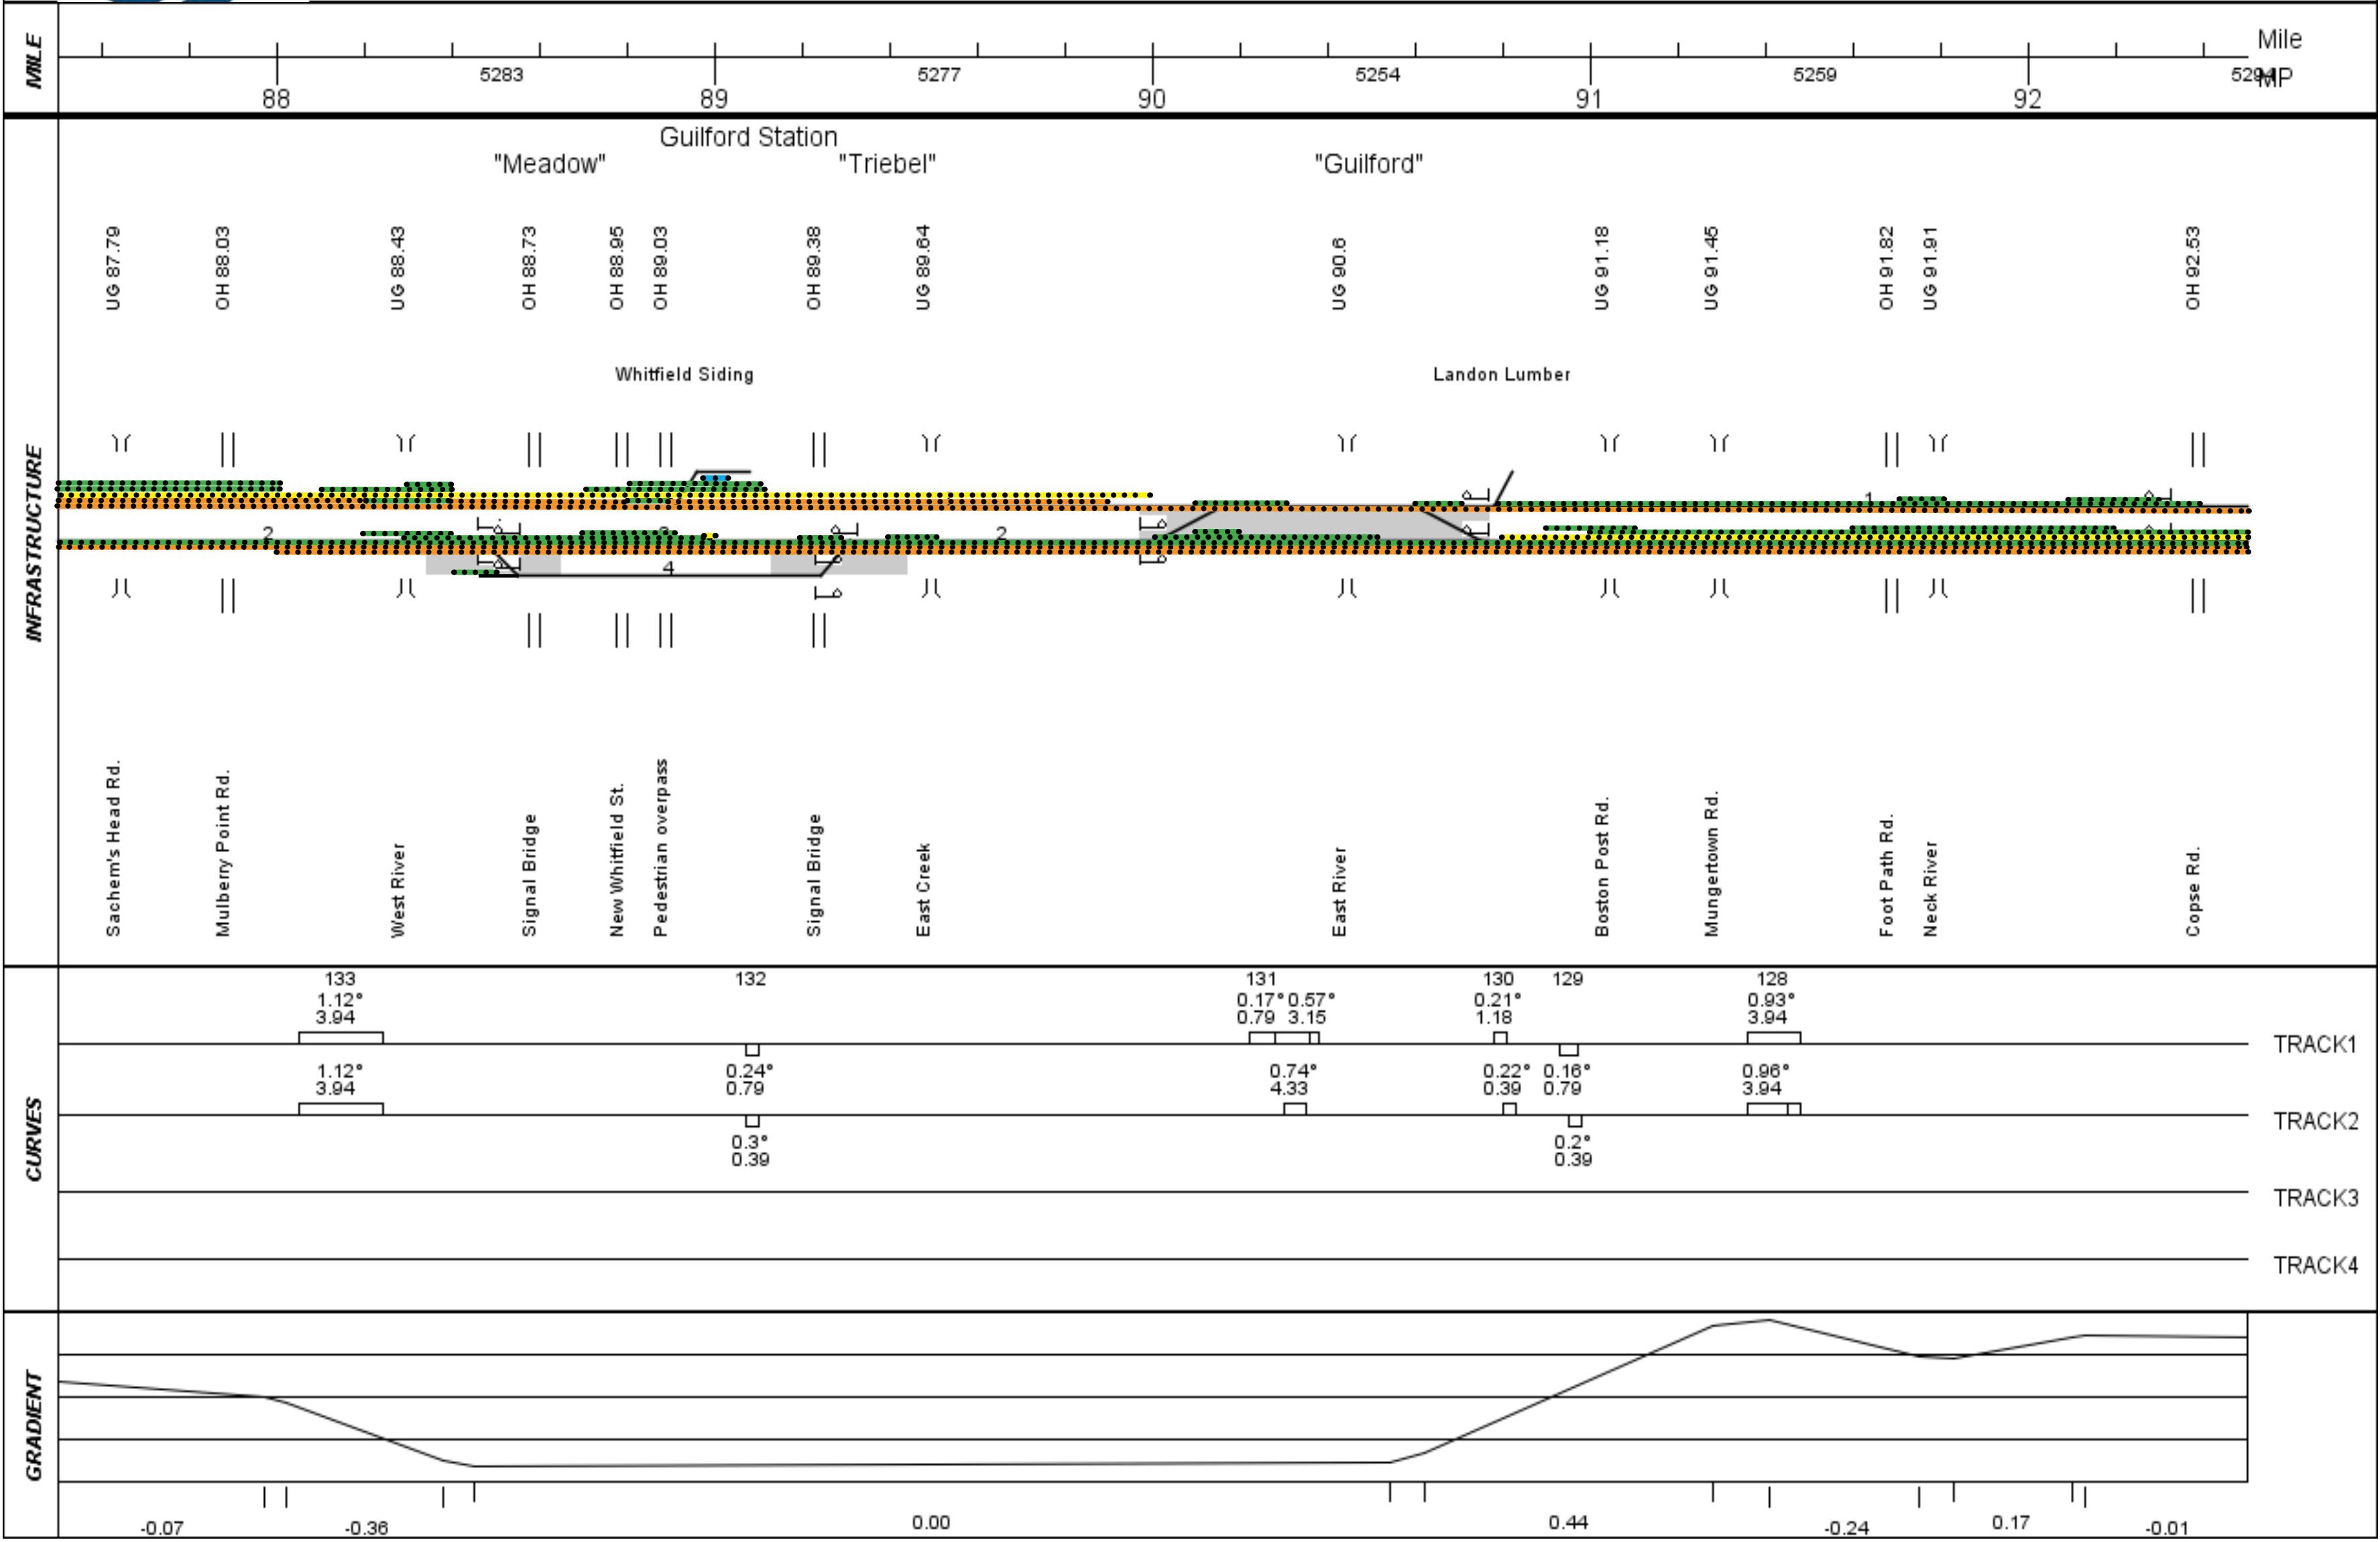
AB Line

Track Charts

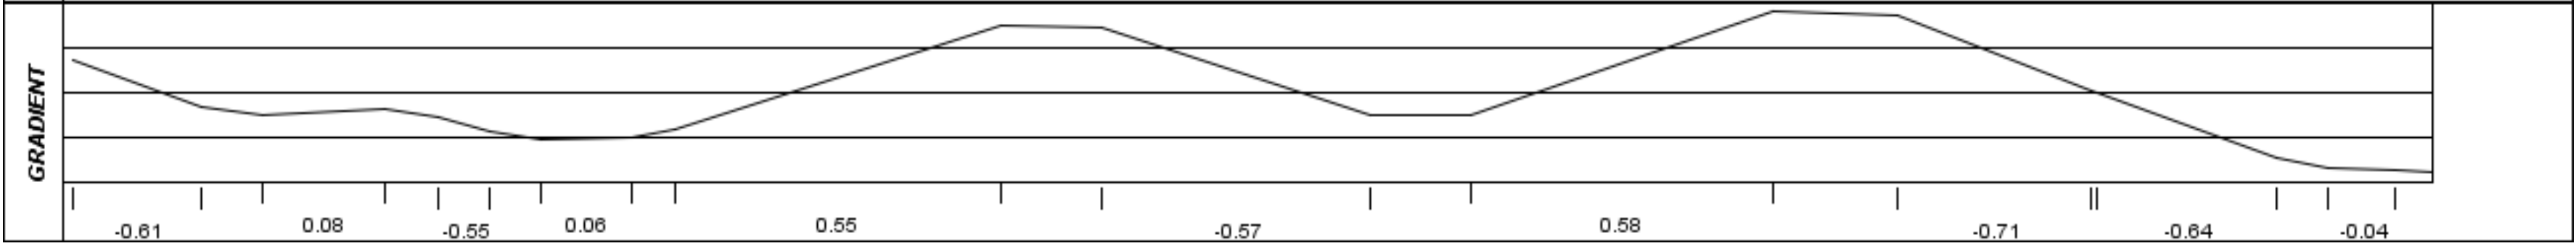
CURVES	102		101		100		99		98					97		96	TRACK
	3.05° 5.91	3.06° 5.51	2.03° 3.54	3.16° 5.51	2.58° 4.33	1.16° 1.18	1.05° 1.18	1.5° 1.57	0.86° 0.79	3.57° 3.94	0.54° 0.79	1.22° 1.18					
	3.02° 5.12	0.99° 1.57	3.12° 5.51			1.25° 1.57	1.01° 1.18	1.51° 1.57	0.84° 0.79	3.7° 4.33	0.72° 0.79	1.08° 1.18			TRACK1		
															TRACK2		
															TRACK3		
															TRACK4

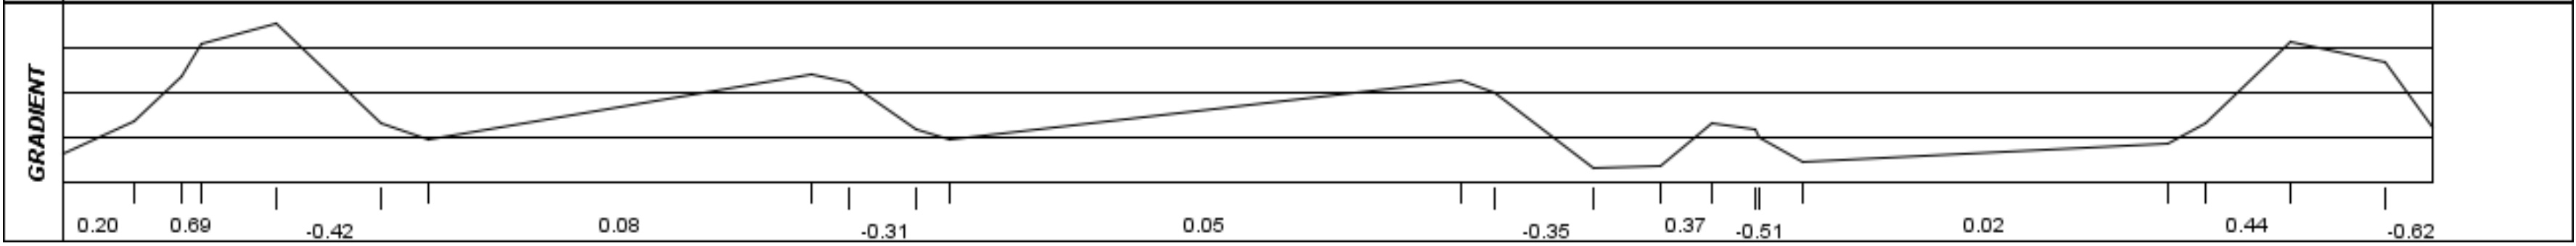
CURVES	80		79		78		77		76		75		
	0.68° 1.18	2.92° 4.72	2.43° 5.12	2.93° 3.94	2.98° 5.12	2.86° 3.94	3.86° 5.12	3.4° 4.33	1.32° 1.57	3.81° 5.12	3.35° 4.72	1.32° 1.97	
TRACK1													
TRACK2													
TRACK3													
TRACK4

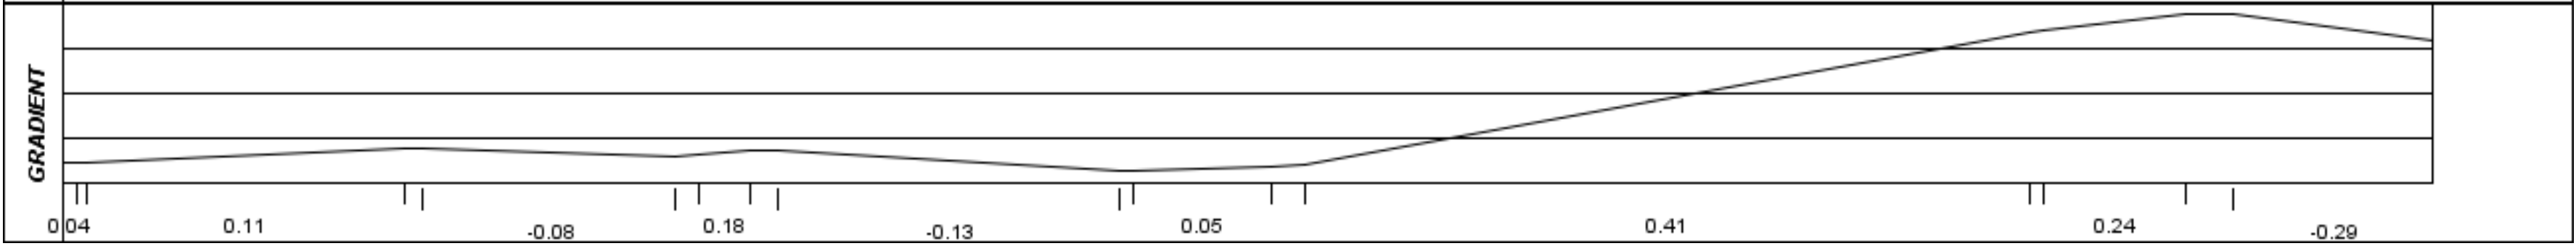
CURVES	66			65			64			63			TRACK
	1.01° 3.15	1.94° 5.91	1.02° 3.15	1.58° 5.91	1.1° 4.33	1.29° 4.72	1.9° 5.91	2.19° 5.12	2.09° 5.12	2.22° 5.12	2.24° 5.51	2.1° 5.12	
	1.01° 2.76	1.97° 5.91	1.05° 3.15				1.81° 5.12

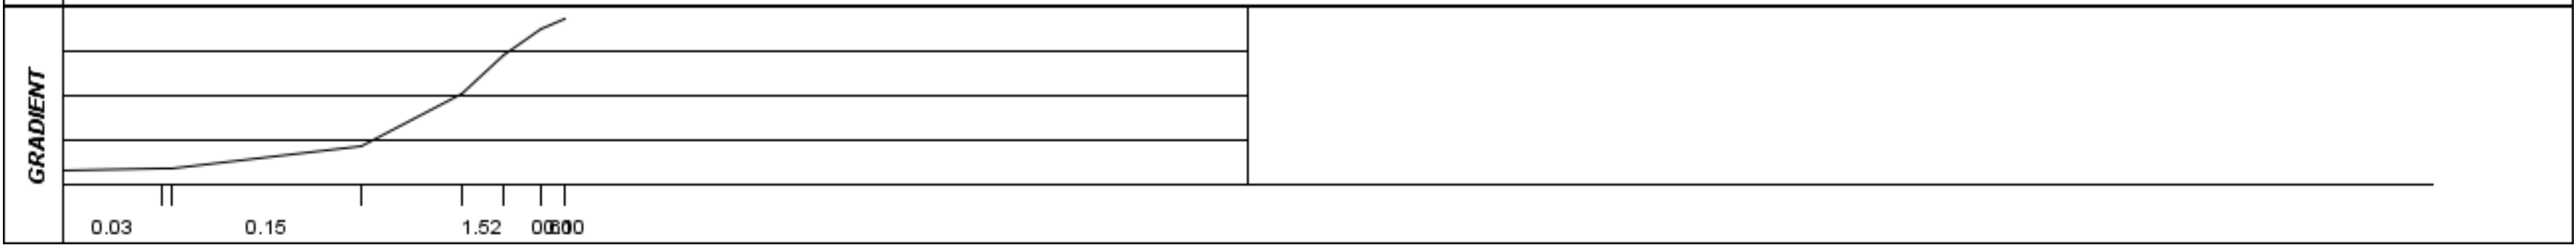
CURVES	7					6		5		4		3		TRACK1
	0.76°	0.0	0.65°	3.83°	4.56°	0.79°	10.35°	0.76°	3.40°	0.39	0.0	1.18		
	0.0	1.18	1.18	0.0	0.0	1.18							TRACK2	
	1.21°	3.38°	3.62°	0.99°	0.39	0.79	0.79	0.39					TRACK3	
			0.22°	12.5°	0.0	1.18							TRACK4

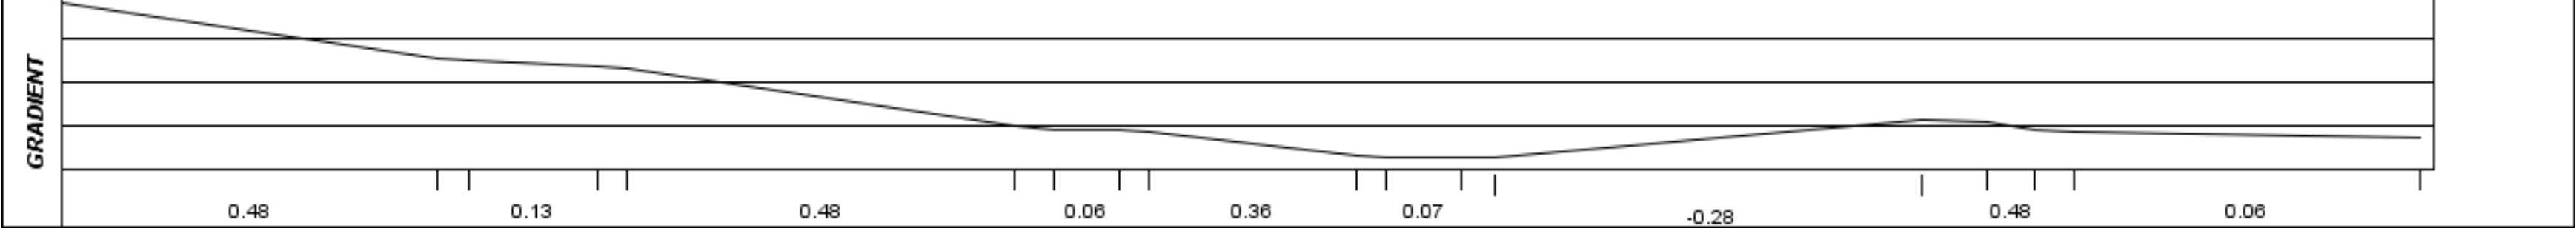
CURVES

265	0.78° 2.76	0.87° 3.15	0.83° 3.15	264	0.77° 3.15	261	0.43° 1.18	0.52° 1.18	0.45° 0.79	258	0.16° 0.79	0.36° 3.15	256
1.83° 5.91	0.44° 1.57	0.79° 3.15	0.85° 3.54	0.83° 3.15	0.76° 2.76	0.72° 2.76	0.4° 1.18	0.53° 1.57	0.08° 0.39	0.31° 1.18	0.2° 0.79	0.36° 3.15	
1.31° 5.12	0.86° 4.33	0.82° 4.33	0.28° 1.57	0.76° 3.15	0.73° 2.76	0.78° 3.94	0.41° 1.57	0.53° 1.57	0.08° 0.39	0.31° 1.18	0.2° 0.79	0.36° 3.15	
1.5° 5.12	0.85° 3.15	0.81° 3.15	0.87° 3.15	0.76° 3.94	0.78° 3.94	0.79° 3.15	0.46° 1.18	0.51° 1.97		0.34° 0.79	0.53° 3.15		
0.44° 1.57				0.71° 2.76	0.82° 3.15	0.85° 4.33		0.63° 1.57	0.41° 0.79		0.49° 1.18
