# Bubble Leak Test

**Tank Car Qualification Report - Tank Qualification**

**Tank Car Qualification  
TCQ-1 Appendix B to DOT - SP 12095  
Inspection and Test Report**

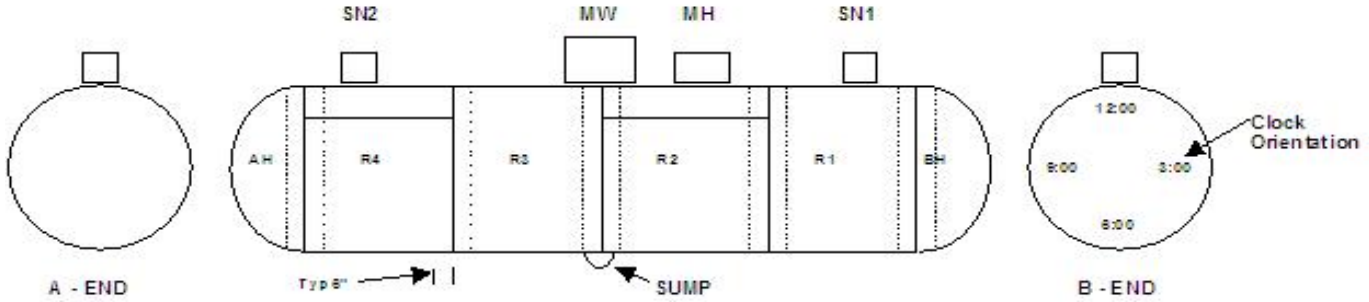
9 Measure the thickness of the following and verify compliance with minimum thickness. If corrosion is visible, then take additional readings in a grid pattern to determine the minimum thickness in suspect areas and record the readings on a corrosion report

**Record Original Shell Thickness: 0.4375**

Location	Thickness	Location	Thickness	Location	Thickness	Location	Thickness	Location	Thickness
R1B12:00	0.446	R2B12:00	0.452	R3B12:00	0.455	R4B12:00	0.455	R5B12:00	0.457
R1B3:00	0.443	R2B3:00	0.460	R3B3:00	0.459	R4B3:00	0.460	R5B3:00	0.458
R1B6:00	0.450	R2B6:00	0.463	R3B6:00	0.466	R4B6:00	0.462	R5B6:00	0.464
R1B9:00	0.448	R2B9:00	0.460	R3B9:00	0.462	R4B9:00	0.452	R5B9:00	0.465
R1A12:00	0.450	R2A12:00	0.452	R3A12:00	0.460	R4A12:00	0.453	R5A12:00	0.455
R1A3:00	0.461	R2A3:00	0.459	R3A3:00	0.471	R4A3:00	0.457	R5A3:00	0.457
R1A6:00	0.451	R2A6:00	0.465	R3A6:00	0.470	R4A6:00	0.457	R5A6:00	0.462
R1A9:00	0.454	R2A9:00	0.462	R3A9:00	0.466	R4A9:00	0.452	R5A9:00	0.461

Location	Thickness	Location	Thickness	Location	Thickness
R6B12:00	0.455	BH	0.523	AH	0.520
R6B3:00	0.455	BH12:00	0.531	AH12:00	0.530
R6B6:00	0.461	BH3:00	0.530	AH3:00	0.533
R6B9:00	0.455	BH6:00	0.533	AH6:00	0.566
R6A12:00	0.458	BH9:00	0.530	AH9:00	0.533
R6A3:00	0.466	MW B	0.722	MH B	0.557
R6A6:00	0.433	MW A	0.724	MH A	0.555
R6A9:00	0.455	SN1 B	0.383	SN2 B	NA
SUMP	0.451	SN1 A	0.385	SN2 A	NA

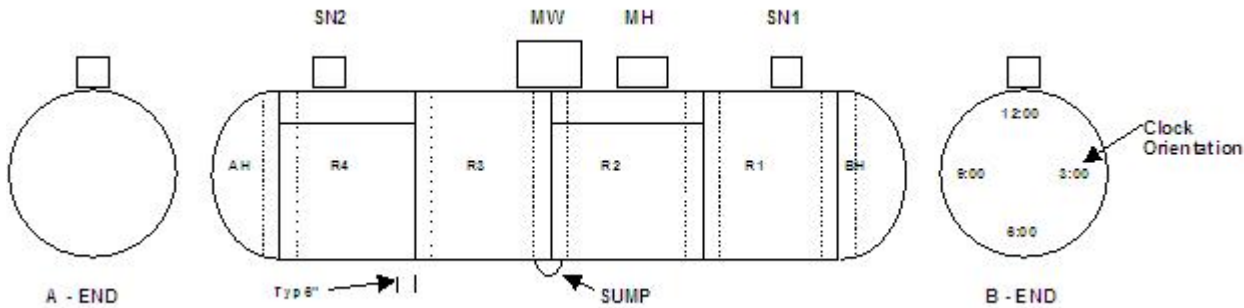
Location	Thickness	Location	Thickness
R1 6:00	N/A	R5 6:00	N/A
R1 10:00	N/A	R5 10:00	N/A
R2 6:00	N/A	R6 6:00	N/A
R2 10:00	N/A	R6 10:00	N/A
R3 6:00	N/A	R7 6:00	NA
R3 10:00	N/A	R7 10:00	NA
R4 6:00	N/A	MW	N/A
R4 10:00	N/A	SUMP	N/A

**Measure and record the coating thickness at the locations listed above:**
