Qualification Inspection & Test

Reporting Mark and Car Number UTLX 209403 Shop Location UTCO Marion, OH
 Stenciled Specification DOT117R100W Built Date (month / yr) 10/2007
 Car Jacketed Car Non-Jacketed Inspection Date (month / yr) 4/19/16
 Previous Commodity CRUDE OIL
 (If under corrosive listing, see UTC Bad Actor List)

Report of Alterations, Conversions, Welded Repairs, and Stub Sill Inspections

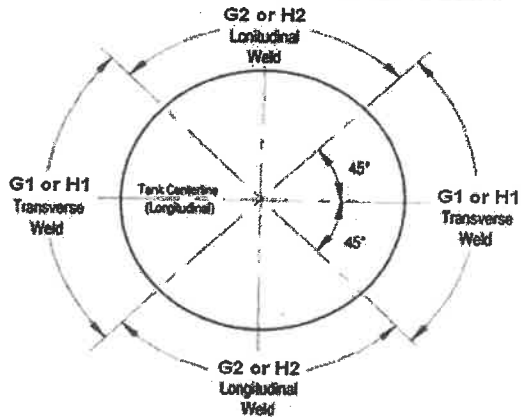
Typical Saddle and Sump Weld Detail

BOV SADDLE WELDS						
Weld Code	Description	Inspection Technique	Number of Cracks	Max Crack Length (0.00)	Crack Orientation Code	How Repaired
G1	Transverse portions of BOV saddle weld. Full length of transverse portions of welds.	VT	0			
		VT	0			
G2	Longitudinal portions of BOV saddle weld. Full length of longitudinal portions of welds.	VT	0			
		VT	0

SUMP WELDS						
Weld Code	Description	Inspection Technique	Number of Cracks	Max Crack Length (0.00)	Crack Orientation Code	How Repaired
H1	Transverse portions of sump weld. Full length of transverse portions of welds.	VT	0			
		VT	0			
H2	Longitudinal portions of sump weld. Full length of longitudinal portions of welds.	VT	0			
		VT	0

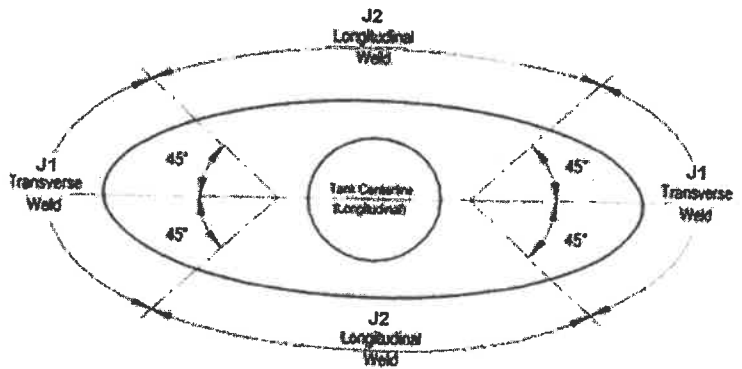
Skid Weld Detail

BOV SKID WELDS						
Weld Code	Description	Inspection Technique	Number of Cracks	Max Crack Length (0.00)	Crack Orientation Code	How Repaired
J1	Transverse portions of BOV skid weld. Full length of transverse welds.	VT	0			
		VT	0			
J2	Termination of BOV skid longitudinal welds.	VT	0			
		VT	0

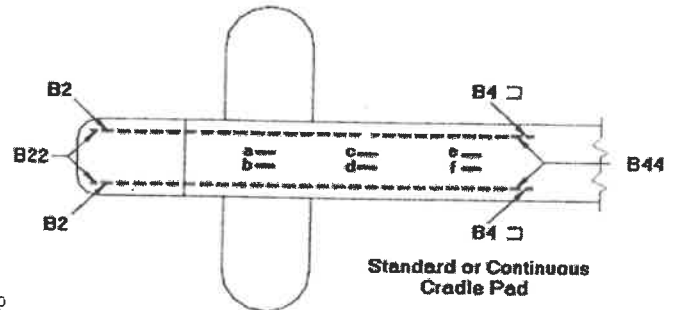
Weld Code	Description	Location	Inspection Technique	Number of Cracks	Max Crack Length (0.00)	Crack Orientation Code	How Repaired
B2	Outboard termination of longitudinal weld (outside of sill). Last 6" of weld.	A-End Right	VT	0			
		A-End Left	VT	0			
		B-End Right	VT	0			
		B-End Left	VT	0			
B4	Inboard termination of longitudinal weld (outside of sill). Last 6" of weld including any portion of weld that wraps around sill and connects with B44.	A-End Right	VT	0			
		A-End Left	VT	0			
		B-End Right	VT	0			
		B-End Left	VT	0			
B22	Outboard termination of longitudinal weld (inside of sill). Last 6" of weld.	A-End Right	VT	0			
		A-End Left	VT	0			
		B-End Right	VT	0			
		B-End Left	VT	0			
B44	Inboard termination of longitudinal weld (inside of sill). Last 6" of weld.	A-End Right	VT	0			
		A-End Left	VT	0			
		B-End Right	VT	0			
		B-End Left	VT	0
