National Transportation Safety Board

CEN22FA317

Group Chair's Factual Report - Attachment #3

T53 Engine S/N LE-23701RX Oil Samples Report
& Oil Analysis Maintenance Manual

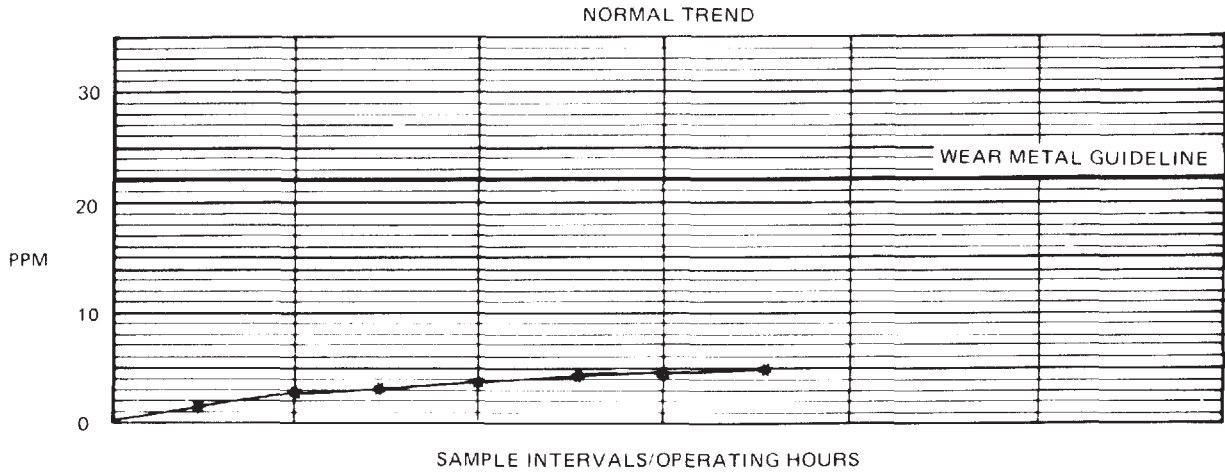
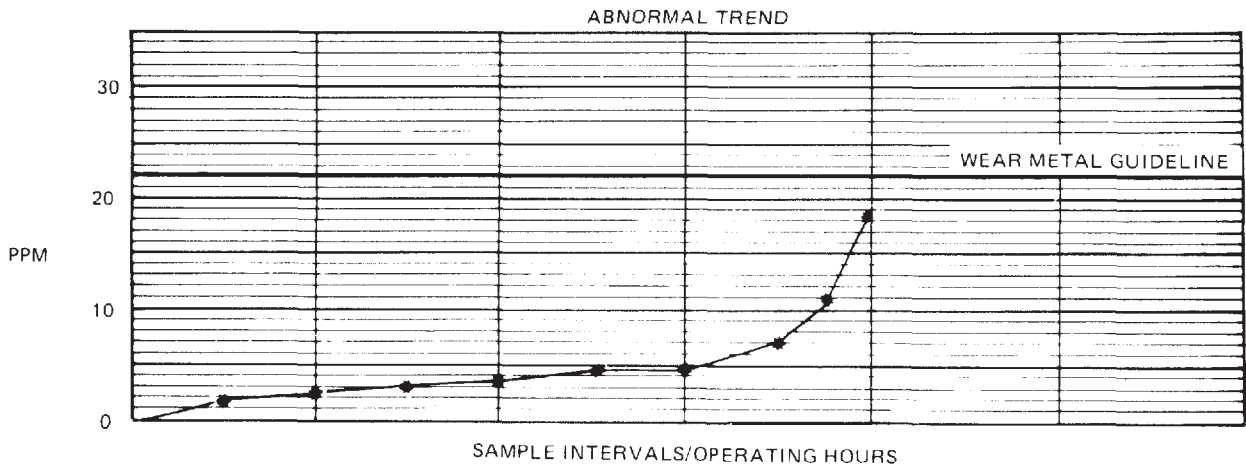
Wear Metal Trend (Example)
Figure 602

XA-738-422

CAUTION: WEAR METAL IS NORMALLY GENERATED AT A SLOW STEADY RATE. SUCCESSIVE OIL SAMPLES SHOULD SHOW A TREND OF INCREASING WEAR METAL CONTENT. A SUDDEN JUMP OR INCREASE IN WEAR METAL CONTENT BETWEEN SUCCESSIVE OIL SAMPLES INDICATES AN ACCELERATED WEAR RATE. AFTER CONFIRMATION OF AN ACCELERATED WEAR RATE, THE CAUSE SHOULD BE IMMEDIATELY IDENTIFIED AND CORRECTED. ALLOWING ACCELERATED WEAR TO CONTINUE MAY RESULT IN FAILURE OF AN ENGINE COMPONENT.

- (b) Evaluate laboratory reports for wear metal buildup trends from one sample to another. (See Figure 602.)
- (c) If an abnormal increase in wear metal is noted, immediately take another oil sample and forward to laboratory for verification of increase.
