CEN20FA110

NTSB Airframe and Engine Examination Report

Airframe (N157SF, Cessna 172S, Serial Number 172S11265)

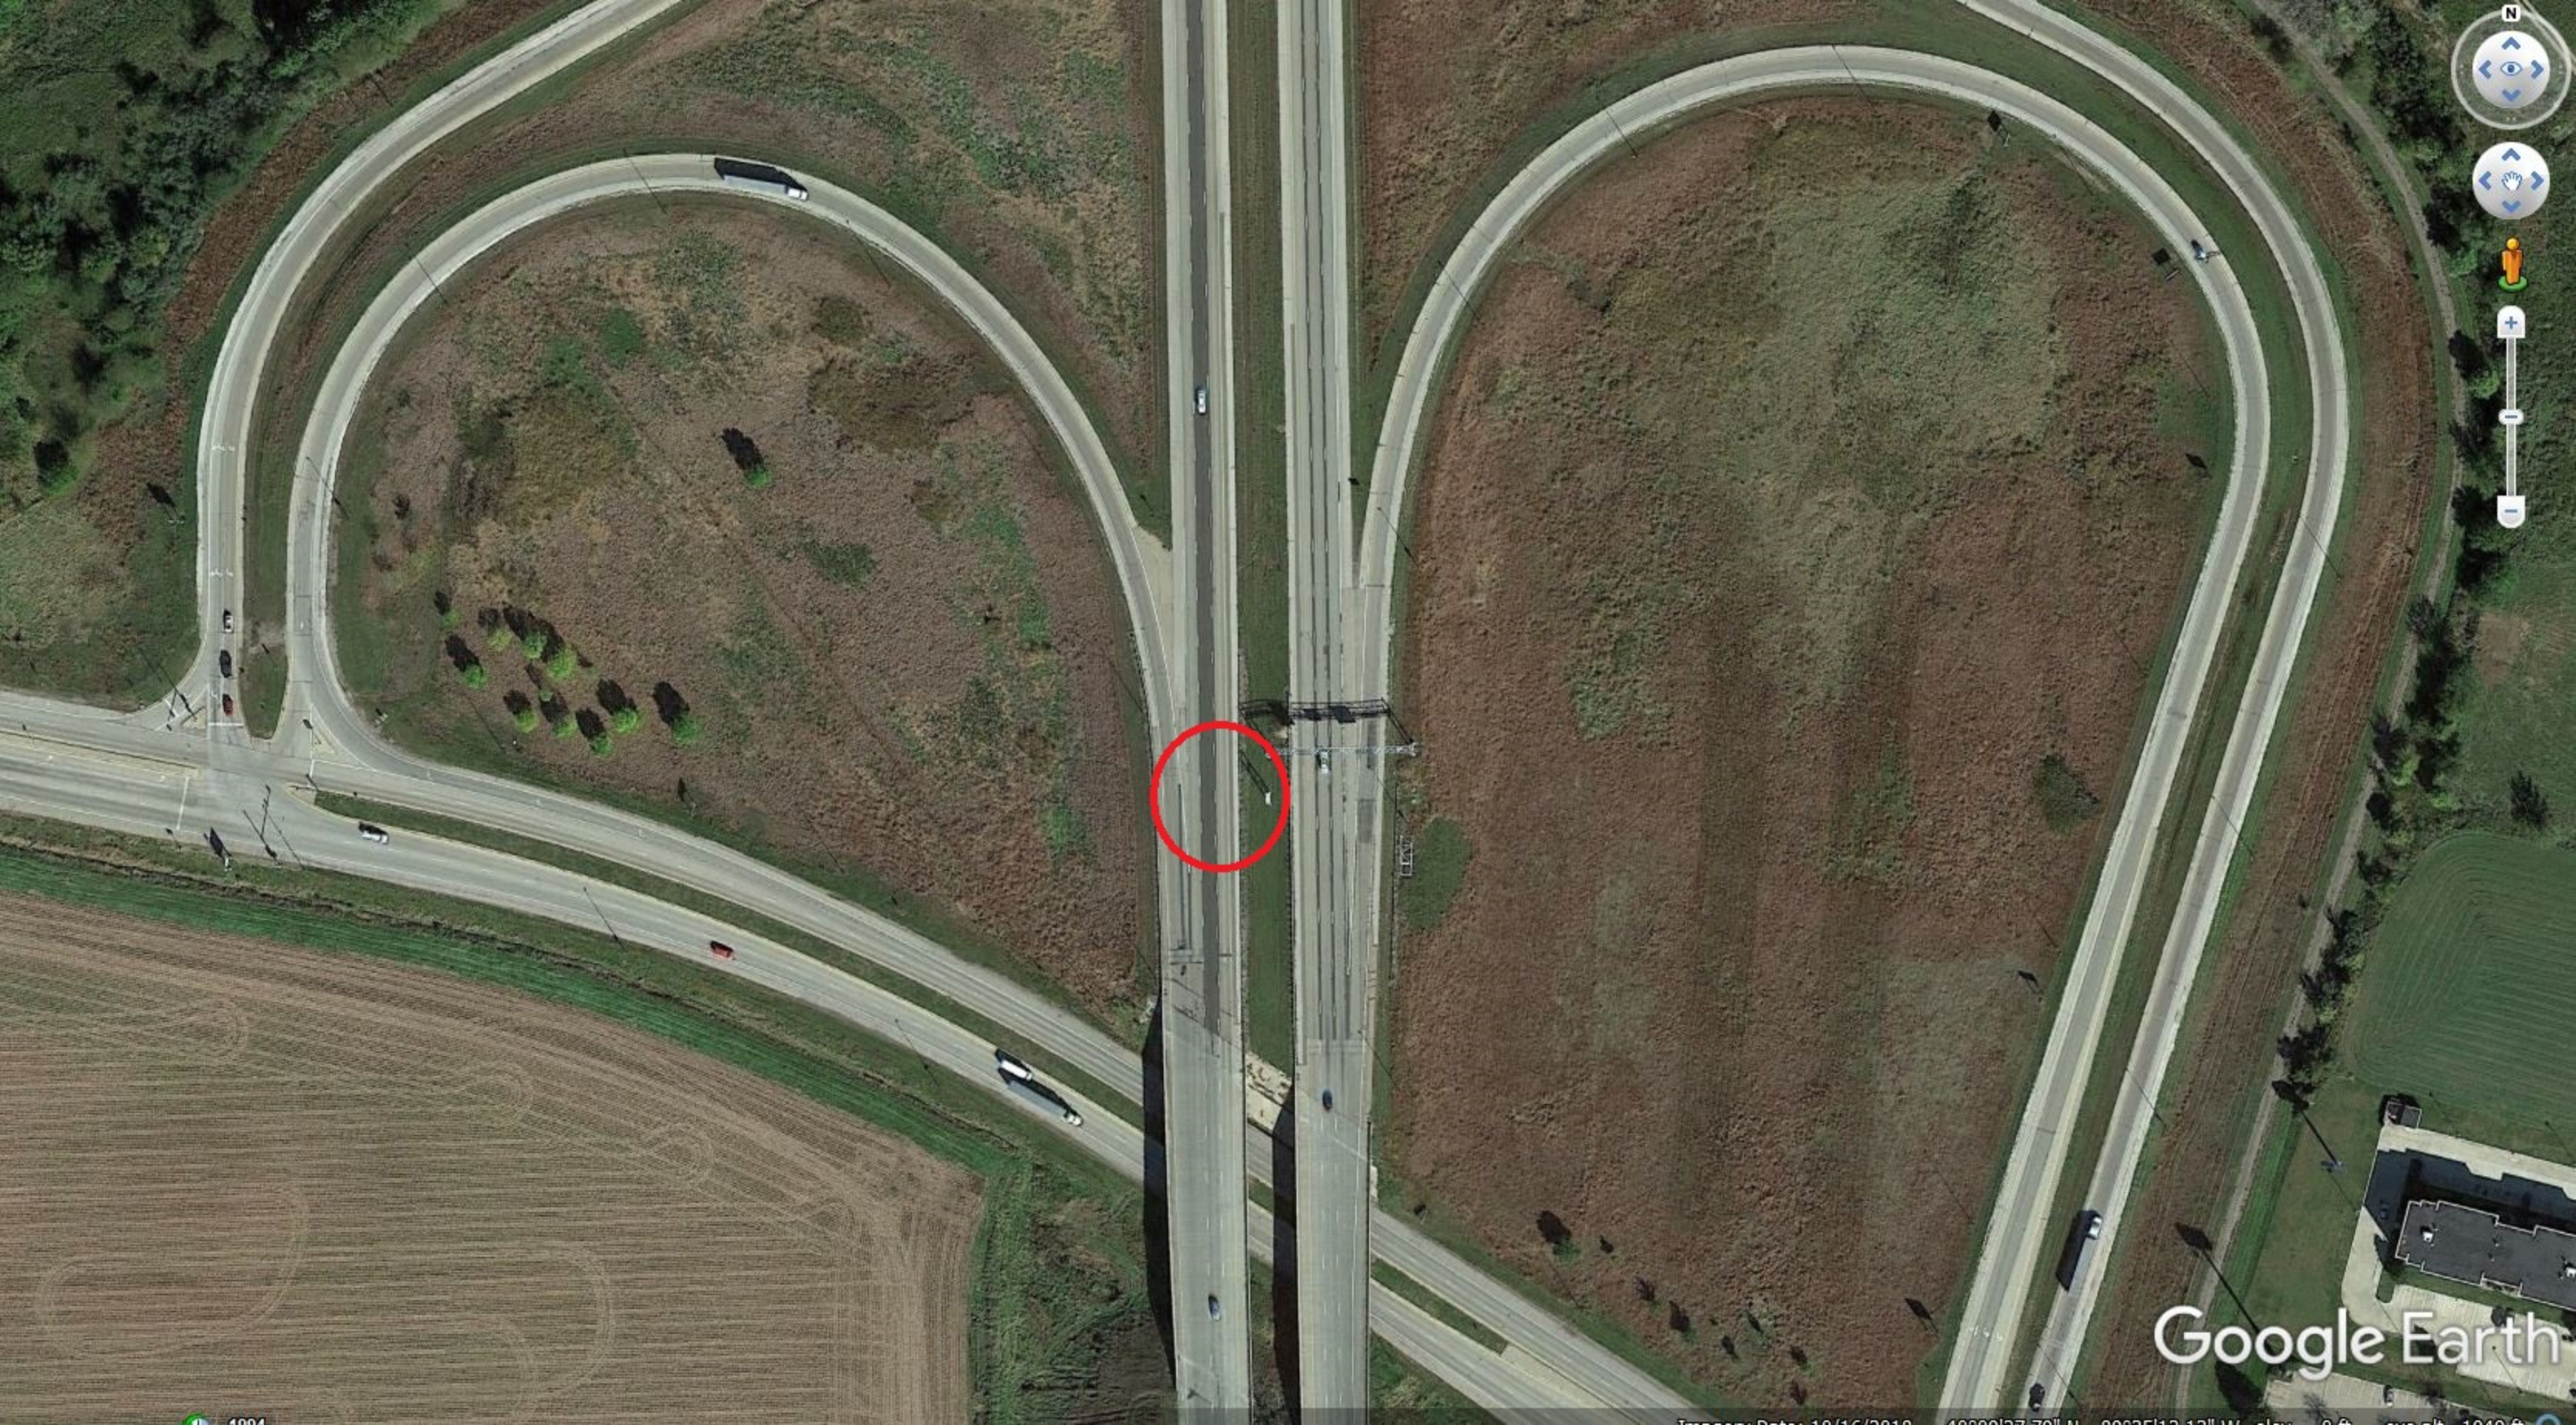
Google Earth

Imagery Date: 10/16/2010 40000127 701 N 00025112 121 W elev: 0 ft zoom: 1010 ft

A Federal Aviation Administration aviation safety inspector responded to the accident site to conduct onsite documentation activities on March 3, 2020. The accident site consisted of asphalt and the airplane came to rest on a heading of about 280° (magnetic). The accident site elevation was about 566 feet above mean sea level. No obstacles in the vicinity of the accident site appeared to be struck from the airplane. The airplane impacted the terrain in a nose-down attitude. All components of the airframe and engine were located at the accident site. Google Earth diagrams of the accident site are attached to this report.

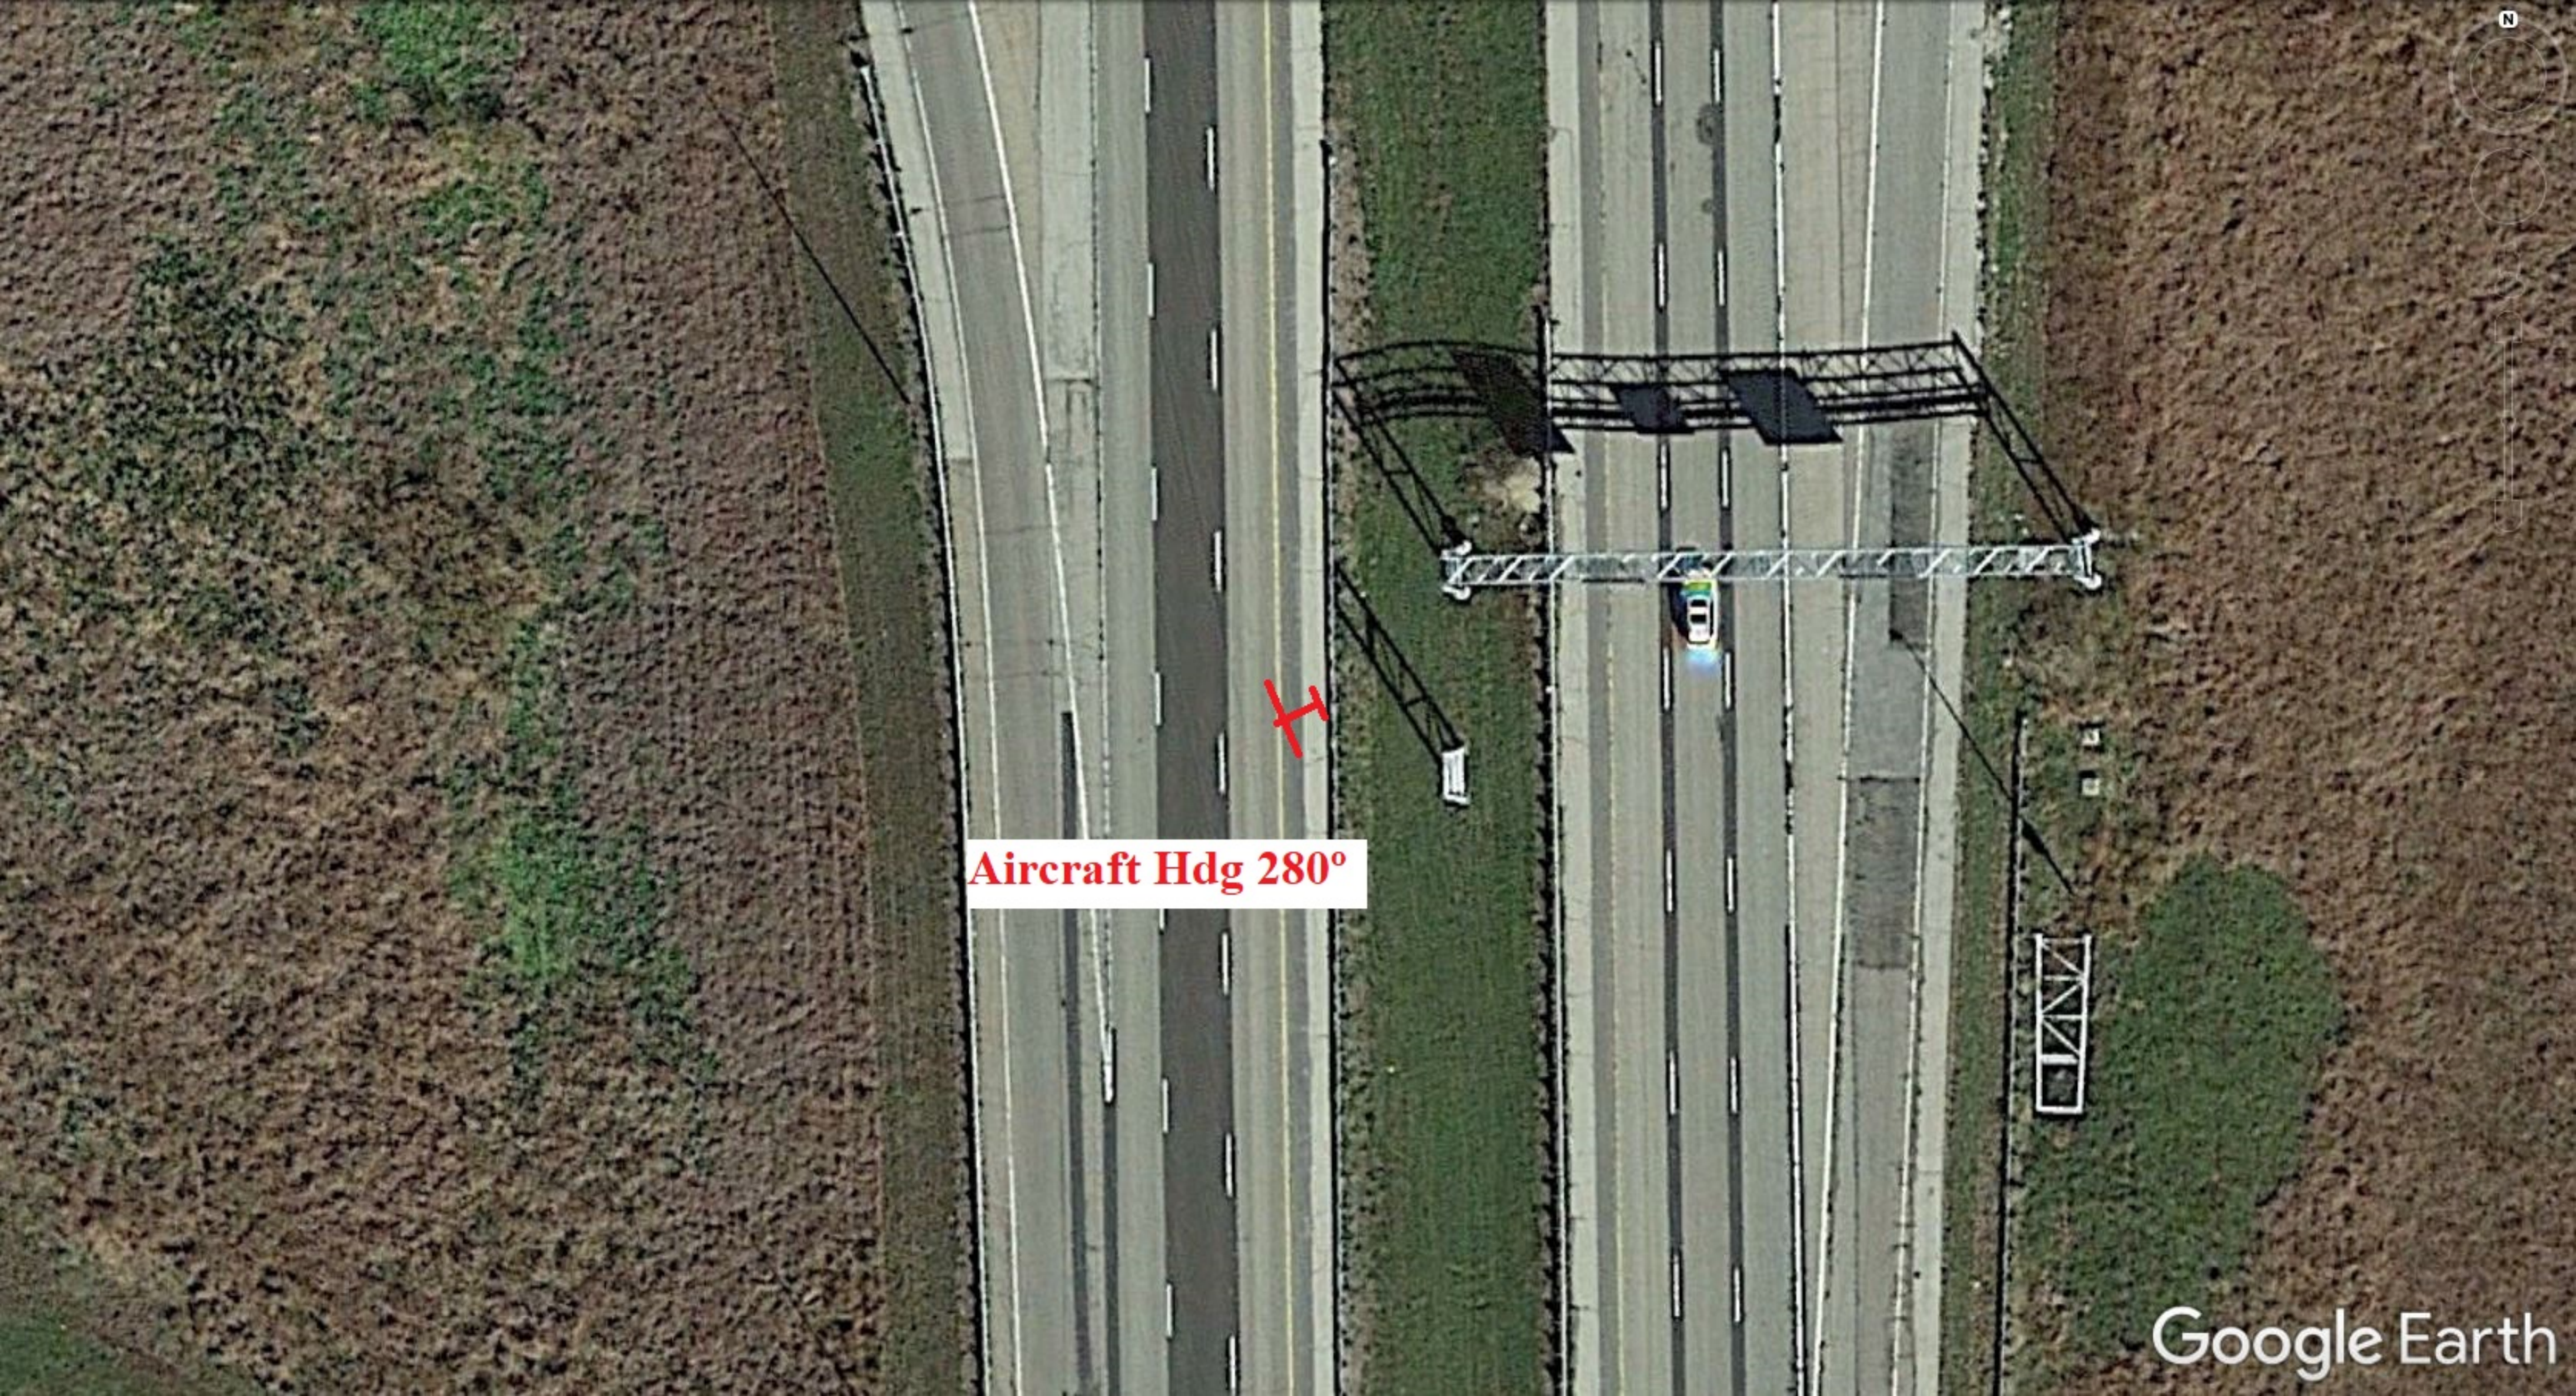
Aircraft Hdg 280°
