# Management of In-Train Forces: Challenges and Directions

Railroad Safety White Paper

Grady C. Cothen, Jr.

June 9, 2022, v3.0

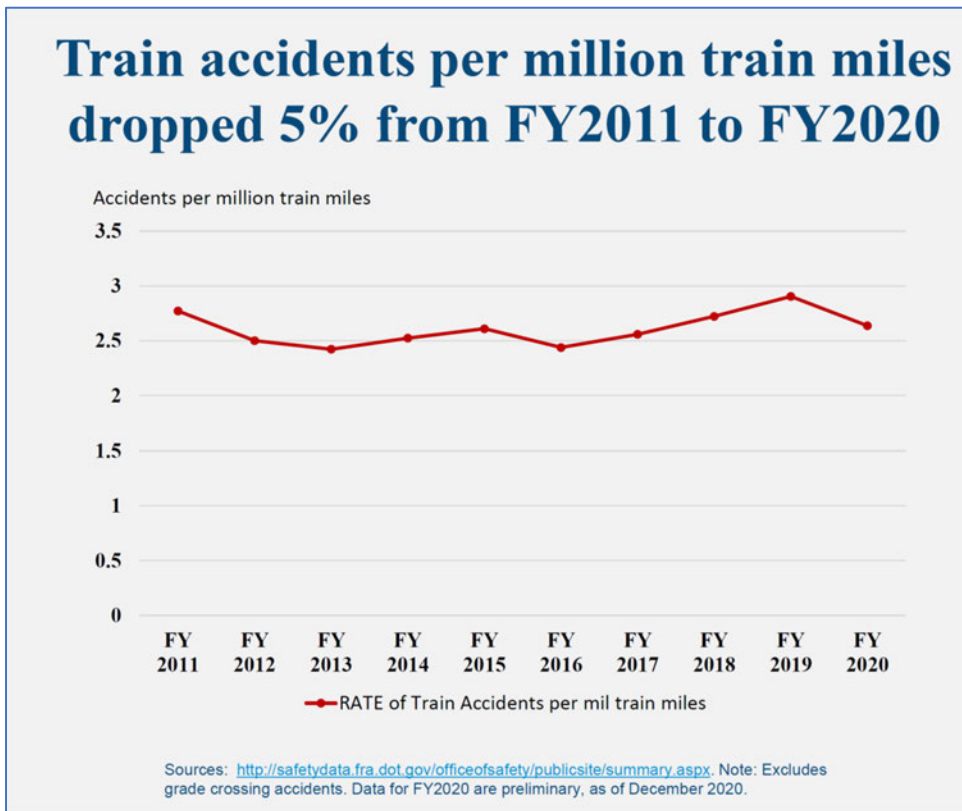
**Figure 1 – Train Accident Rate / All Railroads**

In Figure 1, AAR displays data for Federal fiscal years, which end September 30<sup>th</sup>. It includes all railroads.

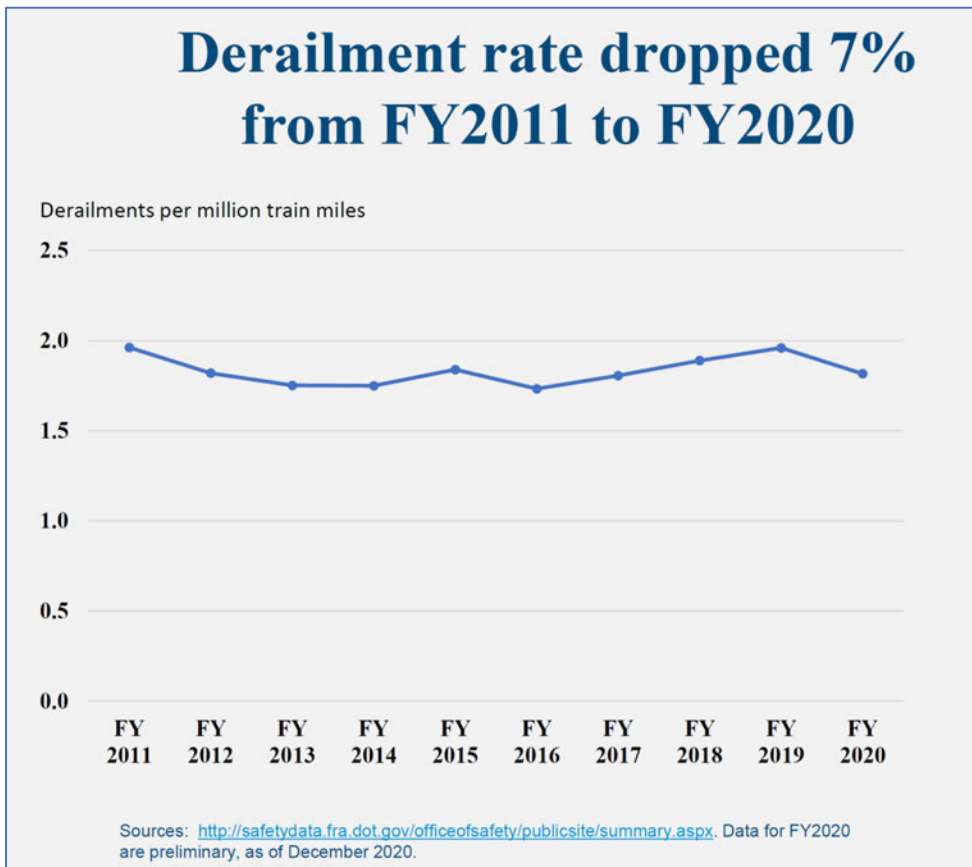
**Figure 2 – Derailment Rates for All Railroads**

Again, this is data for all railroads. It reflects derailments on all track (including yard and main line).

In earlier versions of this paper, we noted that placing a positive spin on these numbers requires accepting that the 2020 results reflect real progress. Let's happily concede that, at 1.90 the derailment rate for FY2021 was better than the derailment rate for FY2020, which was 1.93. Having said that, FY2016 came in at 1.70.<sup>3</sup>

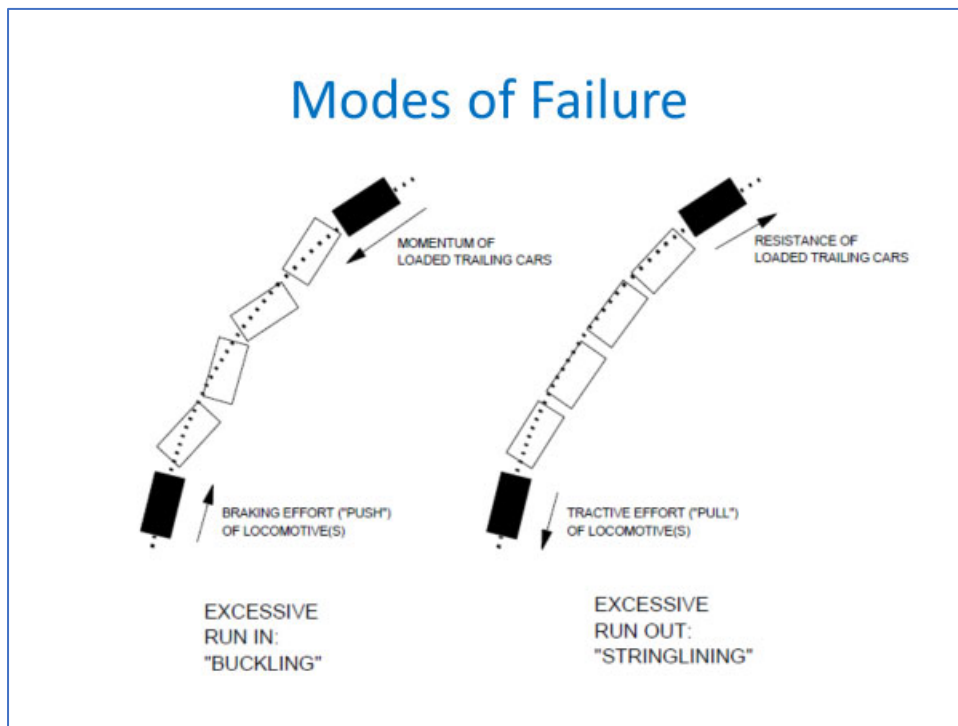
**Figure 3 – Buckling and Stringlining Illustrated**

During the author's time at FRA, the agency, with help from the Volpe National Transportation Systems Center, produced a congressional report<sup>11</sup> that describes the kinds of derailments. Here are illustrations from that report:

These classic derailment scenarios, together with run-away trains, have been staples of railroad operations since the beginning. Note that the modes of failure can result from poor use of motive power, poor braking, or poor train make-up. But other initiating causes, such as wide gage, broken rails, broken wheels, stiff trucks, etc., can set up unfavorable in-train forces; and the severity of the resulting events will increase. Even when an engineer deems it necessary to apply the emergency brake to avoid or mitigate a collision with a tanker truck stuck on the crossing ahead, or children on the track failing to respond to the train horn, the result may be a serious derailment.

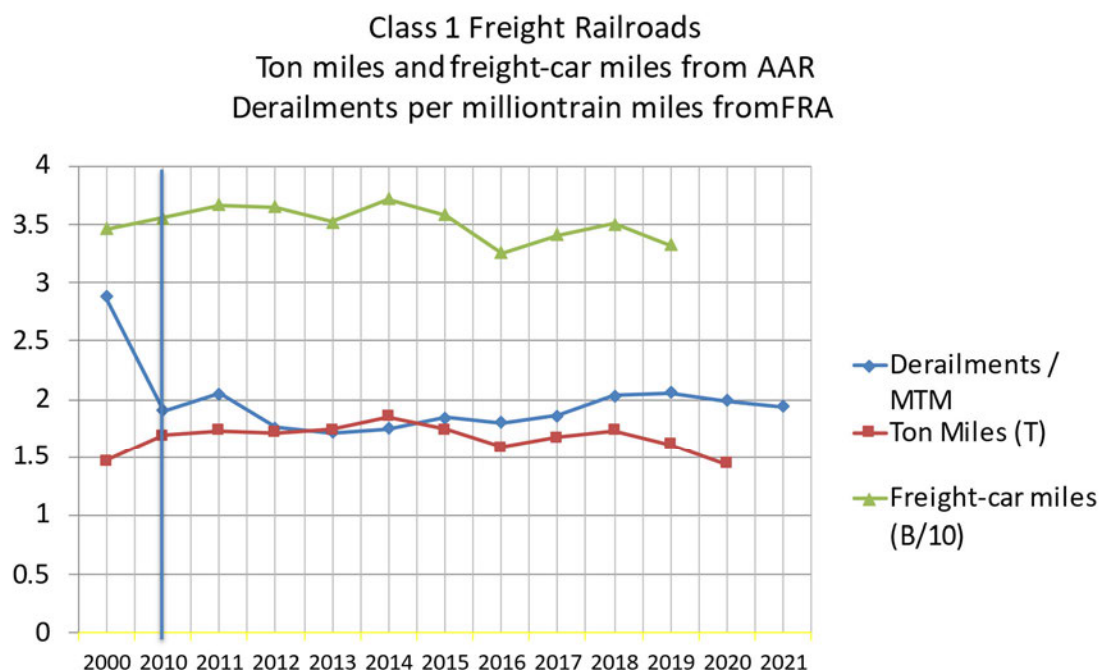
**Figure 5 – Class 1 Freight Railroad Derailment Trends (all tracks)**

Figure 5 data for ton miles and freight-car miles were taken from AAR Fact Books, and the derailments per million train miles were calculated directly from FRA data.<sup>19</sup> Note that this data varies slightly from AAR’s report of FRA data, used in prior versions, perhaps because AAR included all Class 1 railroads (including Amtrak) while the graph above applies to freight railroads only. Temporary increases in coal traffic, and a general recovery of carload traffic, likely pushed ton miles up somewhat in 2021.

There is an ongoing discussion, the resolution of which has not come to the writer’s attention, over what kind of normalizing statistic should be used in an era of very long trains. Figure 5 displays the accidents per train mile metric that both FRA and AAR have used in the past to gauge progress. Running fewer trains yields fewer train miles to serve as the denominator, even if this is being done soundly.

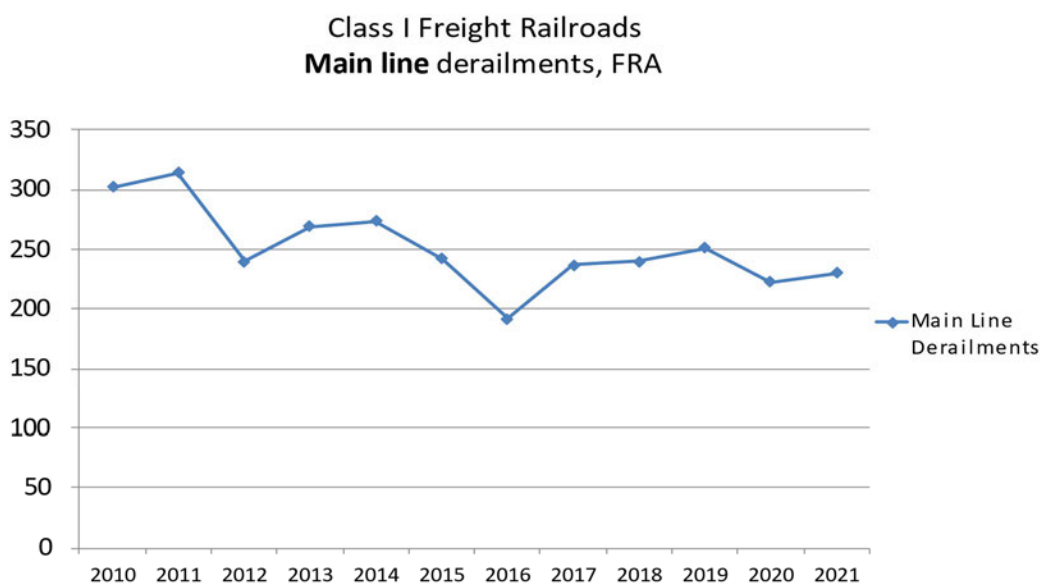
**Figure 6 – Class 1 Main Line Derailments (counts only)**

While running many fewer trains, the major railroads continue to report a steady or increasing number of main line derailments. What is behind this trend? First, “human factor” derailments having been gradually rising, even as track-caused accidents decline steadily. As would be expected with the rise of in-train forces associated with PSR, equipment caused derailments also remain at a significant level—this, despite all of the advances in wayside detection technologies.

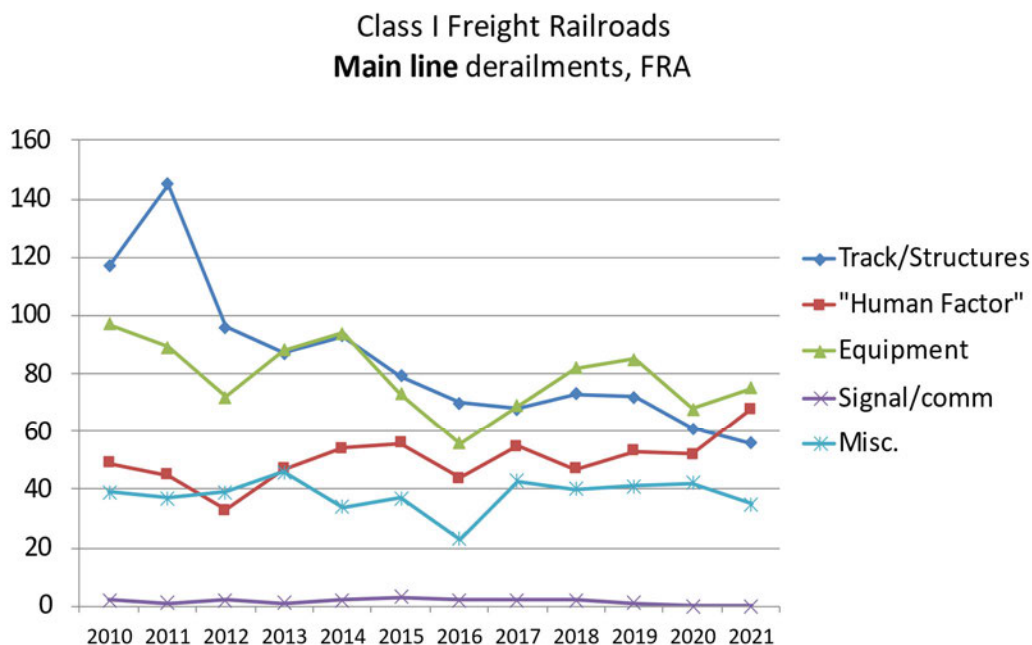
**Figure 7 – Class 1 Main Line Derailments by Cause (counts)**

Figure 7 shows the gradual increase in human factor derailments, even as the number of trains operated has declined steeply. Track accidents continue to decline, but equipment-caused accidents have remained quite persistent. Miscellaneous causes have also shown persistence.

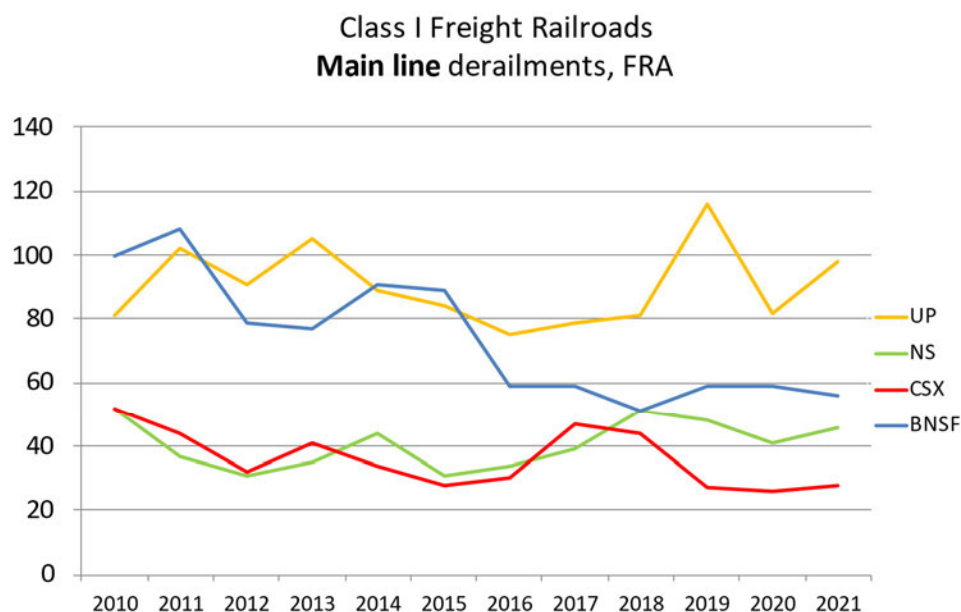
**Figure 8 – Class 1 Main Line Derailments by Major Railroads (counts)**

In Figure 8, note that BNSF is actually the bigger railroad in the west (by volume), but UP is leading in derailments. CSX, which went through a difficult PSR start, now has fewer main line derailment than NS, which is the smaller railroad in the east. These differences look stark when one searches for accidents likely driven by in-train forces (examples abound in Appendix B).
