## **NATIONAL TRANSPORTATION SAFETY BOARD**

### **Group Chairman's Factual Report**

# **OPERATIONAL FACTORS**

DCA16LA100

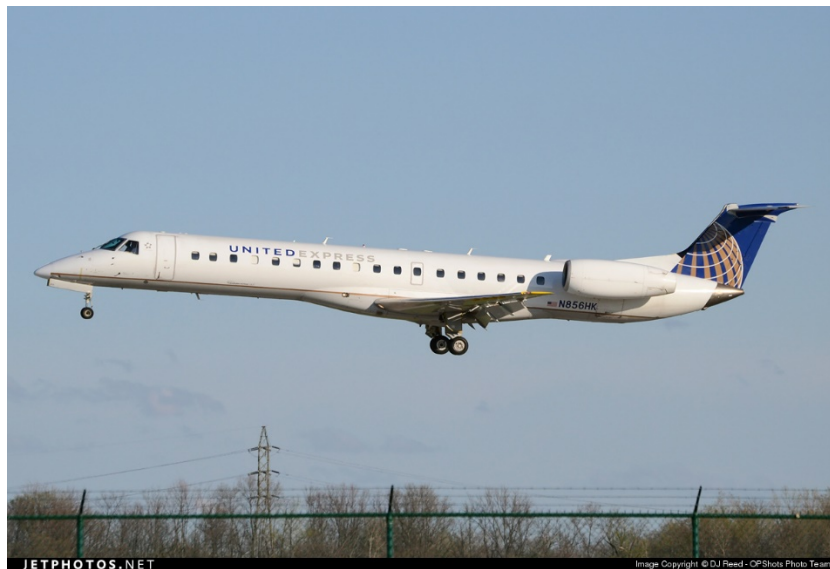
**Photo 1: Courtesy of JetPhotos.net website**

The accident airplane (Registration N856HK, Serial No. 145441) was an Embraer EMB-145MP powered by two Rolls-Royce Corporation AE3007A1 engines. The engines were rated at 7,426 pounds of takeoff thrust each. Engine indications were displayed on the EICAS display. The airplane was built in 2001, registered to AFS Investments XIV LLC, and leased to Trans States Airlines LLC on May 8, 2013, and held a transport category airworthiness certificate. The airplane was configured with 2 pilot seats, a cockpit observer seat, a flight attendant seat, and 50 passenger seats.

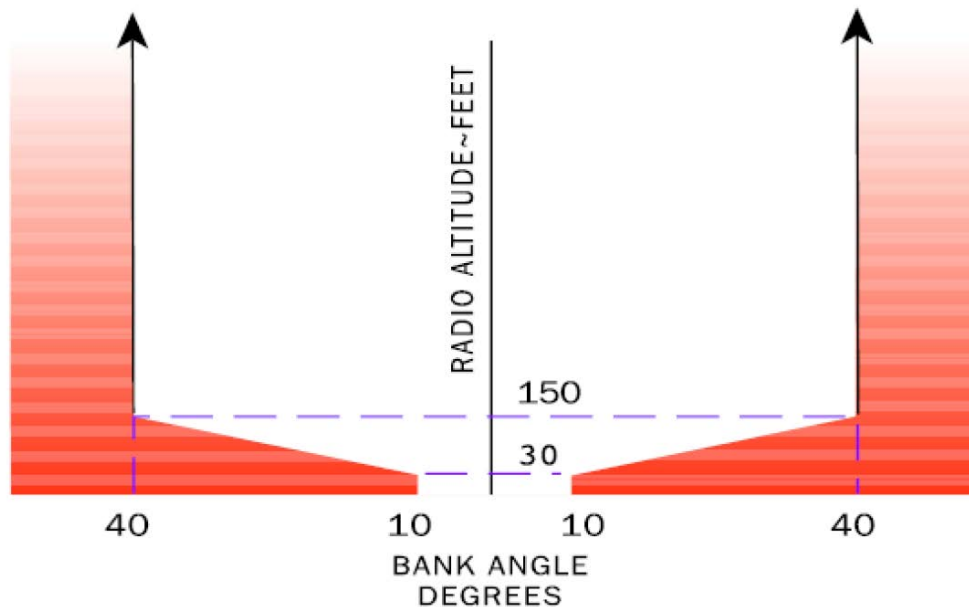
Additionally, it provided the following graphic which showed that that below 150 feet the required bank angle to activate the alert decreased from 150 feet to 30 feet above ground level, and at 30 feet and below that required bank angle was 10 degrees.

**Figure 7: Bank Angle Alert Limits.**  
(Source: Honeywell MK V and VII Pilots Guide)
