NATIONAL TRANSPORTATION SAFETY BOARD

Group Chairman's Factual Report

OPERATIONAL FACTORS/HUMAN PERFORMANCE

DCA18LA163

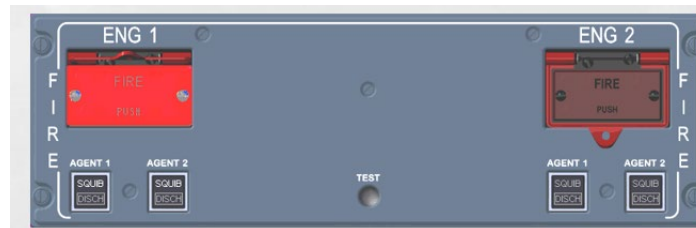
Figure 1: Engine Fire Pushbutton Located on Center Overhead Panel.
(Note: ENG 1 FIRE light is illuminated)

The A330's fire indication system consisted of indications for both engines, the auxiliary power unit, cargo smoke, avionics smoke, and lavatory smoke. Each system consisted of 2 detection loops that sensed a high temperature. The system, when it indicated a high temperature, would then illuminate the FIRE push button light (see figure 1), located on the center overhead

panel and sound an audible continuous repetitive chime (CRC), if not in takeoff or landing inhibit mode.

ENG FIRE IN FLIGHT emergency checklist (see section 7.5 for the entire emergency checklist) provides guidance to crews when there is an engine fire. Step 3 of the ENG FIRE checklist stated “ENG Fire p/b (affected engine) CONFIRM [and] PUSH”. According to training guidance provided by Delta Air Lines pushing and releasing the ENG FIRE pushbutton will automatically accomplish the following:
