#### NATIONAL TRANSPORATION SAFETY BOARD WASHINGTON, D.C.

DCA19FA089

#### AIRPORT SPECIALIST'S FACTUAL REPORT

#### FAA GUIDANCE

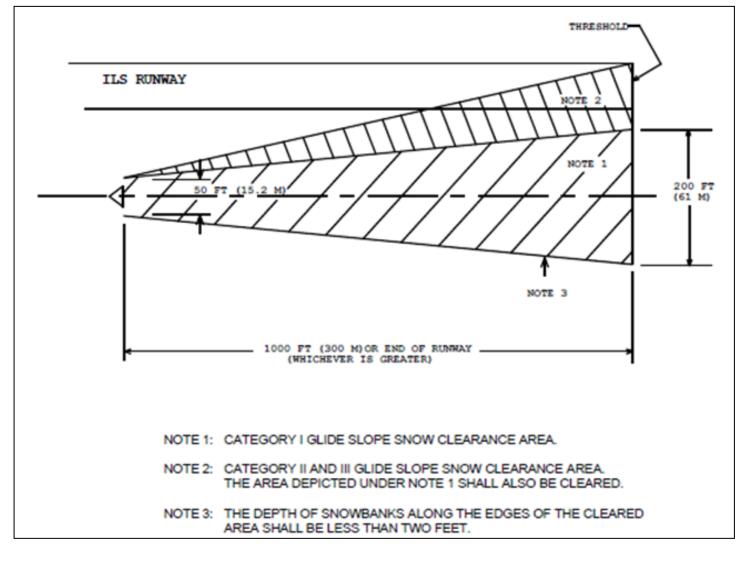
6750.49A Figure 1-1. Glide Slope Snow Clearance Areas

6750.49A, Maintenance of ILS Facilities, Figure 1-1 outlines two areas for snow removal for Glide Slope facilities. Note the snow clearance areas differ for CAT I operations versus CAT II/III operations.

**b.** Snow Accumulations. If the average snow and ice accumulations in the critical areas exceed specified limits, follow the guidelines of Table 5-3d for localizer, or Figure 1-1 and Table 5-4 for glide slope, until the conditions revert or are corrected.

**lower heights.** Figure 4-2 provides graphic representations of the glide slope ground snow clearance areas with prescribed snow depth limitations according to type of facility and aircraft approach category. When snow depths exceed the specified depth limitations, minima are raised to the "localizer only" function until the conditions revert or are corrected.

Given that the cleared areas in Figure 1-1 provide sufficient coverage of the Fresnel Zones for the required categories of operation, see Note 3 in Figure 1-1: "The depth of snow banks **along the edges of the cleared area** shall be less than two feet." This means just that. The edges of the cleared area must be less than two feet. It is recommended that the area 10 - 20 feet beyond this edge be tapered off (i.e. in this 10 - 20 foot area beyond the edge there should be no snow banks or drifts greater than two feet). Areas beyond this will not contain a significant portion of the Fresnel Zone and need not be cleared to the two foot limitation.

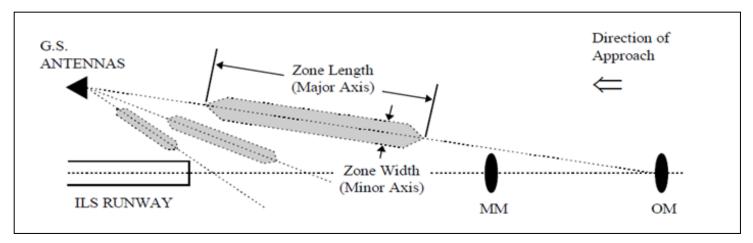
6750.16E Figure 3-2

6750.16E, Siting Criteria for ILS, Figure 3-2 illustrates that the major axis of the First Fresnel Zone for the Glide Slope lies on a line between the glide slope mast and the aircraft position.

Note: A Fresnel zone is a series of concentric ellipsoidal regions of alternating double strength and half strength volumes of a wave's propagation, caused by a wave following multiple paths as it passes by an object and is partially refracted by it, resulting in constructive and destructive interference as the different length paths go in and out of phase.
