NATIONAL TRANSPORTATION SAFETY BOARD

Group Chairman's Factual Report

OPERATIONAL FACTORS/HUMAN PERFORMANCE

DCA19MA143

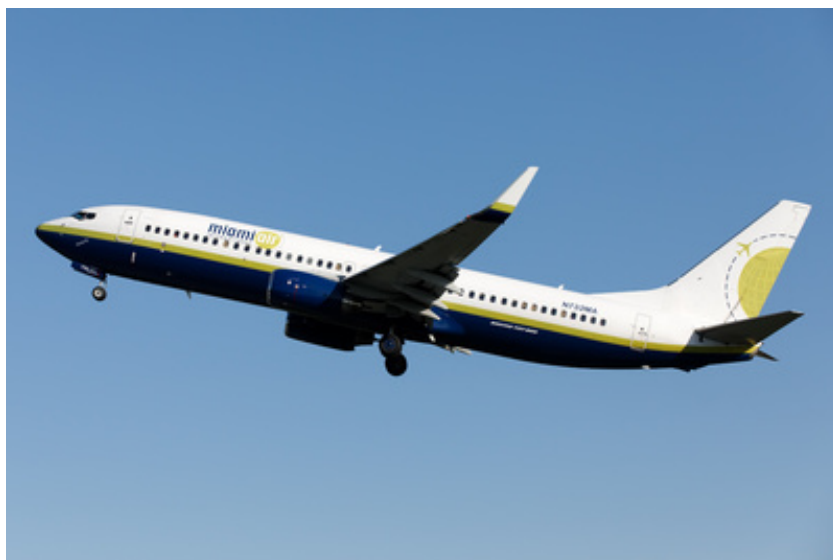
Photo 1: Accident airplane (Courtesy of AeroPX Aviation Online Photos).

The accident airplane N732MA, Serial No. 30618, was a B-737-81Q, and was manufactured in 2001 and issued an airworthiness certificate in April of 2001. It was owned by Wells Fargo Trust Co., registered on April 26, 2001 as a transport category aircraft, and operated by Miami Air International since its original registration. The airplane was powered by 2 CFM56-7B26 engines each capable of producing 26,300 lbs of thrust. The airplane's airworthiness

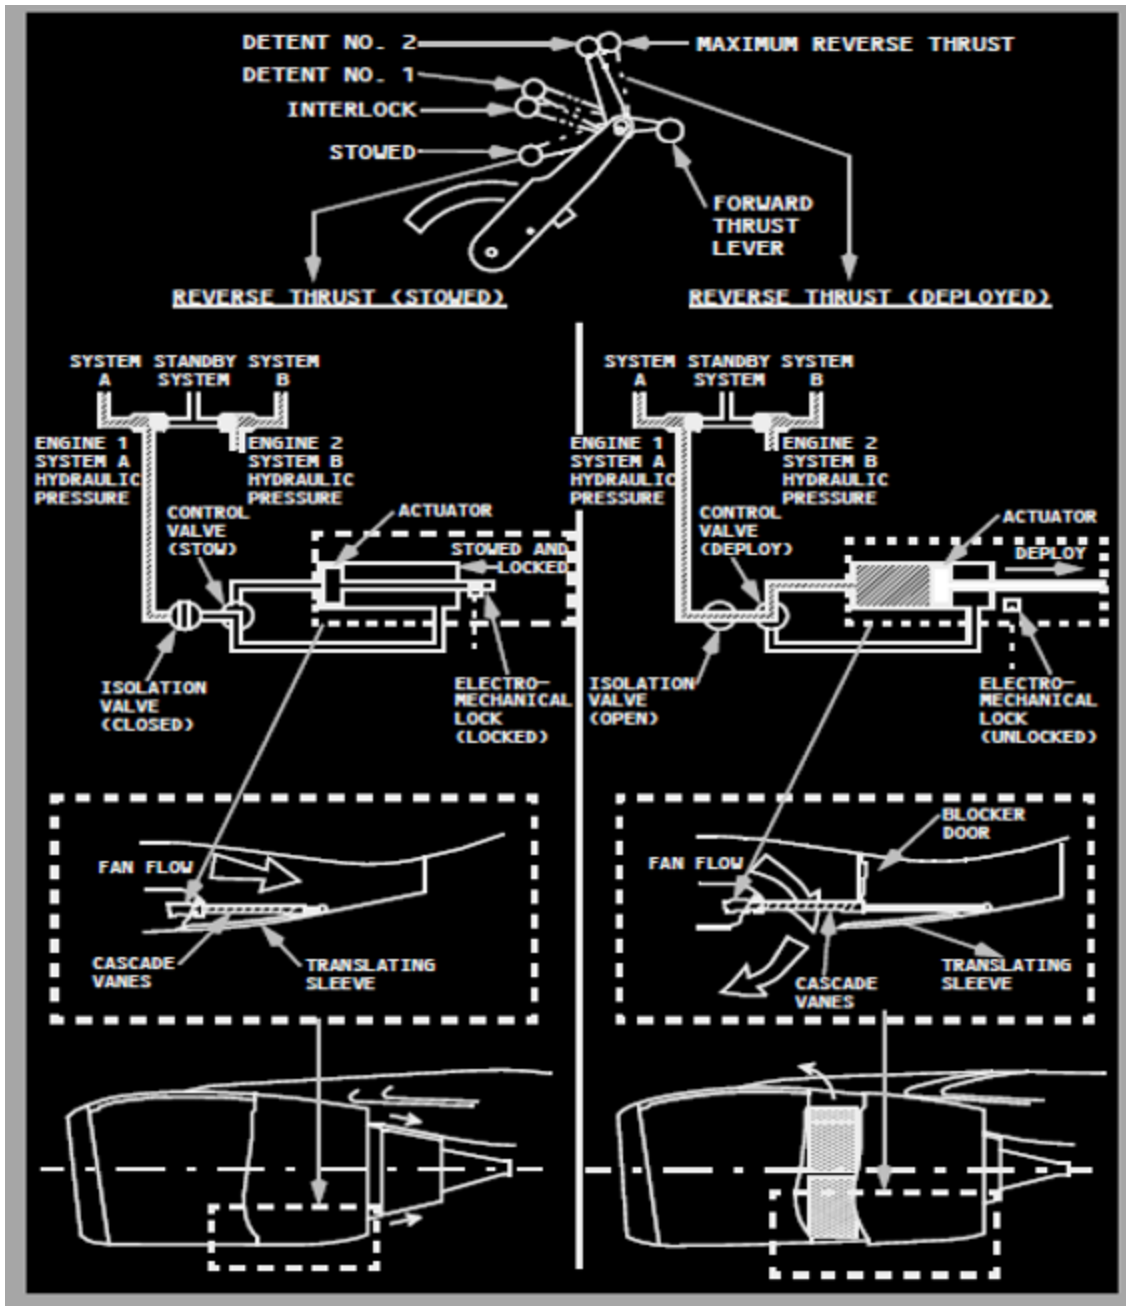
When the reverser sleeves are in the stow position, an electro-mechanical lock and hydraulically operated locking actuator inhibit motion to each reverser sleeve until reverser extension is selected. Additionally, an auto-restow circuit compares the actual reverser sleeve position and the commanded reverser position. In the event of incomplete stowage or uncommanded movement of the reverser sleeves toward the deployed position, the auto-restow circuit opens the isolation valve and commands the control valve to the stow position directing hydraulic pressure to stow the reverser sleeves. Once the auto-restow circuit is stowed activated, the isolation valve remains open and the control valve is held in the stowed position until the thrust reverser is commanded to deploy or until corrective maintenance action is taken.

Figure 10: Thrust Reverser Schematic (Source: Miami Air 737-800 Operations Manual Vol. 2).

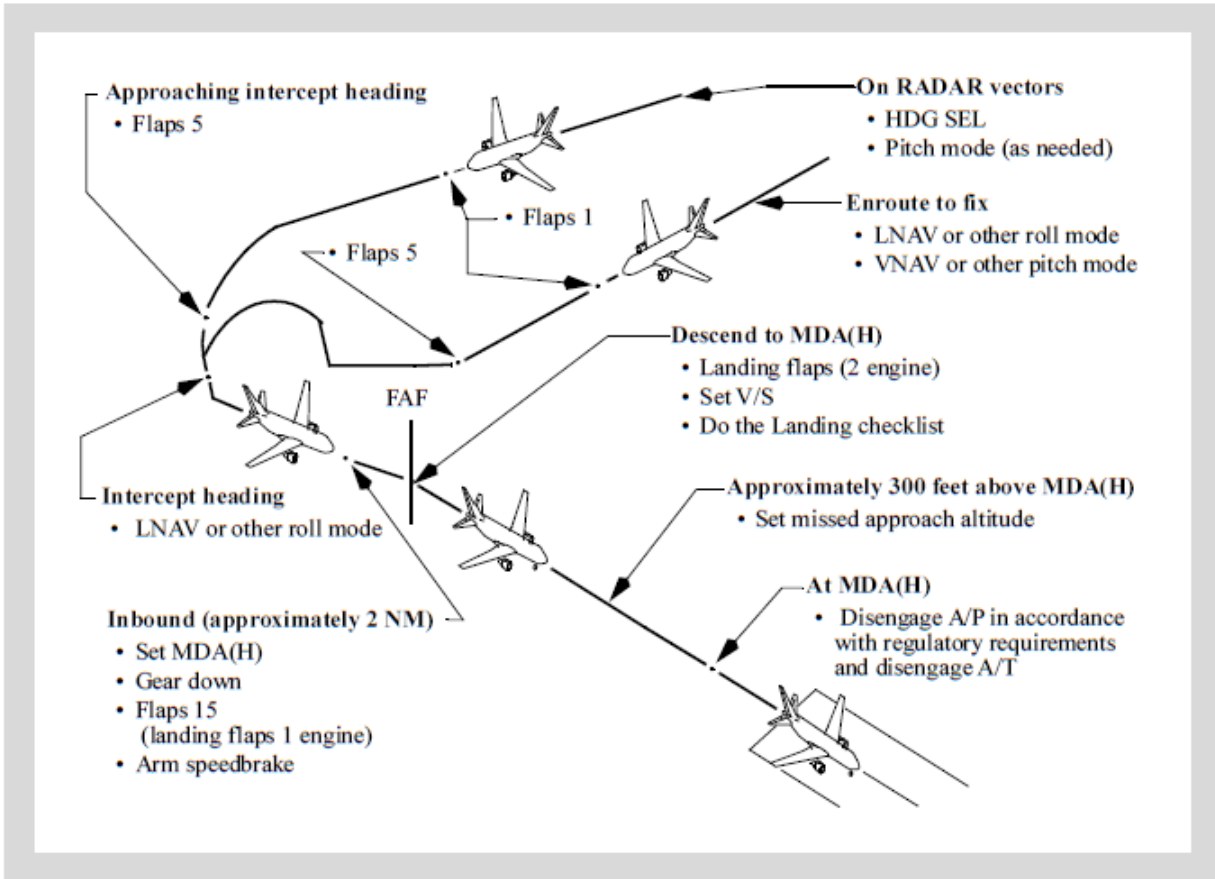
The Miami Air, 737 Quick Reference Handbook (QRH), "Maneuvers-Flight Patterns," provided the following pictorial guidance on conducting an instrument approach using vertical speed (V/S) to an airport:

Figure 11: Instrument Approach using Vertical Speed (V/S) Guidance (Source: Miami Air 737 Quick Reference Handbook Maneuvers Section 2.3).
