NATIONAL TRANSPORTATION SAFETY BOARD

Group Chairman's Factual Report

OPERATIONAL FACTORS/HUMAN PERFORMANCE

DCA20CA058

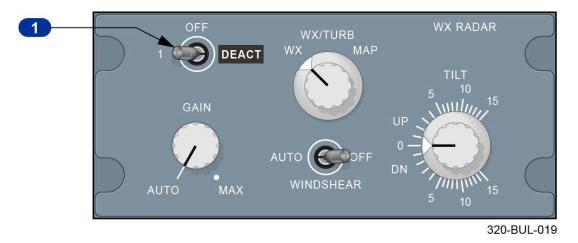
Weather Radar Control Panels

Note: 48XX/49XX aircraft may either have one of two different weather radar control panels, as shown below. *Location:* Control Pedestal

Radar Switch Position 1 activates the weather radar for display on the ND in any mode except PLAN.

Note: Position 2 is deactivated. Inadvertently selecting this position will not turn on the radar.

Note: The OFF position is the middle position; therefore, exercise care to ensure the system is off after landing since the switch is positioned either full left or full right on UA-configured aircraft.

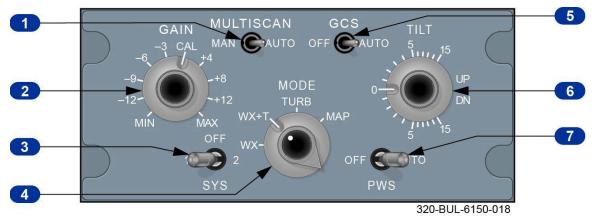
Location: Control Pedestal

The normal settings are:

- (1) MULTISCAN AUTO
- (2) GAIN CAL
- (3) SYS 1
- (4) MODE WX + T
- (5) GCS AUTO
- (6) TILT 0
- (7) *PWS AUTO*
 - 1

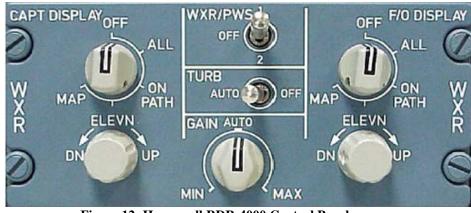
Figure 12: Honeywell RDR-4000 Control Panel (Source: Airbus Safety First #22)

The Honeywell RDR-4000 model is part of the new generation of weather radars including a 3D volumetric buffer.

It can probe hundreds of miles ahead (up to 320 NM on A320 & A330 families and up to 640 NM on A350 and A380) to show the enroute weather picture, as well as automatically scan from the ground up to 60 000 feet to provide information targeted at various altitudes. The required display data are then accessed from the 3D buffer.
