NATIONAL TRANSPORTATION SAFETY BOARD

Specialist's Report

OPERATIONAL FACTORS

DCA20CA071

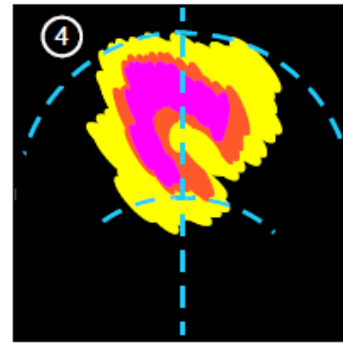
Pendant shape with scallops (hail shafts) along far edge of red on 3-color radar.
