NATIONAL TRANSPORTATION SAFETY BOARD

Specialist's Report

OPERATIONAL FACTORS

DCA20LA013

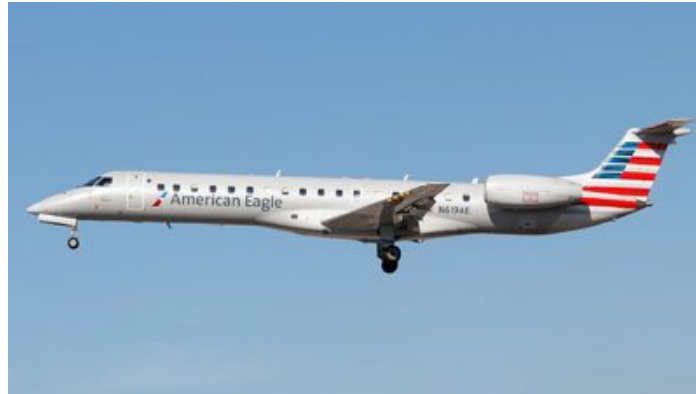
Photo 1: Accident Airplane, N619AE (Courtesy of flightradar24.com)

The accident airplane (Registration N619AE, Serial No.145101) was an Embraer EMB-145LR, powered by two Rolls-Royce Corporation AE3007A engines. The engines were rated at 7,426 pounds of takeoff thrust each. The airplane was built in 1998, registered to American Airlines, Inc., leased to Envoy Air Inc. on September 10, 2018, and held a transport category airworthiness certificate. The aircraft was certified for operation during day and night, VFR¹⁸ and IFR¹⁹, flight in icing conditions, and RVSM²⁰. The airplane was configured with 2 pilot seats, a cockpit observer seat, a flight attendant seat, and 50 passenger seats.
