#### National Transportation Safety Board

#### DCA23LA096

#### **OPERATIONAL FACTORS**

Group Chair's Factual Report July 15, 2024

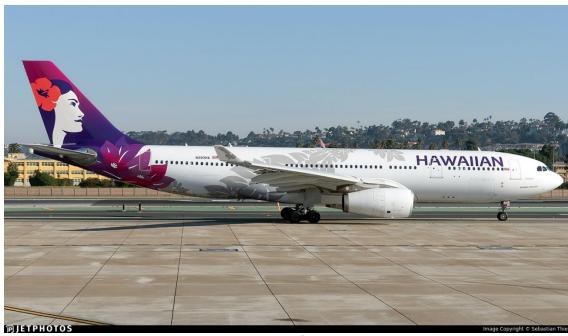
Figure 1: Accident Airplane, N393HA (courtesy of JetPhotos.net)

The accident airplane (Registration N393HA, Serial No. 1422) was an Airbus 330-243. The airplane was manufactured in 2013, registered to Hawaiian Airlines and held a transport category airworthiness certificate dated January 20, 2013, with an expiration date of June 30, 2029. The airplane was powered by 2 Rolls-Royce RR772B-60 engines. The airplane was configured with 2 pilot seats, 2 cockpit observer seats, 11 flight attendant seats, and 278 passenger seats.

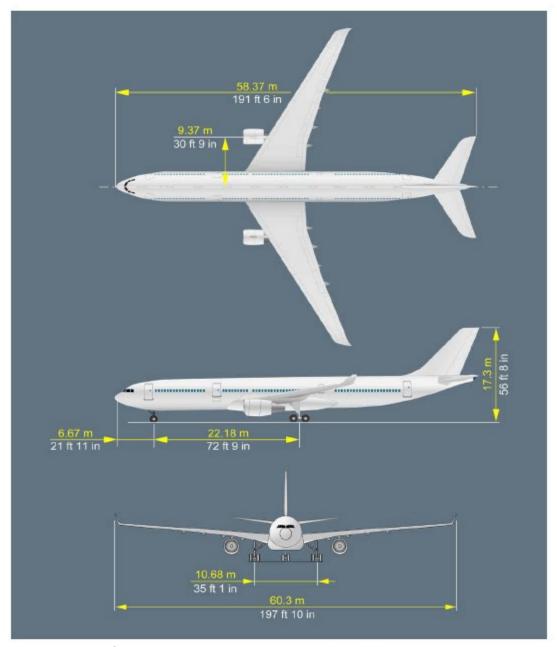
#### 3.1 A330 Dimensions

**Figure 2**: Aircraft Dimensions (Source: Hawaiian Airlines Flight Crew Operating Manual dated December 12, 2022.)

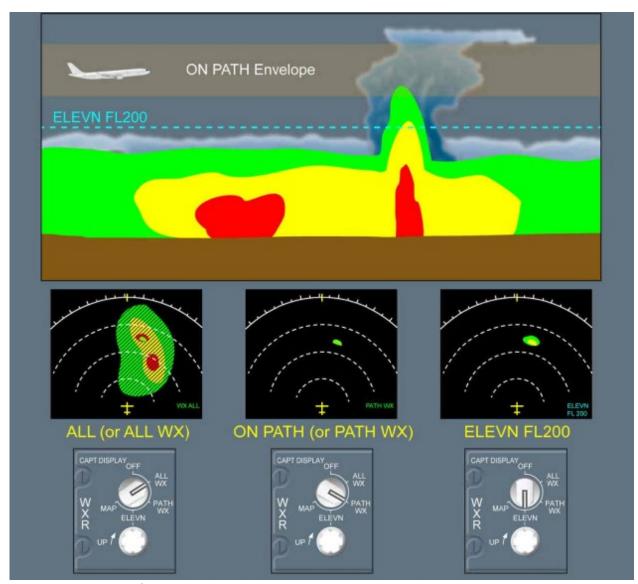
**Figure 5:** Depiction of All, On Path and Elevation Modes on the weather radar. (Source Hawaiian Airlines A330 Flight Crew Operating Manual )

At high altitude, when the weather radar display mode is set to ON PATH (or PATH WX), any weather return (green, yellow, or red) should be considered as a potential threat.

In the case of low altitude weather, the flight crew can also use the ELEVN display mode, with an elevation setting above the low altitude weather, to identify the threatening storm cells.

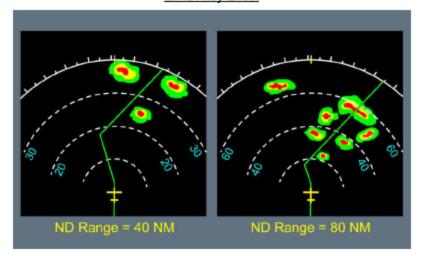
#### Blind Alley Effect

**Figure 7:** Weather Radar Depicting Blind Alley Effect. Source; Hawaiian Airlines A330 Flight Crew Operating Manual.
