National Transportation Safety Board

DCA23FA149

OPERATIONAL FACTORS

Group Chair's Factual Report

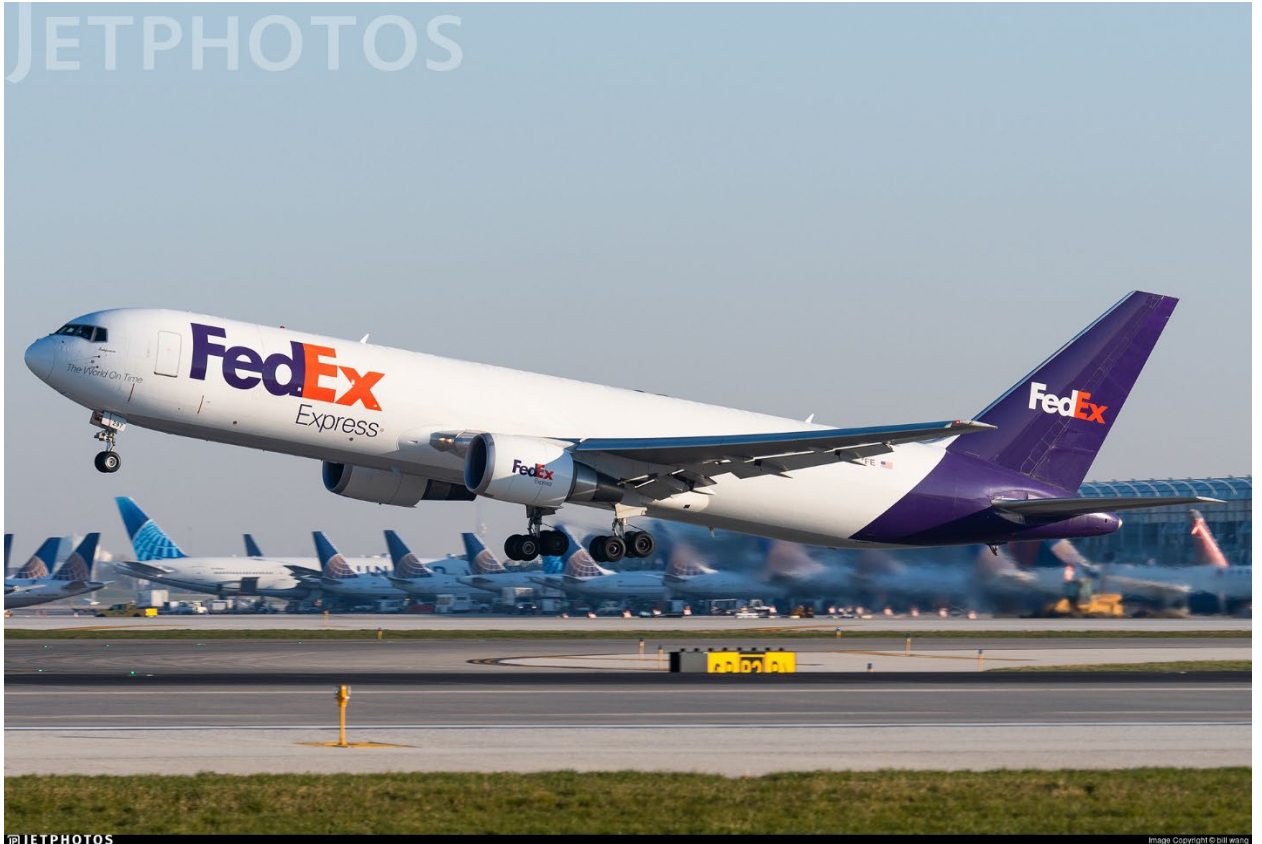
Figure 1. Incident Airplane. (Source : Jetphotos.com)

The incident airplane was a Boeing B-767-32LF, N297FE, serial number 41068, and was manufactured in 2012. It was powered by two GE CF6-80C2B6F engines, each capable of producing 60,200 lbs. of thrust. It was registered to and operated by Federal Express Corp of Memphis, Tennessee. The airplane was equipped with 2 flight crew seats, 1 observer seat and 3 jumpseats. See Photo 2.

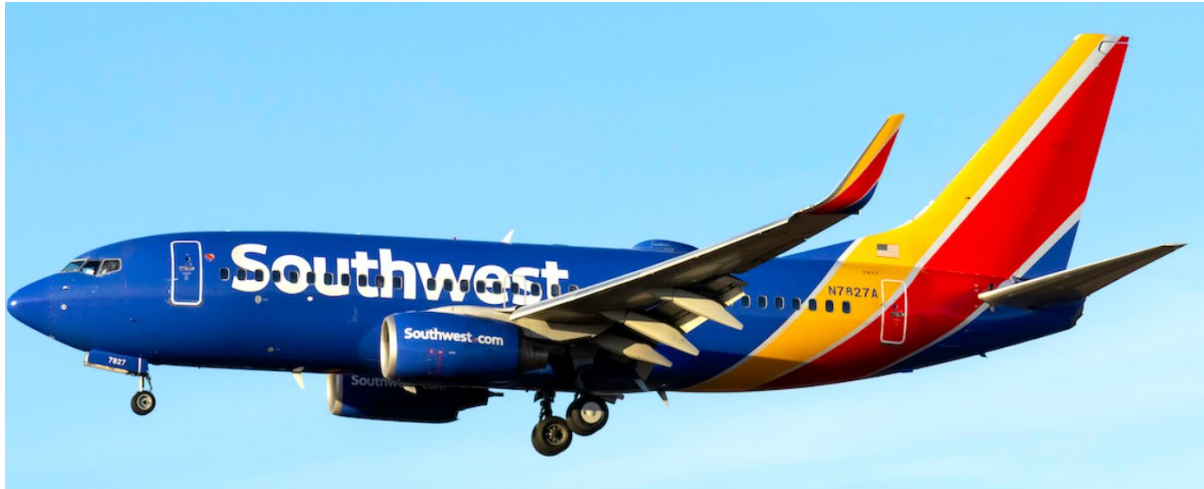
Photo 3. SWA Incident Airplane. (Source: Jetphotos.net)

The incident airplane was a Boeing B-737-79P, N7827A, serial number 28255, and was manufactured in 2003. It was powered by two CFM56-7B24 International engines, each capable of producing 24,000 lbs. of thrust. It was registered to and operated by Southwest Airlines Co. of Dallas, Texas at the time of the incident. The airplane, a -700 model, was equipped with 4 flight crew seats, 4 cabin crew seats, and 143 passenger seats.

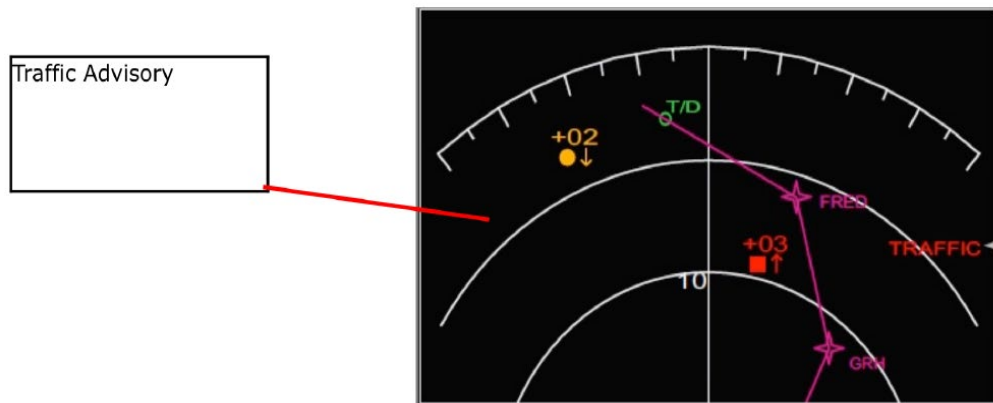
Maneuvers based solely on a TA may result in reduced separation and are not recommended.

Photo 11: Example of a TA. (Source, FedEx)

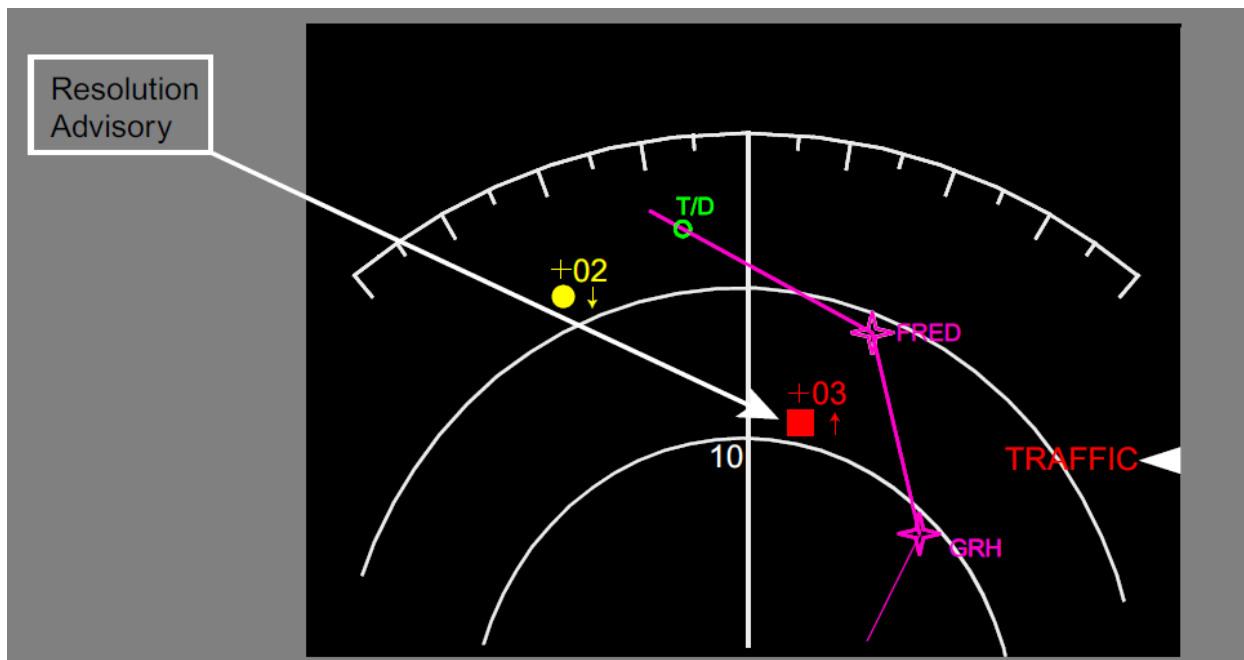
Photo 12: Example of Resolution Advisory, RA. (Source FedEx)

When TCAS determines that separation from approaching traffic may not be sufficient,
