National Transportation Safety Board

RPH23FR013

SIGNAL AND WAYSIDE DETECTOR

Group Chair's Factual Report

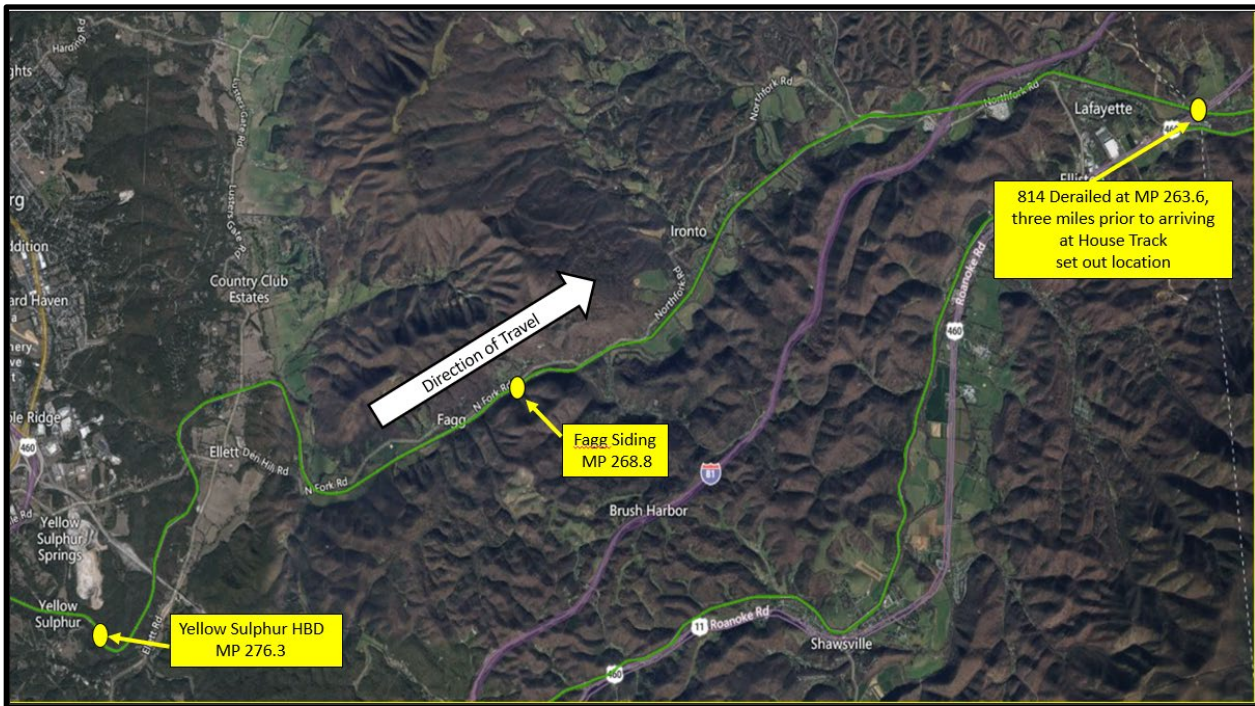
Figure 4: Map of 814 travel and points of interest (Google Earth edited)

The 814 train then derailed (MP 263.3) at approximately 7:44pm before reaching the set off location. The crew contacted the dispatcher at 7:48 and instructed the dispatcher of the emergency brake application.

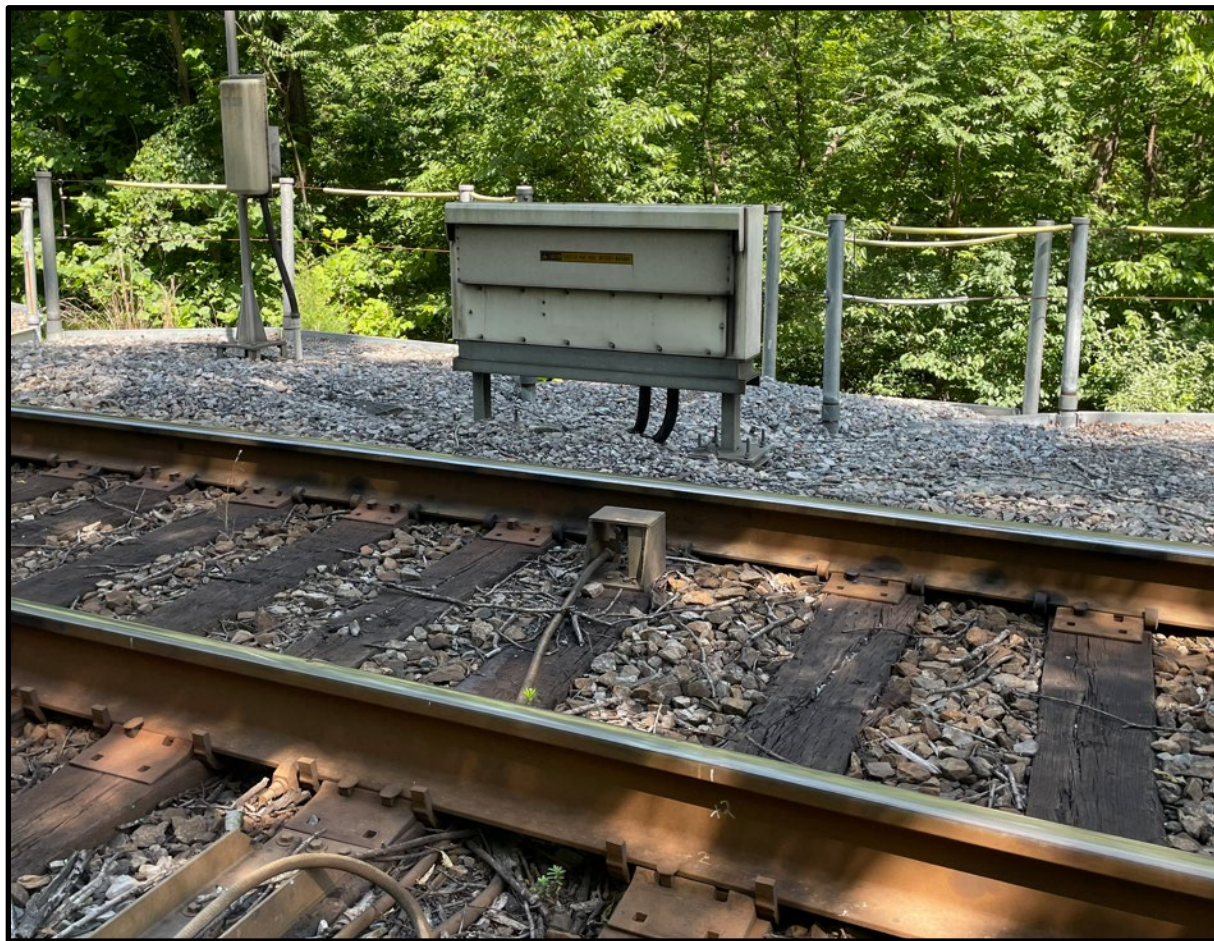
Figure 5. Photo: Norfolk Southern Ironto acoustic detector MP 266.5

Acoustic Bearing Detectors are designed as early warning systems that detect bearing defects prior to them reaching an industry condemnable level for the purpose of preventative maintenance planning. **(Figure 5)**
