**NATIONAL TRANSPORTATION SAFETY BOARD**  
Vehicle Recorder Division

## **Onboard Image Recorder & Security Video**

### **Specialist's Factual Report By Kyle Garner**

Location: Houston, Texas  
Date: October 29, 2021  
Time: 04:02 central daylight time (CDT)  
NTSB Number: RRD22LR002

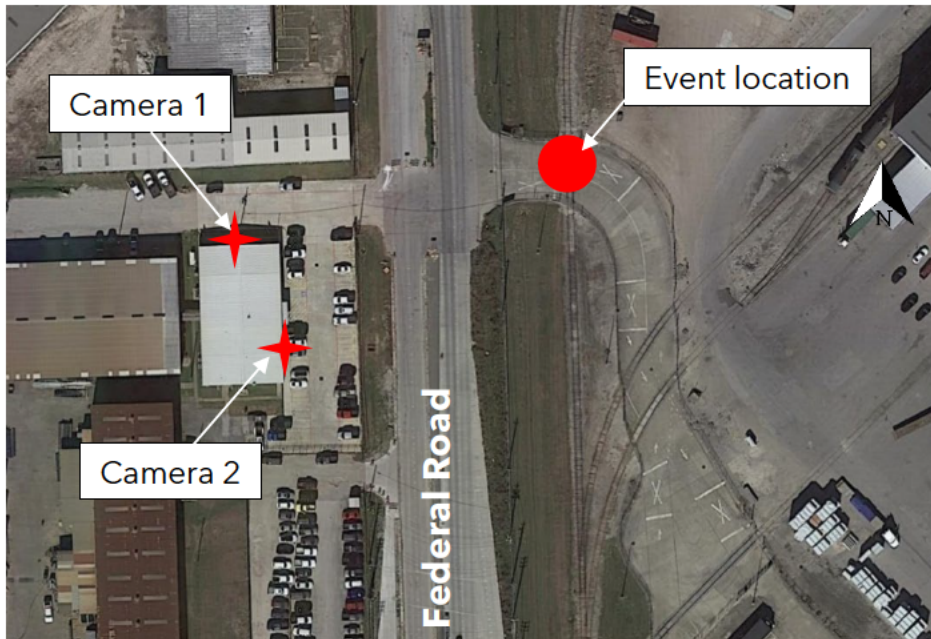
The cameras were located outside a business on the west side of Federal Road and faced the industrial park across the street, as shown in the Google Earth overlay in Figure 1. Conditions shown in the Google Earth overlay are not representative of the conditions at the time of the event.

**Figure 1. Security camera 1 and 2 location.**
