NATIONAL TRANSPORTATION SAFETY BOARD
Vehicle Recorder Division

Onboard Image Recorder

Specialist's Factual Report
By Kyle Garner

Location: Phoenix, Arizona
Date: June 9, 2021
Vehicle: Truck-tractor with stainless equipment tank trailer
Operator: Arizona Milk Transport Inc.
NTSB Number: HWY21MH008

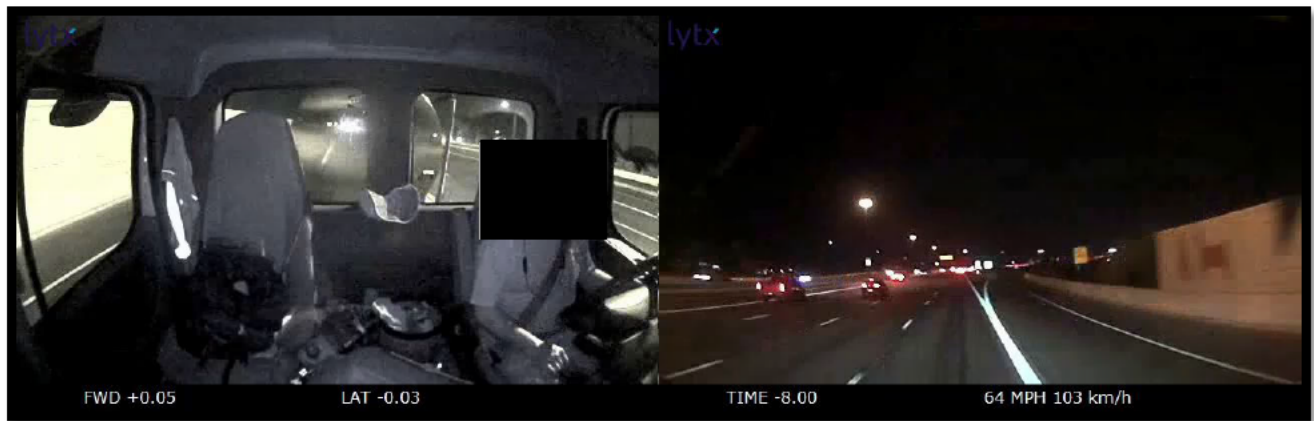
The video from the Lytx DriveCam, provided in .mp4 format, was 12 seconds in duration and had a frame rate of 4 frames per second (fps). The left side of the recording displayed footage from the inward-facing camera (IFC) and the right side of the recording displayed footage from the forward-facing camera (FFC).

Below the two camera views, values for longitudinal acceleration, lateral acceleration, time to impact, and speed in miles per hour (mph) and kilometers per hour (km/hr) were displayed. Figure 1 is a snapshot of the first frame of the video recording.

Figure 1. Snapshot of the first frame of video recording (time to impact = -8.00s).
