NATIONAL TRANSPORTATION SAFETY BOARD  
**Investigative Hearing**

Norfolk Southern Railway general merchandise freight train 32N  
derailment with subsequent hazardous material release and fires,  
in East Palestine, Ohio, on February 3, 2023

**System Safety and Human Performance  
Group Chair's Factual Report**

## **SYSTEM SAFETY AND HUMAN PERFORMANCE**

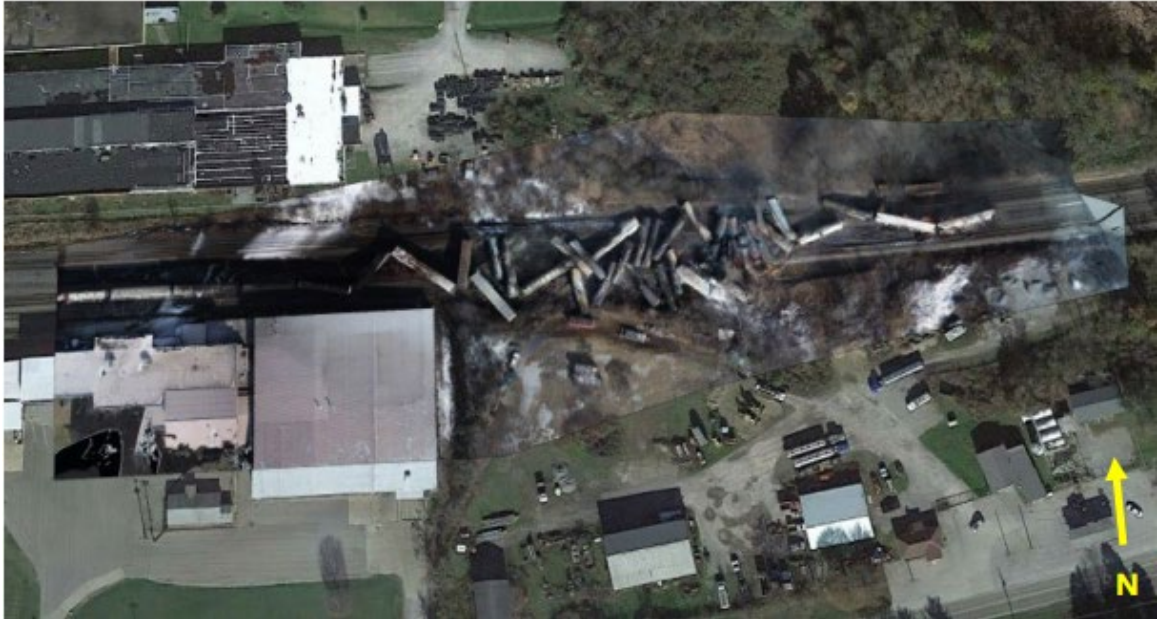
**Figure 1:** Overhead view of the Norfolk Southern Railway's train derailment with hazardous materials release in E. Palestine, OH. This is an orthomosaic image overlaid atop Google Earth, as developed by NTSB's UAS Aerial Imagery Specialist/RPIC, Eric Gregson and presented in the Unmanned Aircraft System Aerial Imagery Specialist's Field Notes.
