# National Transportation Safety Board

PLD24FR003

## **INTEGRITY MANAGEMENT**

Group Chair's Factual Report

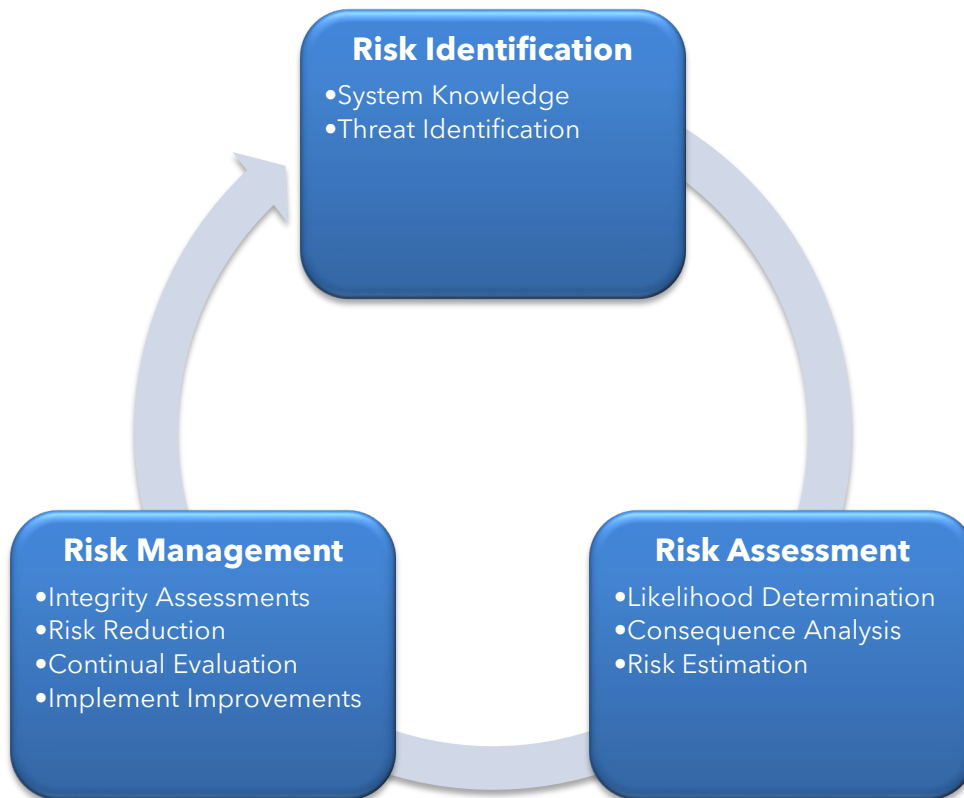
**Figure 1.** Integrity Management Flowchart

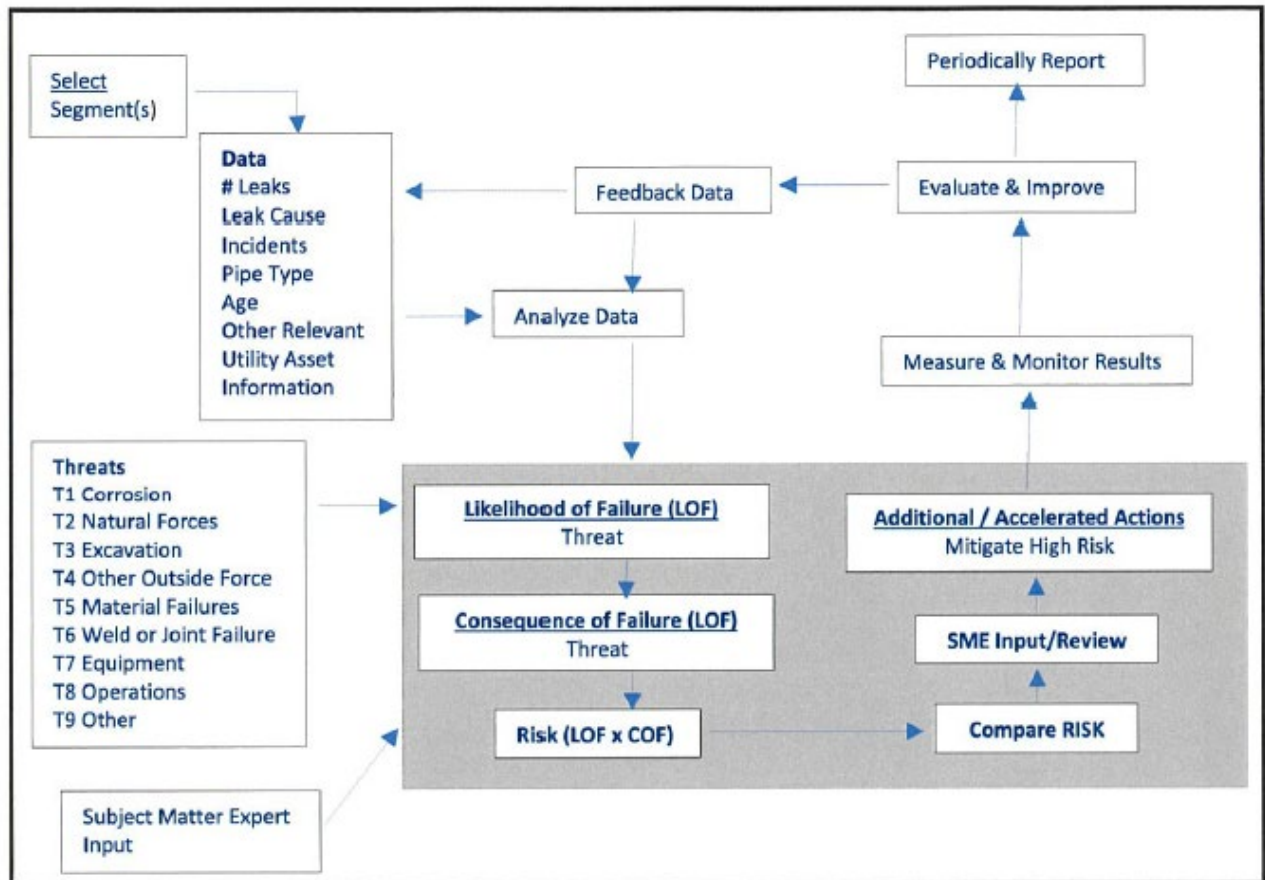
A diagram summarizing Atmos’s distribution integrity management program (DIMP), including processes to evaluate, monitor, and record threats and risks on its distribution system, is presented below. <sup>1</sup>

**Figure 2.** Atmos Energy’s DIMP flow diagram

At the time of the accident, Atmos used two approaches to identify and evaluate risk in the distribution system, as outlined in Figure 2. The quantitative and qualitative approaches were used for risk evaluation and to analyze risk on mains, services, regulator stations and meter sets.

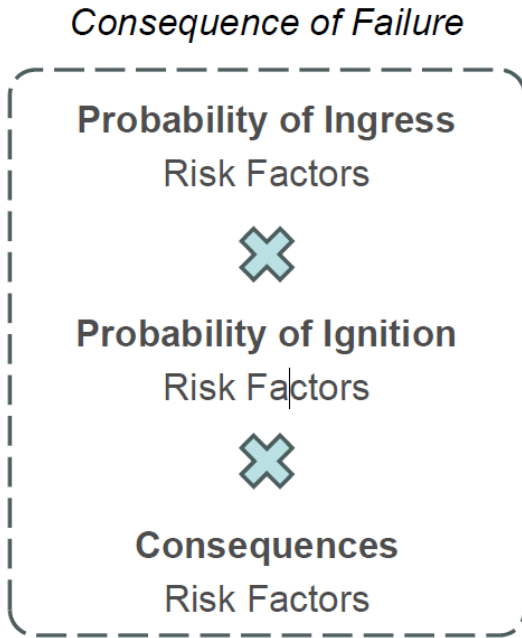
**Figure 8** - DRAM's consequence of failure calculations<sup>40</sup>

Probability of ingress risk factor applies to all assets and varies in value based on the impervious surface coverage that the pipe of point location intersects. The weighing factors vary from 1 to 6.94.
