NATIONAL TRANSPORTATION SAFETY BOARD

Group Chairman's Factual Report

Maintenance Records

1. EVENT DCA21FA085

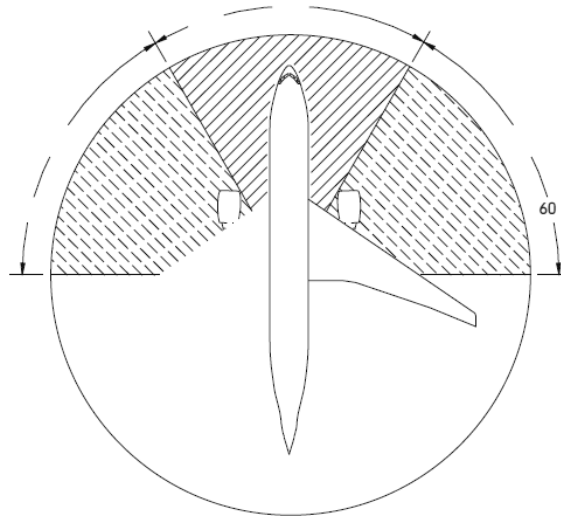
Engine Runup Wind Limits

RELATIVE WIND

RECOMMENDED (25 KNOTS MAXIMUM WIND VELOCITY) ¹
-

¹ THE WIND VELOCITY IS FOR STABLE WIND CONDITIONS. DECREASE THE MAXIMUM WIND LIMIT 5 KNOTS FOR GUSTY WIND CONDITIONS, OR UNTIL THE SVA INDICATION ON THE EICAS EPCS PAGE BECOMES STABLE.

The United 777-maintenance training student book for engine high power engine runs was reviewed paying particular attention to crosswind precautions. The following training is noted. Wind direction - When possible, the engine must be operated with the inlet pointed into the wind as specified in the figure, "Relative Wind Direction during Engine Operation", reference attachment one. The figure illustrates three zones, with the first zone being 30 degrees maximum wind angle either side of the nose, the second zone up to 90 degrees from the nose, and the third zone for wind direction from the aft 180 degrees. The first zone is the recommended zone for stable winds with a 25-knot maximum wind velocity. Further noted that the wind velocity is for stable wind conditions. Decrease the maximum wind limit 5-knots for gusty wind conditions, or until the SVA indication on the EICAS page becomes stable. Stop the engine run if the SVA indication on the EICAS, EPCS page is not stable. Also, stop the engine run if the inlet noise increases, or the inlet sound changes to a blow torch type sound.
