NATIONAL TRANSPORTATION SAFETY BOARD

Survival Factors

Group Chairman's Factual Report of the Investigation

Event description: apparent unintended release of commercially supplied natural gas,

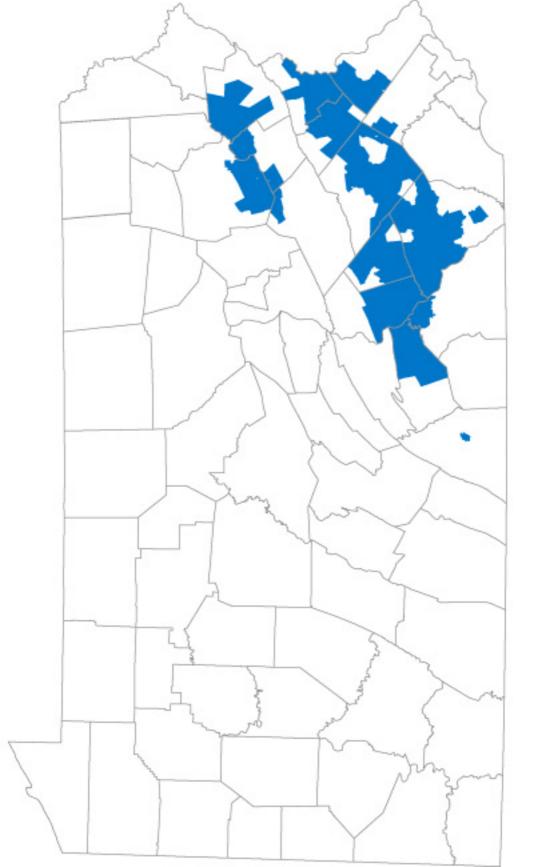
^{2.} Map (next page) of Pennsylvania, illustrating the UGI Retail Natural Gas Supplier / Distribution System and the UGI Lancaster Gas Operations Area.
