NATIONAL TRANSPORTATION SAFETY BOARD

Group Chairman's Factual Report

OPERATIONAL FACTORS

OPS17IA014AB

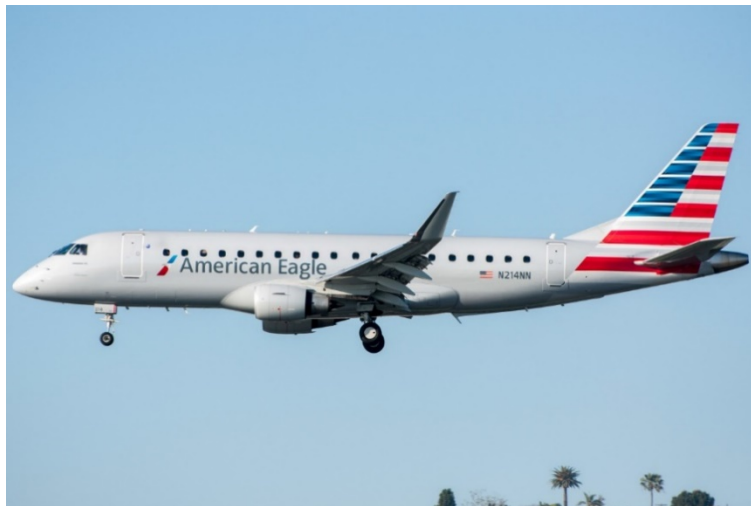
Photo 1: Photo of incident airplane, N214NN

The incident airplane was an Embraer E-175-200LR, N214NN, Serial number 17000508. It was powered by 2 GE CF34-8E5 engines. It was registered to American Airlines Inc, Fort Worth, Texas and operated by Compass Airlines.

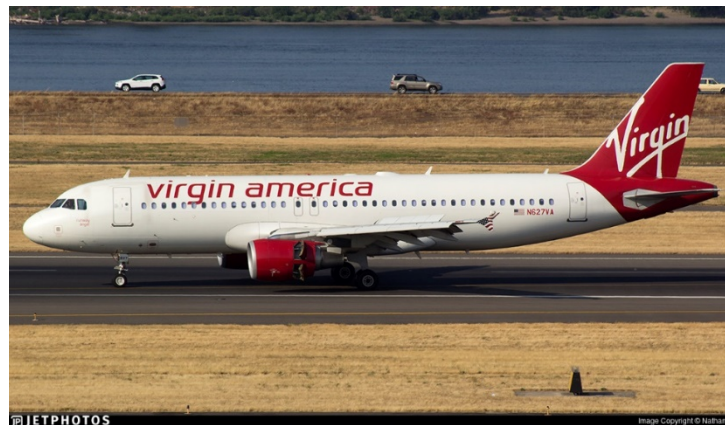
Photo 2: Photo of incident airplane, N627VA.³³

The incident airplane was an Airbus 320-214, N627VA, serial number 2851. It was equipped with two CFM International CFM56-5B4/P engines. It was registered to Wells Fargo Bank Northwest NA Trustee, Salt Lake City, Utah and operated by Virgin America.
