NATIONAL TRANSPORTATION SAFETY BOARD
Investigative Hearing

Alaska Airlines Flight 1282

Boeing 737-9, N704AL

Left Mid Exit Door Plug Separation in Portland, OR

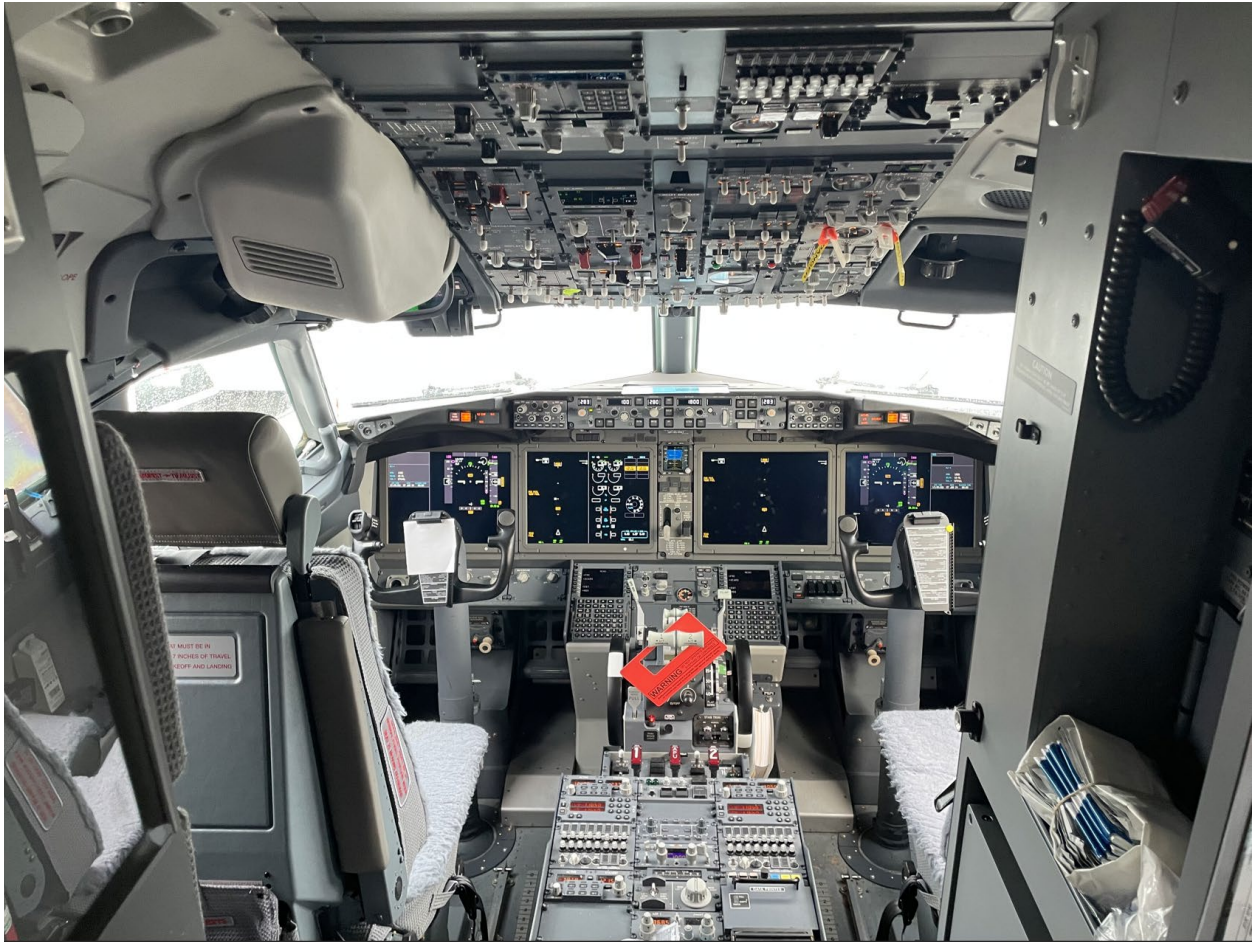
Figure 5. Flight deck of accident airplane (Source: NTSB)

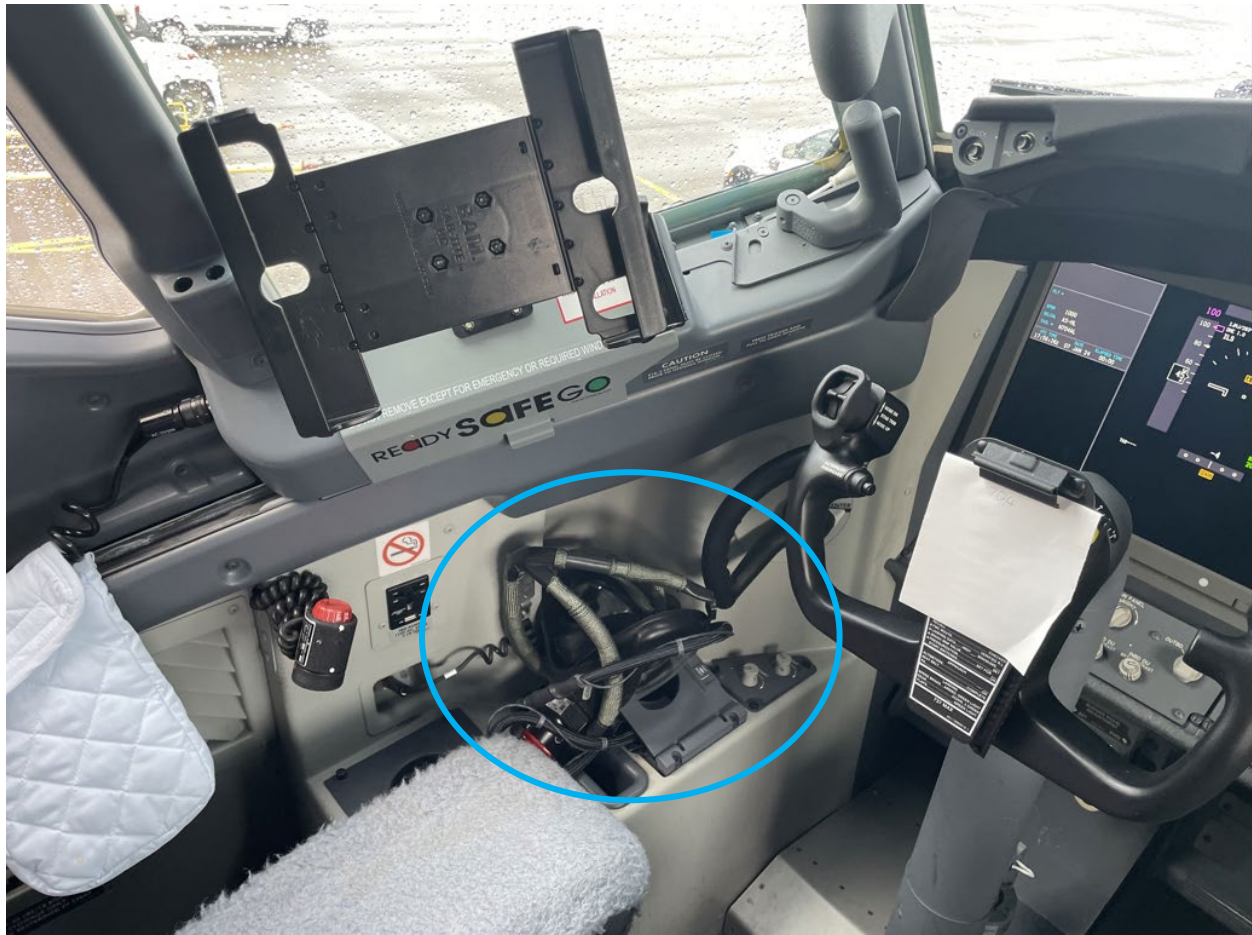
Figure 7. Captain side panel of accident airplane with oxygen mask and stowage box indicated by blue circle. (Source: NTSB)

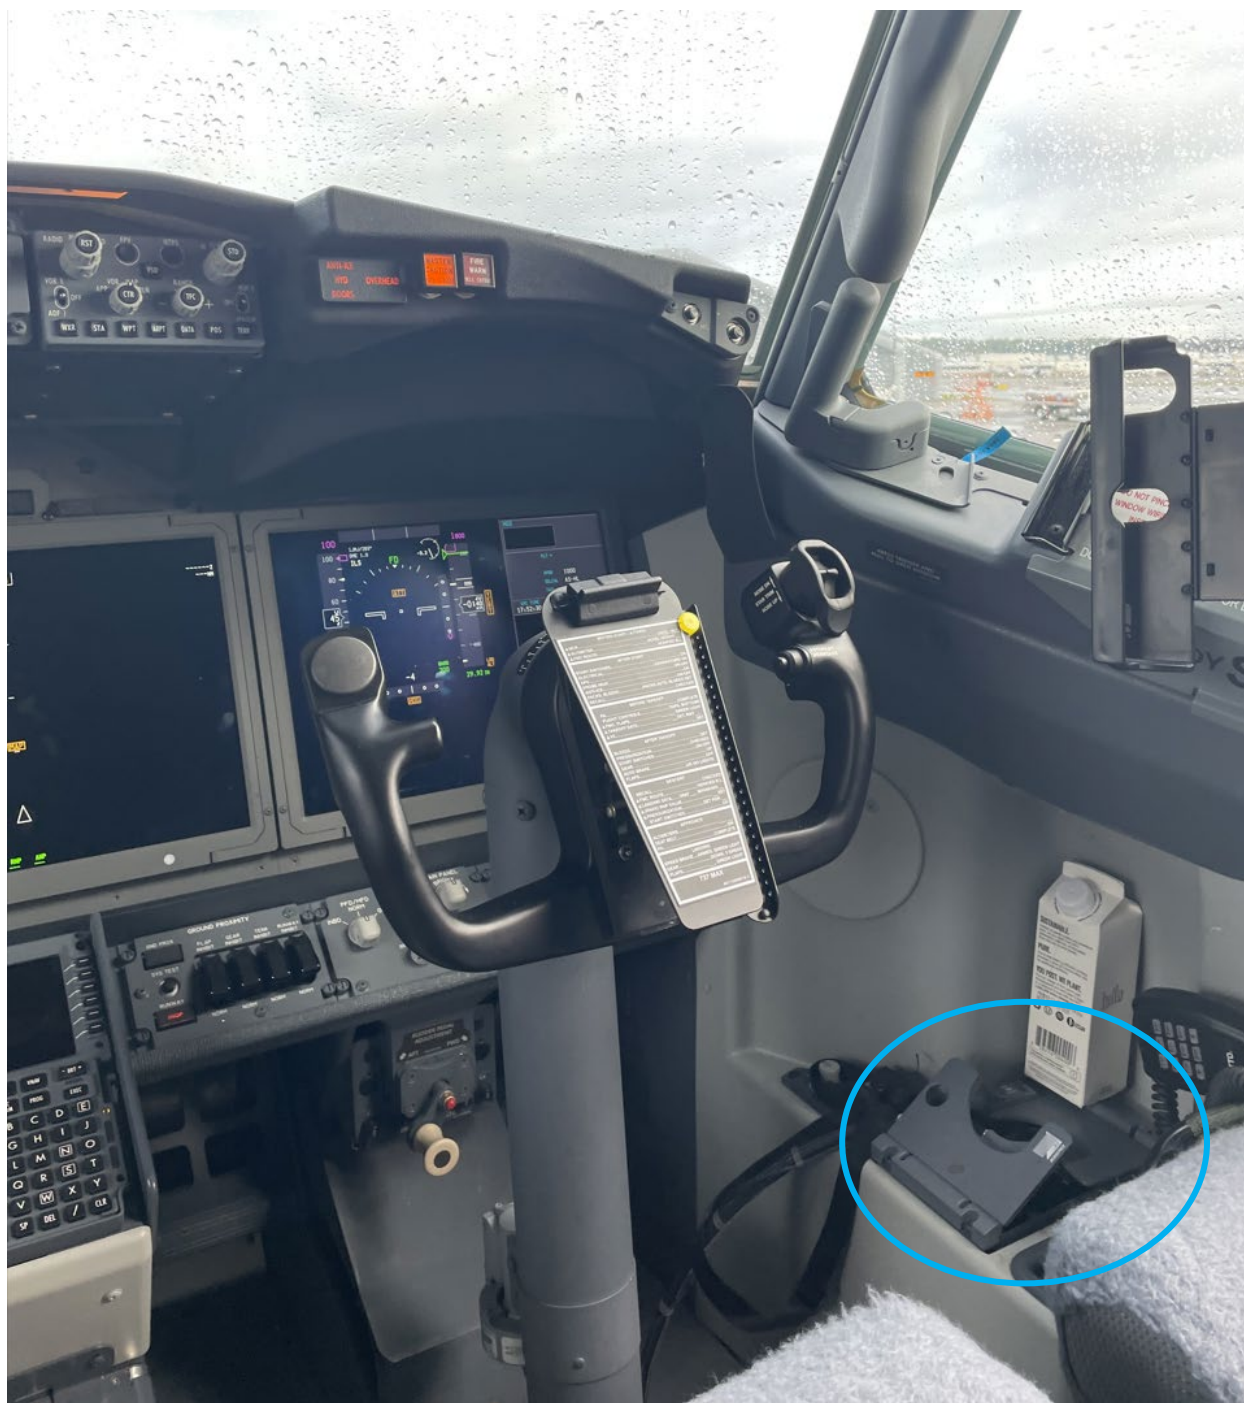
Figure 9. FO's oxygen mask stowage box indicated by blue circle (Source: NTSB)

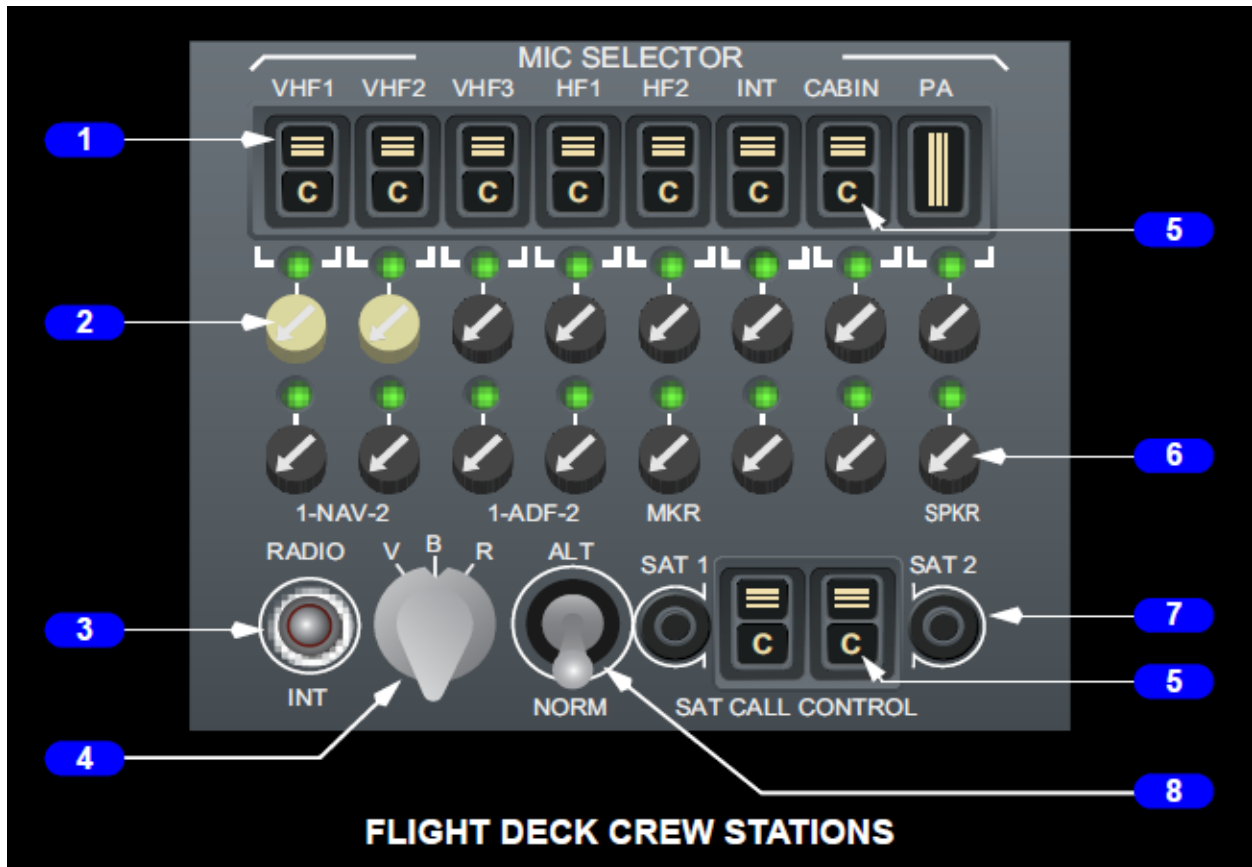
Figure 11. 737-9 Audio Control Panel (Source: Alaska SH)

An ACP was installed at the captain, FO, and observer stations. This allowed the selection of the desired radios, navigation aids, interphones, and passenger address (PA) systems for monitoring and transmitting. Any microphone at that crew station may be keyed to transmit on the selected system. The following excerpts are from the Alaska Airlines 737 System Handbook (SH), in Section 5.030, Page 2 - "Communications Differences" provided the following about the ACP.

(1) The Transmitter Selector (MIC SELECTOR) Switches, when illuminated, indicate respective switch is active. When pushed:

- *NORM (Normal)* - ACP operates normally
- *ALT (Alternate)* - ACP operates in degraded mode

The B737-9 has no MASK-BOOM switch on the ACP (See Figure 11.) The mask microphone is automatically selected, and the pilot's headset boom microphone is deselected when the oxygen mask is removed from the stowage box and the right stowage box door is open. For the pilot to reestablish headset boom microphone communications after discontinued use of the oxygen mask, the right stowage box door must be closed⁴⁰, the TEST/RESET switch (See Figure 10) actuated, and the OXY ON flag no longer displayed. Only then will the mask microphone be deselected and the boom microphone be selected.

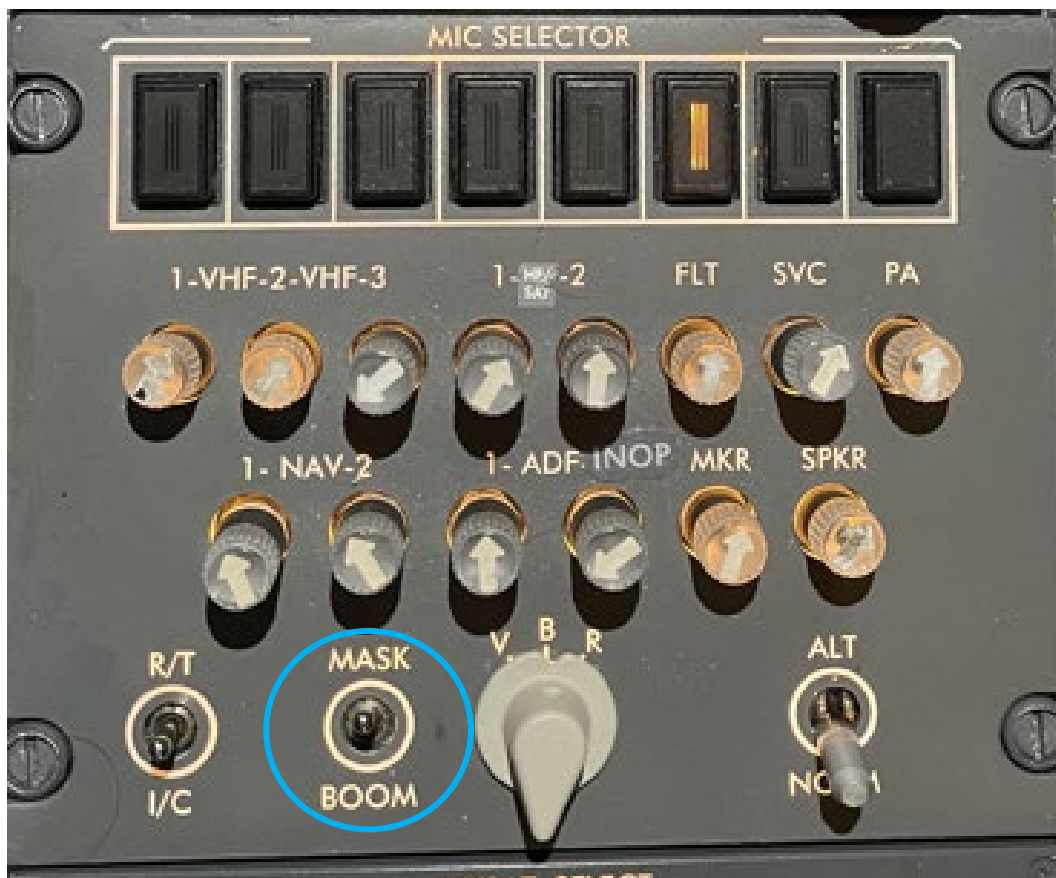
In the B737 NG models, the ACP can have a MASK-BOOM switch that allows selection of the oxygen mask microphone for transmissions with MASK selected or headset boom microphone for transmissions with BOOM selected. (See figure 13.) The oxygen mask microphone is not automatically selected, the switch must be placed to MASK.

Figure 12. 737 NG ACP. Mask/Boom switch indicated by blue circle (Source: NTSB)
