# National Transportation Safety Board

ERA22FA004

## **OPERATIONAL FACTORS FACTUAL REPORT**

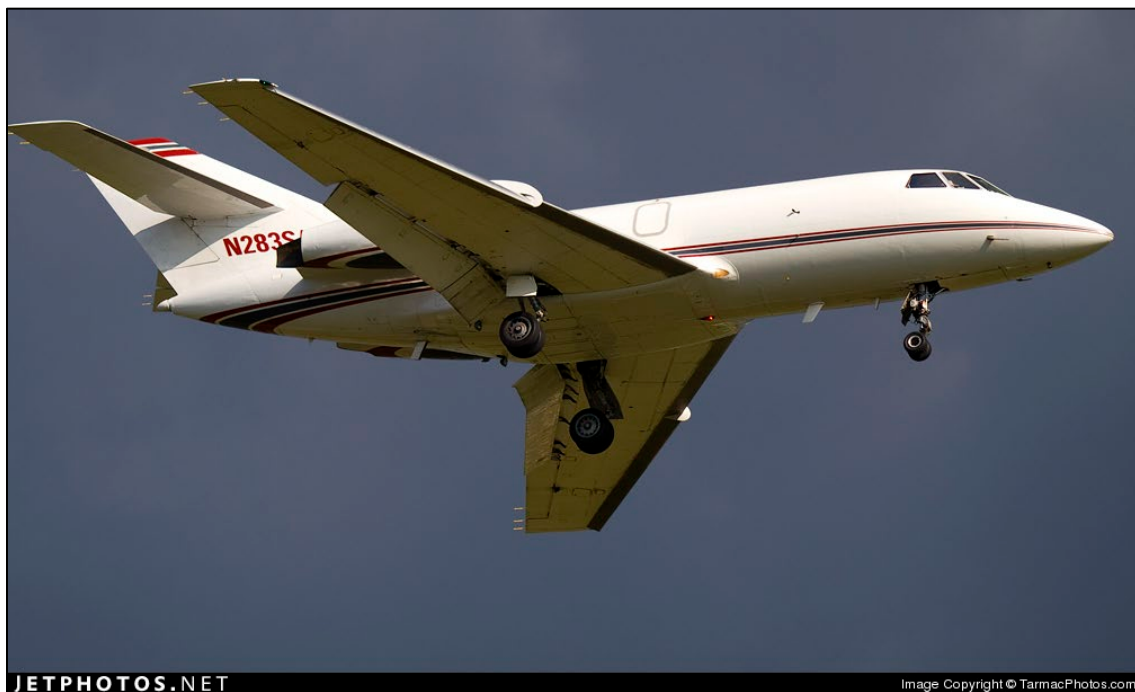
Photo 1: Accident airplane photographed on August 6, 2010 (Credit TarmacPhotos.com)

The airplane was a Dassault Falcon 20 manufactured in 1967. It was powered by two General Electric CF700-2D-2 turbine engines. The airplane required two type-rated flight crew members and was equipped with the cargo conversion cabin.

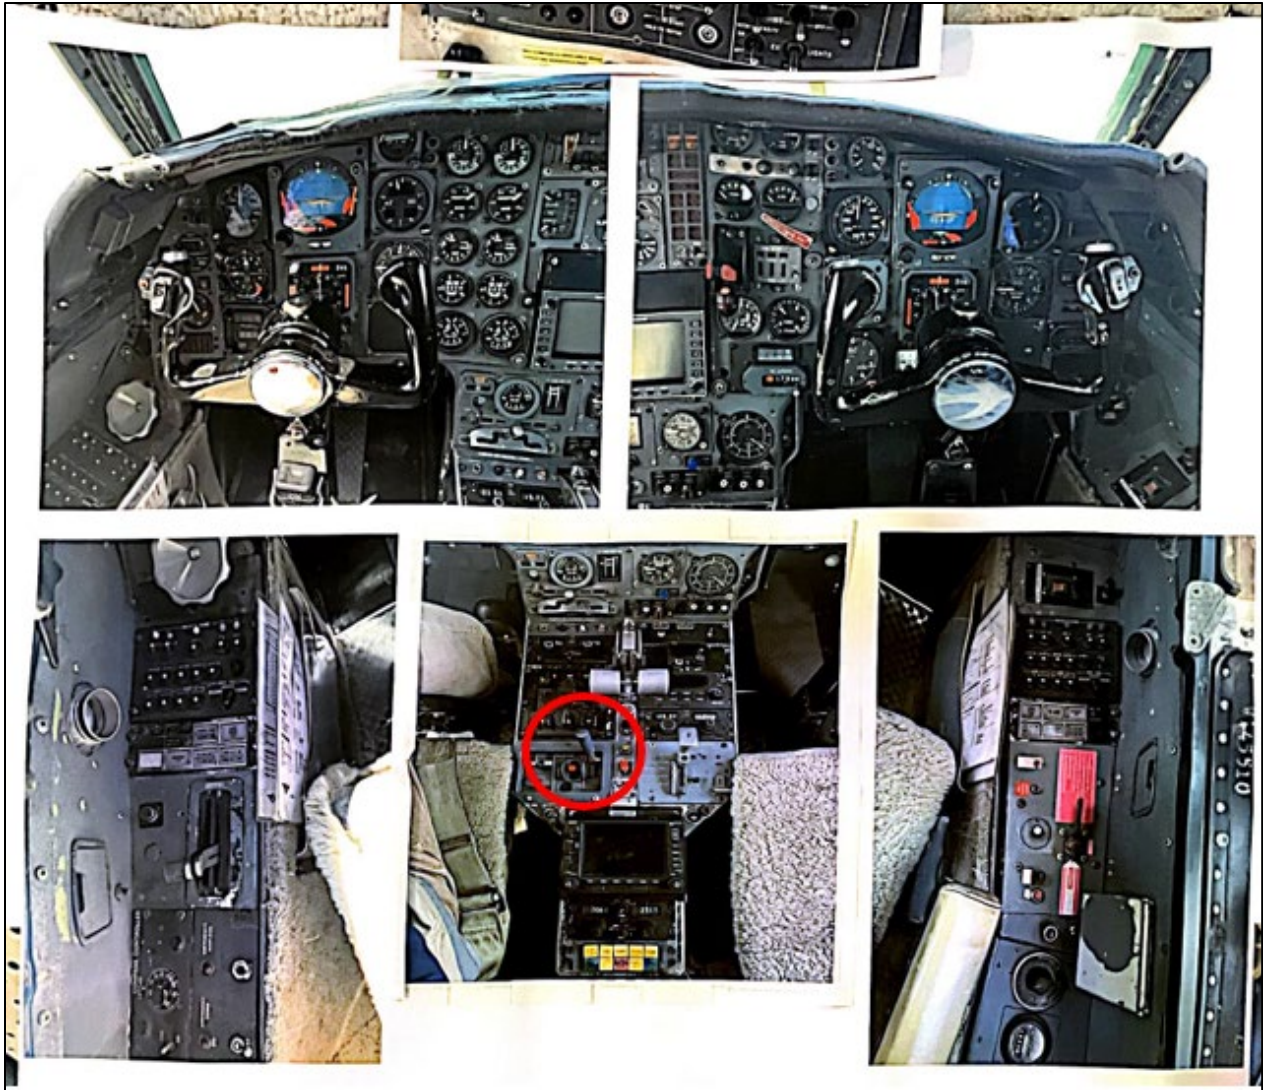
The airbrakes are deployed through the use of a handle located in the center console of the cockpit, aft of the thrust levers on the captain side, as circled in red below. The airbrakes operate in a deployed or stowed configuration. The time to extend the airbrakes is 2 to 3 seconds and retraction is 3 to 4 seconds.

Figure 6: Photographs of the accident airplane cockpit taken at an unknown date prior to the accident  
(Photos Courtesy of The Operator)
