NATIONAL TRANSPORTATION SAFETY BOARD

OPERATIONS GROUP CHAIRMAN'S FACTUAL REPORT

WPR09MA159

LOCATION: Butte, Montana
DATE: March 22, 2009
TIME: 1430 Mountain daylight time¹
AIRCRAFT: Pilatus PC-12/45, N128CM, Serial Number 403

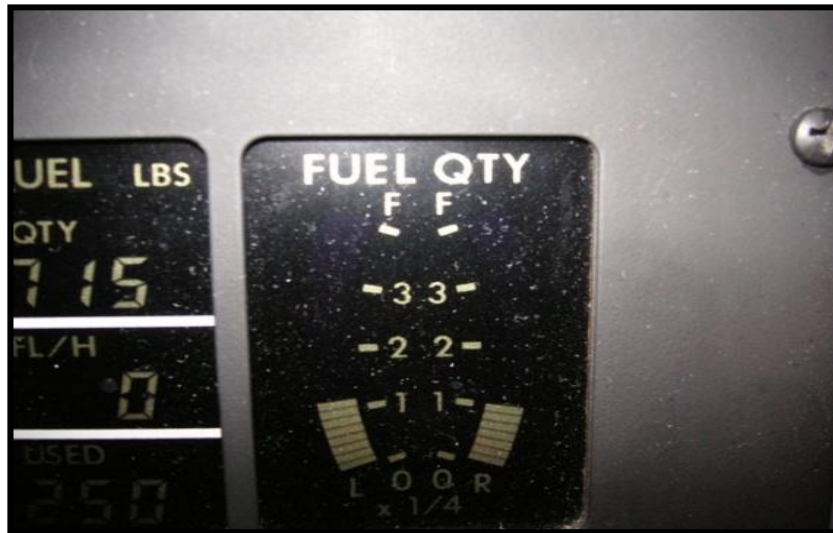
Figure 1 Picture of Fuel Indicator

Normal system operation is indicated by the left and right fuel quantity gauges (see Figures 1 and 2 below) remaining within 2 LCD segments of each other. When a difference of 3 LCD segments is observed, the fuel boost pump for the tank with the higher quantity should be turned ON until the quantities are even. Monitor the fuel quantity gauges for fuel symmetry for the remainder of the flight.

switch to ON for the fuel tank with the higher quantity until a balanced fuel condition is restored and then turning OFF the fuel boost pump. During normal operation the pilot should monitor the fuel quantity gauges to verify that the Fuel Balancing Device is operating properly. Normal system operation is indicated by the left and right fuel quantity gauges remaining within 2 LCD segments of each other. (When a difference of 3 LCD segments is observed, the fuel boost pump for the tank with the higher quantity should be turned ON until the quantities are even. Monitor the fuel quantity gauges for fuel symmetry for the remainder of the flight.)
