National Transportation Safety Board

Jackson, Mississippi
January 24 & 27, 2024

PLD24FR003

EMERGENCY RESPONSE

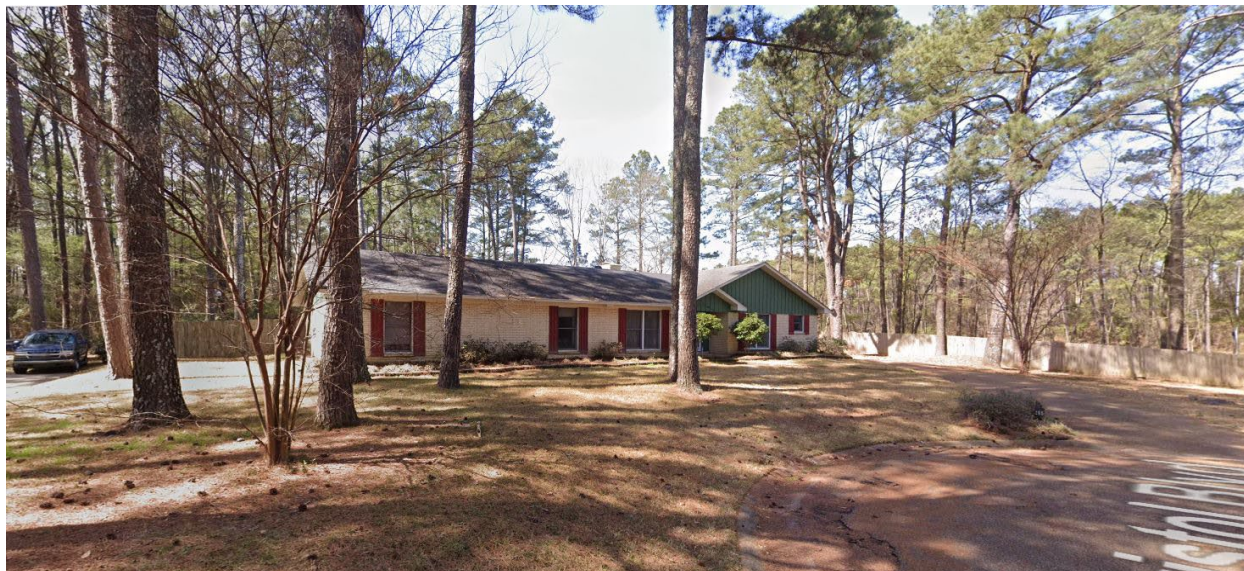
Figure 1: Pre-accident property photograph (Google photo from March 2022)

The house at 185 Bristol Boulevard was a single-family home located in a southwest neighborhood in Jackson, MS. The house was a one-story ranch style dwelling with an attached garage. The construction of the house and attached garage consisted of National Fire Protection Association “Type 5” light weight wood frame construction. The square footage of the residence was between 1500 square feet to about 2000 square feet which includes the attached garage.⁴

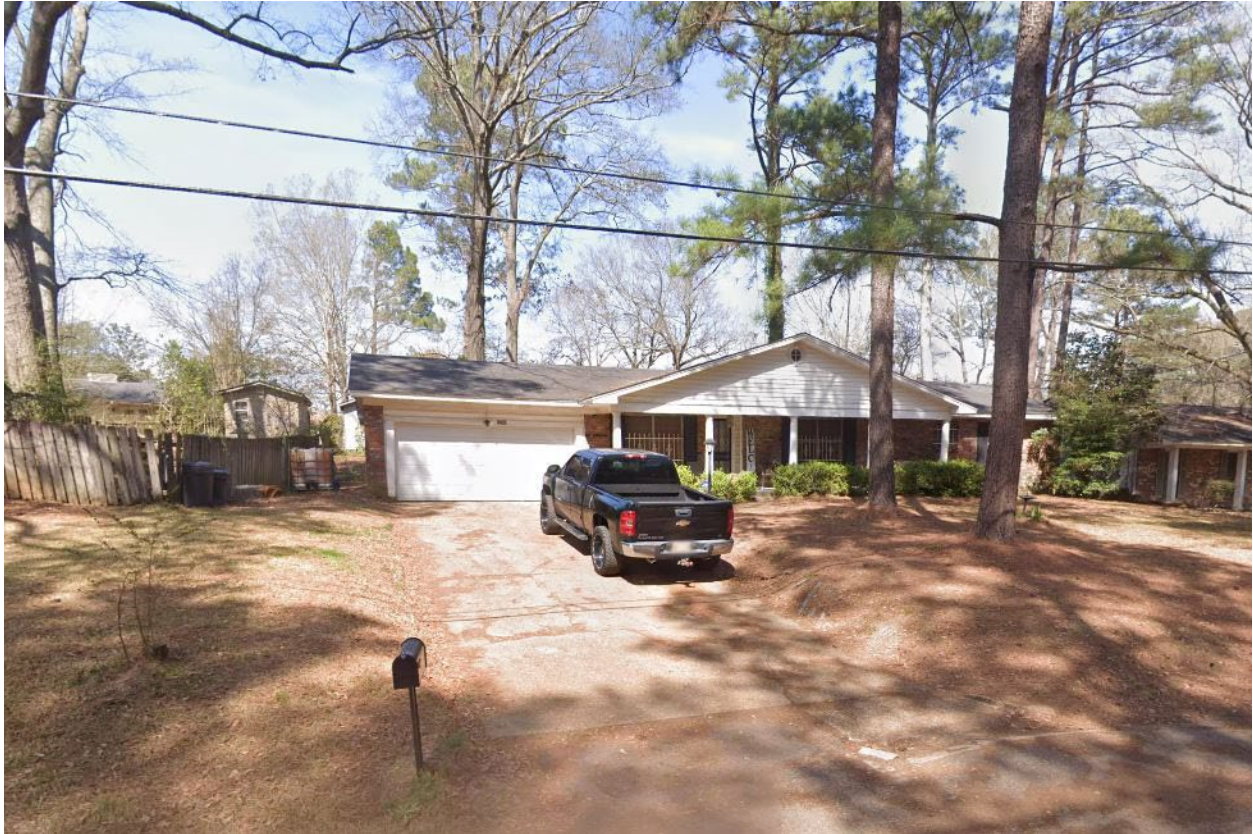
Figure 2: Pre-accident property photograph (Google photo from March 2022)

The house at 1146 Shalimar Drive was a single-family home in southwest neighborhood in Jackson, MS.⁶ The house was a one-story ranch style dwelling with an attached garage and was not occupied at the time of the explosion. The construction of the house and attached garage consisted of NFPA "Type 5" light weight wood frame construction. The square footage of the residence was between 1500 square feet to about 2000 square feet which includes the attached garage.
