Laurence and Associates, LLC 918 Government Street Mobile, AL 36604

SOUTH CAROLINA PORTS AUTHORITY 200 Ports Authority Dr Mt Pleasant, SC 29464

Subject: SCPA ZPMC Crane H-39-037 (#37) Vessel Impact Damage Assessment

LA, LLC Project Number 2405

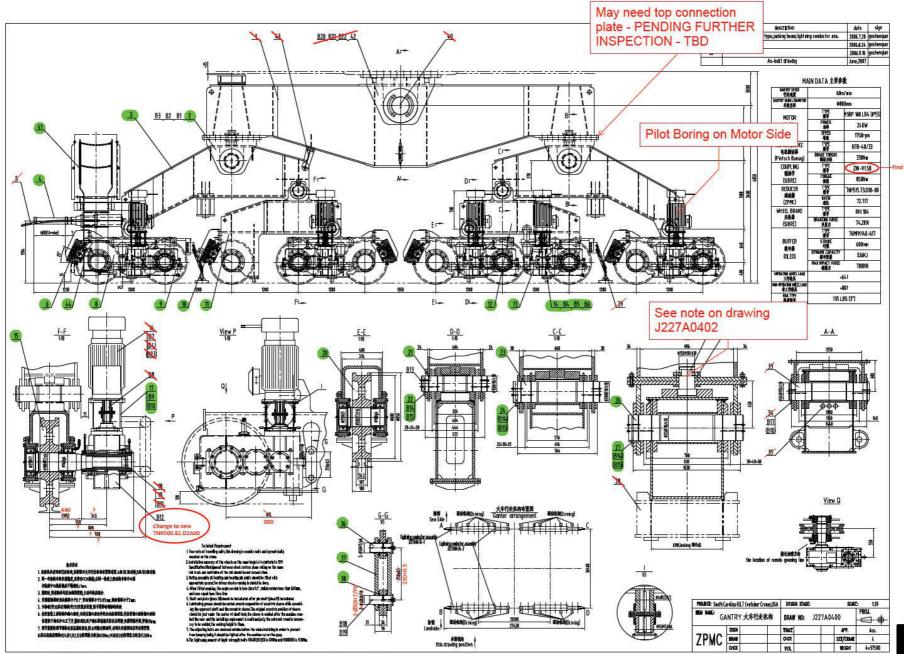
ZPMC gantry drawings with requested new parts indicated.

\*Note - ZPMC Engineering to verify dimensions, component updates, and comments in red.

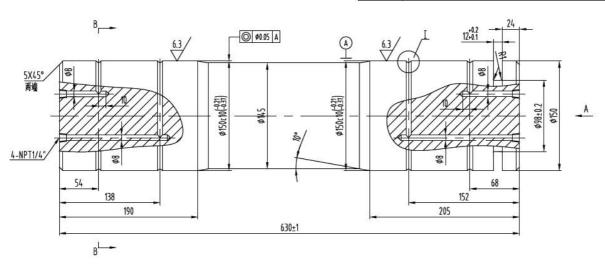
NO.	SUB-NO	or STDD	NAME & SIZ	E MTRL or S	STYLE Q'TY/SET	SET*WEIGHT	SCALE
	J22	7A0419	Shaft(轴)ø15	0 35CrMc	16	16×85	1:3
71	OMC	DRAW	TI	ECH.	TRAC	Ε	
ЬΓ		СНСК	S	TDD	CHC	K

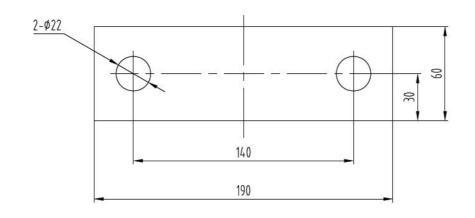
Breaking sharp cornser 注:棱边倒角1X45°.

NO.	SUB-NO	or S	TDD	NAM	E & S	SIZE	MTRL	or S	TYLE	Q'TY/SET	SET*WEIGHT	SCALE
	J22	7A0420		Shaft e	nd plat	e(卡轴板)		Q235		16	16×1.1	1:2
70		DRAW	,		3	TECH.	9			TRAC	E	
$\angle \Gamma$		CHCK	A.		3	STDD	9			CHCI	(
