**RE: BK-117 Accident of April 15, 1997**  
**Reg. No. N909CP NTSB ID NYC97FA076**

#### RK-117 INSPECTION INTERVALS

#### VERTICAL FIN SPAR CRACKS

#### USE OF BLIND RIVETS - COMMON INDUSTRY INFORMATION

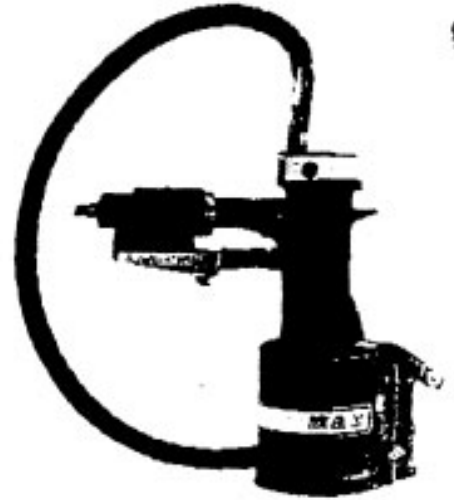
Cherry G-704-40SR Split Riveter utilized In the Sikorsky robot

Sikorsky installing CherryMAX rivets with a robot in production of the SH-60B Seahawk. CherryMAX is the ideal fastener for robotic/automatic blind riveting — the pulling head installs six diameters and five different head styles with no tooling changes or adjustments!
