**NATIONAL TRANSPORTATION SAFETY BOARD
OFFICE OF AVIATION SAFETY
WASHINGTON, D.C.**

**SURVIVAL FACTORS GROUP CHAIRMAN'S
FACTUAL REPORT**

I. A. ACCIDENT : DCA05MA004

LOCATION : Kirksville, Missouri
DATE : October 19, 2004
TIME¹ : 1945 Central Daylight Time (CDT)
AIRCRAFT : Jetstream 3200, Flight 5966,
N875JX, Operated by Corporate
Airlines, Inc.

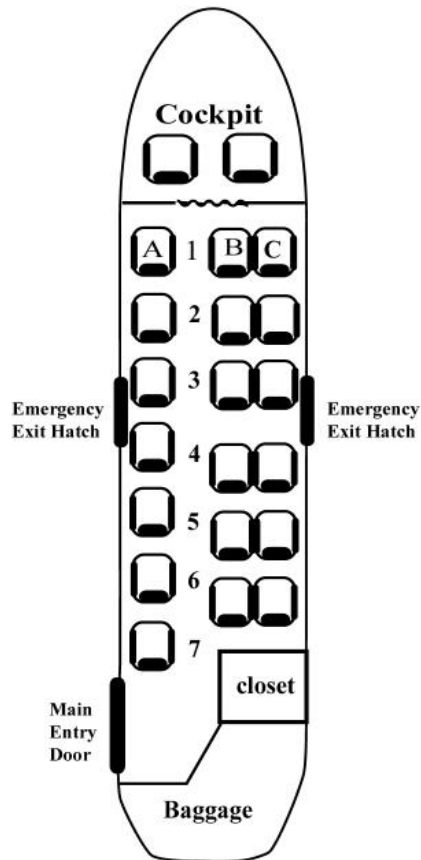
Figure 1. Jetstream 3200 Interior Diagram

The Jetstream 3200 was configured with 19 coach class passenger seats and 2 cockpit flight crew seats. The coach seats were configured with a row of 7 single seats on the left side of the cabin and 6 sets of double seats along the right side of the cabin separated by an aisle. The main cabin door was located on the left side of the cabin behind the last passenger seat. There were two overwing emergency exits at row 4 on either side of the cabin. See Figure 1, Jetstream 3200 Interior Diagram.
