NATIONAL TRANSPORTATION SAFETY BOARD
Office of Aviation Safety
Washington, DC 20594

ADDENDUM 2 TO THE SYSTEMS GROUP CHAIRMAN'S FACTUAL REPORT
ADDITIONAL SYSTEMS DESCRIPTIVE INFORMATION

DCA05MA004

Location: Kirksville, Missouri
Date: October 19, 2004
Time: 1945 central daylight time (CDT)
Aircraft: British Aerospace Jetstream 32, N875JX
Corporate Airlines Flight 5966

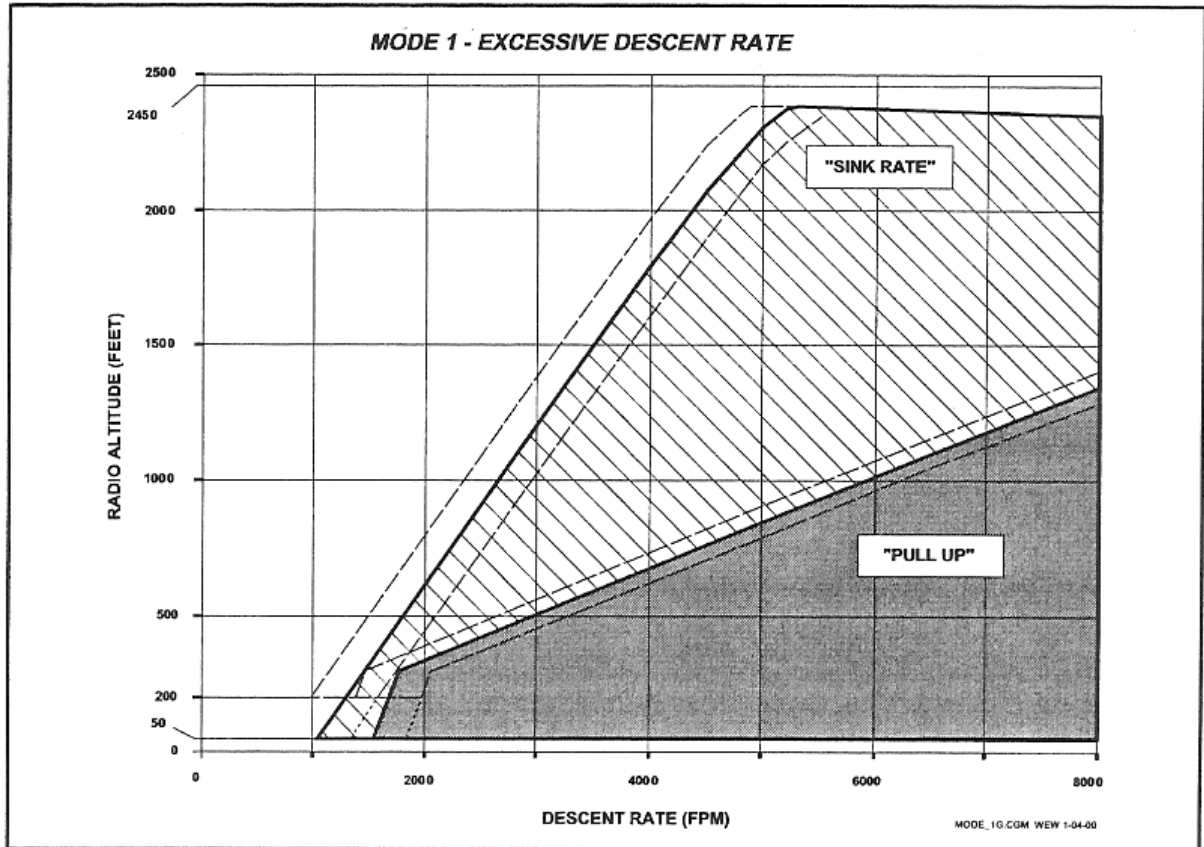
There is an outer alert boundary and an inner warning boundary, as shown in Figure 1. Penetration of either boundary results in illumination of the GPWS alert

lamps on the indication unit. In addition, the outer alert boundary provides an aural warning of 'sink rate' every three seconds, and the inner warning boundary provides a continuous aural warning of 'pull up' with increased emphasis.

Figure 1 – GPWS Mode 1 Clearance Alert Envelope
