**NATIONAL TRANSPORTATION SAFETY BOARD**  
**Office of Aviation Safety**  
**Washington, DC 20594**

**Group Chairman's Factual Report**  
**February 14, 2005**

**SYSTEMS GROUP**

**DCA05MA004**

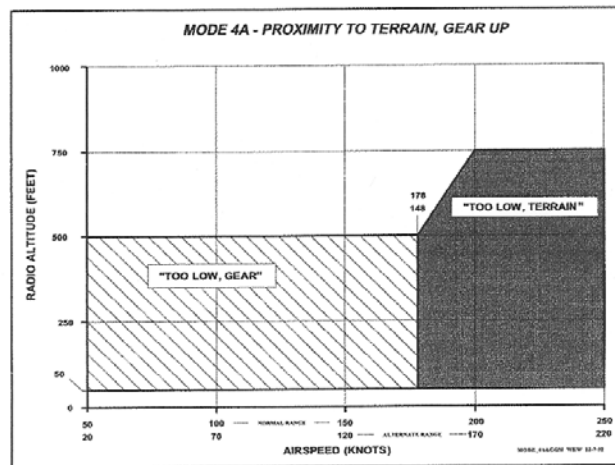
A mode 4A alert occurs whenever its envelope is penetrated (See Figure 1.) This causes a voice message to be repeating every three seconds, and the cockpit lamp(s) to illuminate. If the aircraft speed is less than 178 knots, the repetitive voice message will be “TOO LOW, GEAR”. For speeds above 178 knots, the Mode 4A voice message is “TOO LOW, TERRAIN”.<sup>6</sup>

**Figure 1 – GPWS Mode 4A Clearance Alert Envelope**

Mode 4 generates three types of alerts based on Radio Altitude, Airspeed, and flight mode. These are referred to as Modes 4A, 4B, and 4C. Mode 4A is active during cruise and approach with landing gear up. Mode 4B is active during cruise and approach with landing gear down and flaps NOT in the landing range, and the GPWS FLAP OVERRIDE switch in the cockpit is not selected. Mode 4C is active during takeoff. Warnings from modes 4A, 4B, and 4C cannot occur simultaneously.
