## **A.O. Smith Hard Spot Response and Repair Criteria**

Remedial Work Plan, Increment 2 rev. 1

PHMSA Second Amended Corrective Action Order, CPF 2-2019-1002H

July 10, 2020 (rev. 1)

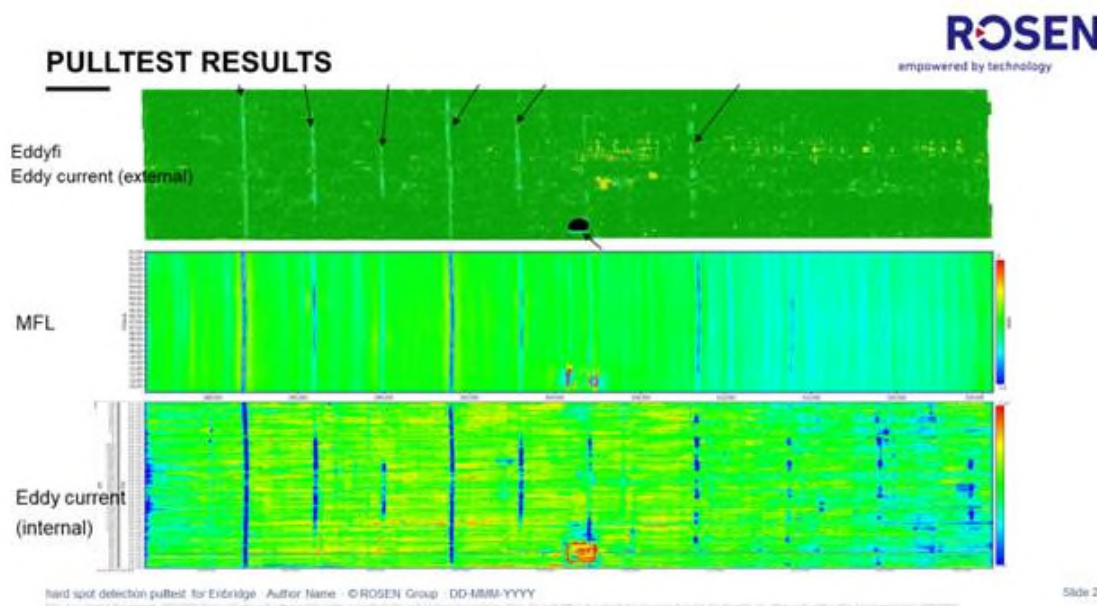
**Figure 2.0, Rosen Image of Expander Marks**

As described above, hard spots with hardness properties of less than two hundred and eighty (280) HB are not an integrity threat and are not actionable. In addition, low field magnetic flux leakage (MFL) ILI tools can detect other magnetic anomalies within the pipe that are not hard spots. In relevant part, MFL tools frequently detect expander mark features. Expander mark features were created when the pipe was expanded to a final diameter using expander rings. This resulted in localized areas of higher hardness as compared to the rest of the pipe body. Expander marks typically have hardness between two hundred and forty (240) HB and two hundred and eighty (280) HB. This elevated hardness is caused by cold work hardening, however, and does not present a microstructure change. Figure 2.0 below depicts expander marks.

A hard spot has a quenched martensitic microstructure and high hardness susceptible to hydrogen embrittlement and HSC. In contrast, expander marks have material microstructure that is not susceptible to HSC, and therefore there are no integrity issues associated with expander marks. The expander marks can be reliably identified as nonactionable ILI features based on the following characteristics: (1) alignment in the circumferential direction; (2) equidistant at approximately every three (3) feet;<sup>13</sup> and (3) a distinct magnetic signature. Expander marks are not typically reported by ILI tool service providers because they do not impact pipeline integrity. The detection of expander marks on the Affected Segment, however, may be used to further demonstrate that the ILI hard spot tool functioned within the relevant parameters for hard spot

Figure 2.0 – Rosen Image of Expander Marks..... 7

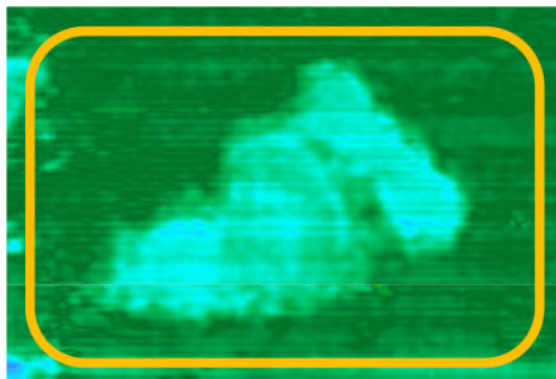
**Figure 3.0 – EddyFi Spyne Tool Hard Spot Mapping**

The entire exposed area will be scanned using the EddyFi Spyne tool. The tool is able to detect potential hard spots for investigation because it is designed to detect changes in magnetic permeability of the material using an Eddy current array. In addition, this mapping will provide additional information on the feature and it will confirm whether the hard spot ILI tool reports any false negative findings (*i.e.*, hard spot confirmed in the ditch but not reported by the ILI tool). To ensure consistent results, the EddyFi Spyne tool will typically be calibrated before initial use, every four (4) hours, and at the end of each day. Figure 3.0 below depicts a hard spot using EddyFi Spyne tool hard spot mapping.

Figure 3.0 – EddyFi Spyne Tool Hard Spot Mapping .....11

tool will be etched. TETLP will use acid etching to confirm if the feature is a hard spot. Pursuant to TETLP SOPs, the pipe surface will be cleaned and the surface polished in order to remove surface oxides and to obtain a relatively smooth surface. Acid etching with five percent (5%) or ten percent (10%) nital acid solution will be used to evaluate hard spot indications and locations of features to identify detailed microstructure variations. TETLP will identify and document any surface variations that occur as a result of the acid etching process. Figure 4.0 below depicts acid etching of the same hard spot that is represented in Figure 3.0 using the EddyFi Spyne tool mapping.
