NATIONAL TRANSPORTATION SAFETY BOARD
Vehicle Recorder Division
Washington, DC 20594

Track Image Recorder Factual Report

Location: Pine Bluff, Arkansas
Date: April 3, 2015, 9:23 pm central daylight time (CDT)
Operator: Railroad Switching Services
NTSB Number: DCA15FR007
Locomotive: UP1912

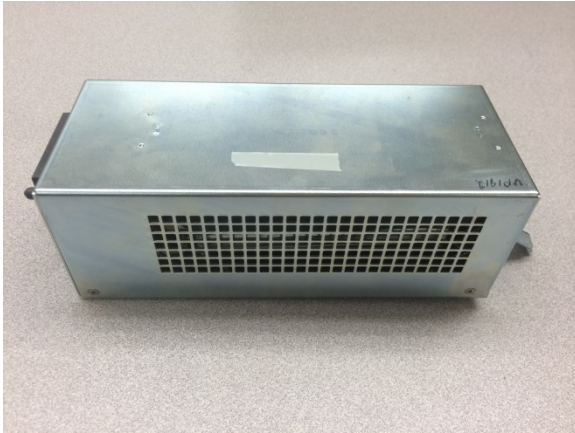
Figure 1. Side view of Wabtec TIR hard drive.

The Wabtec TIR system contains a forward facing video camera and microphone that record to an external hard drive (Figures 1 and 2). It records color video at a resolution of 704x480 pixels and 15 frames per second (fps). External audio is also recorded. Some versions will also record GPS position and speed. The recorders are not required by regulation and are not protected from impact or fire.

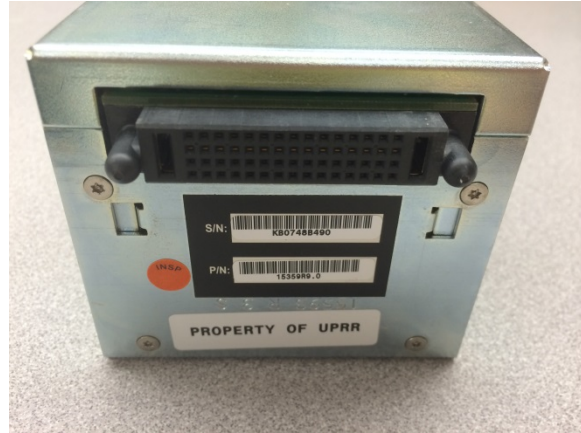
Figure 2. Front view of Wabtec TIR hard drive.
