NATIONAL TRANSPORTATION SAFETY BOARD

Group Chairman's Factual Report

OPERATIONAL FACTORS

DCA16IA200

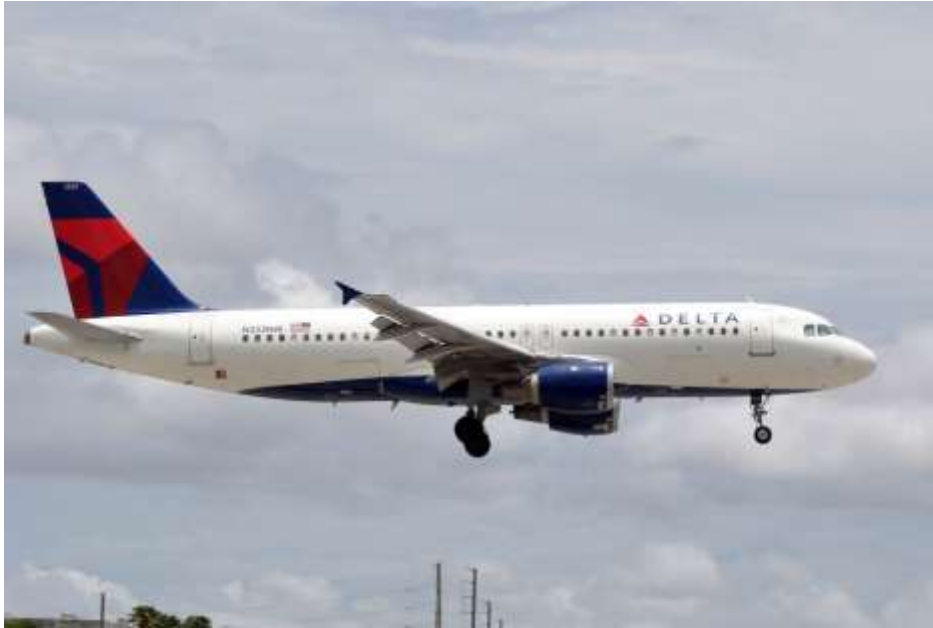
Photo 1: Incident Airplane (Registration N333NW)

The incident airplane was an Airbus A320-211 (Registration N333NW), Serial No. 0329, and was manufactured in 1992. The registered owner was Delta Air Lines, Inc., and it held a transport category airworthiness certificate dated July 10, 1992. The airplane had a maximum ramp weight of 170,635 pounds, and had a total passenger seating capacity of 160, and contained 4 flight crew seats and 5 cabin crew seats. A review of NTSB and FAA records found that the incident airplane had not been involved in any previous incidents that merited a formal investigation or accidents.³³

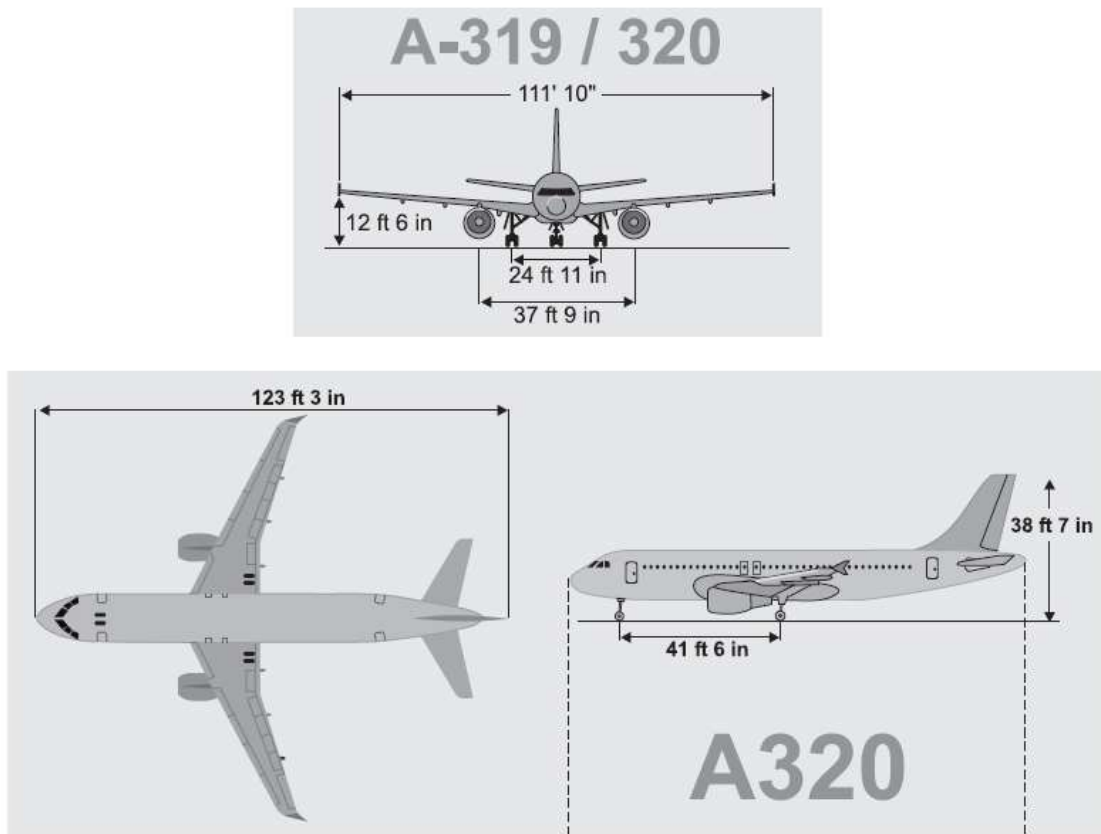
Figure 1: Airplane Dimensions

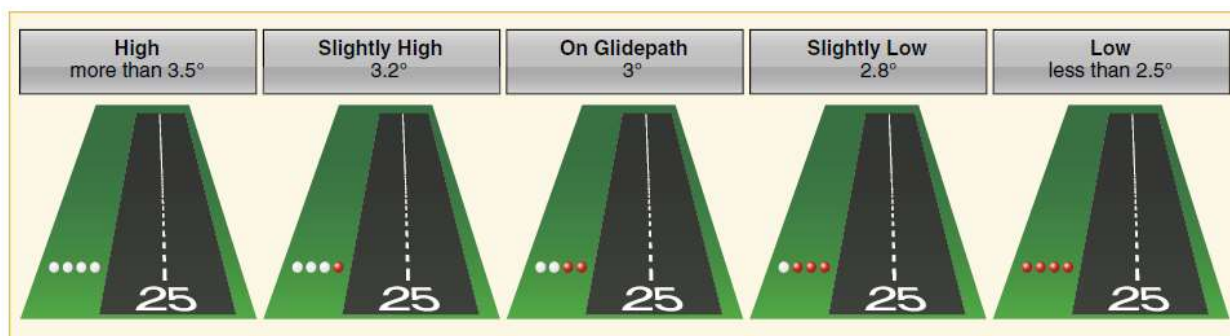
Figure 2: 4-Light Precision Approach Path Indicator (PAPI)⁴⁷

RAP had two runways designated as 5/23 and 14/32. Runway 5/23 was 3,601 feet long and 75 feet wide and was an asphalt runway and was noted as not available for scheduled air carrier operations with aircraft designed for 10 passenger seats or more. Runway 14/32 was 8,701 feet long and 150 feet wide, the surface was concrete and grooved. Runway 5/23 was equipped with MIRL (medium intensity runway lights), runway 14 was equipped with HIRL (high intensity runway lights) and REIL⁴⁶, and runway 32 was equipped with HIRL and MALSR (medium-intensity approach light system with runway alignment indicator lights). Runways 5 and 23 were equipped with a 2-light PAPI on the left side and runway 14 and 32 were equipped with a 4-light PAPI on the left side of the runway with a 3.00-degree glide path angle.

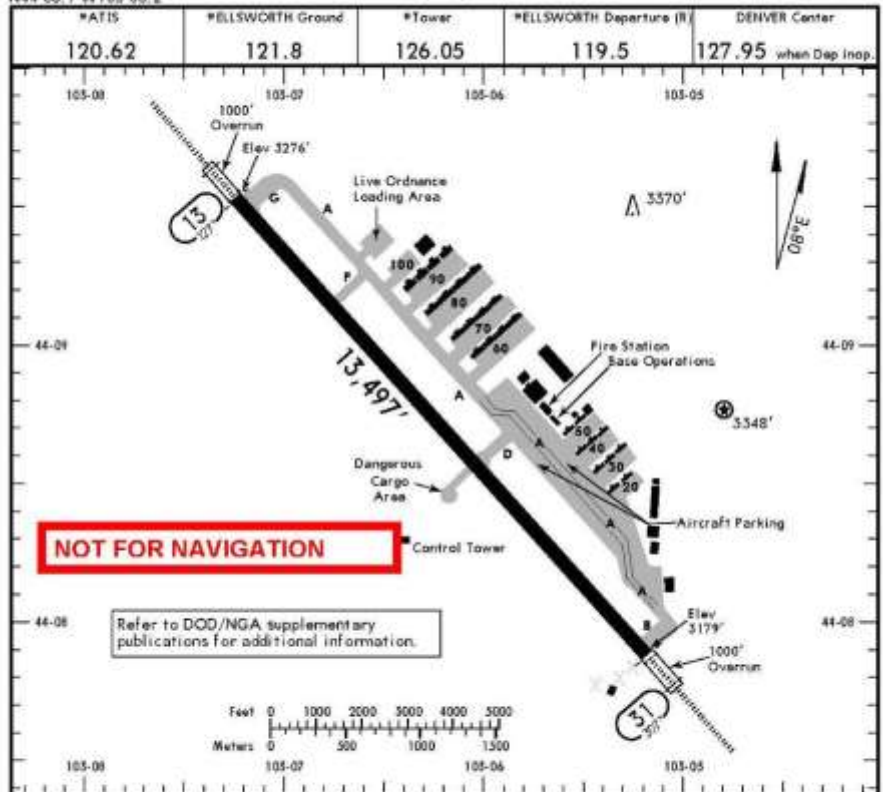
ELLSWORTH AFB
RAPID CITY, S DAK

RWY	HIRL ALSF-I REIL PAPI-L (angle 3.0°)	RVR	USABLE LENGTHS		TAKE-OFF	WIDTH
			Threshold	Glide Slope		
13	HIRL ALSF-I REIL PAPI-L (angle 3.0°)	RVR		12,069'		300'
31	HIRL ALSF-I REIL PAPI-L (angle 3.00°)	RVR		12,476'

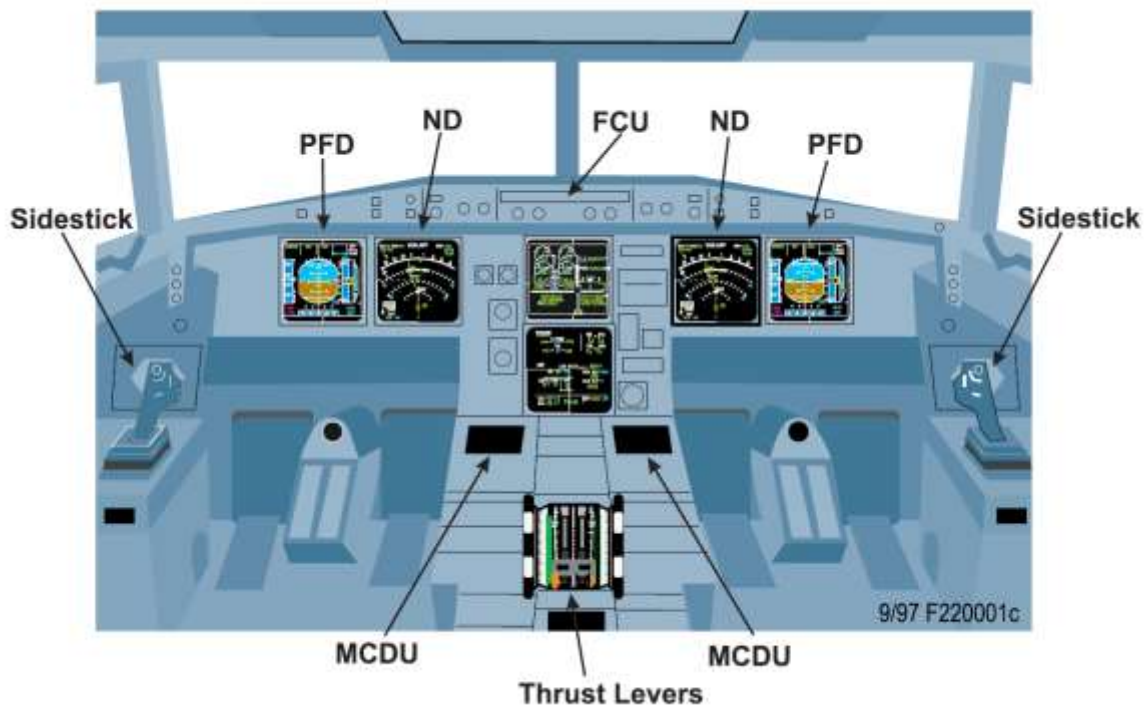
The incident airplane was an Airbus A-320-212 airplane, equipped with an electronic flight instrumentation system. The system included 6 flat panel displays, of which 2 were considered the Primary Flight Displays (PFD) and 2 were considered Navigation Displays (ND), which provided flight and navigation information in a digital format. The center two screens make up the Electronic Centralized Aircraft Monitor (ECAM) system.

Figure 10: Cockpit EFIS Layout Diagram⁵⁶

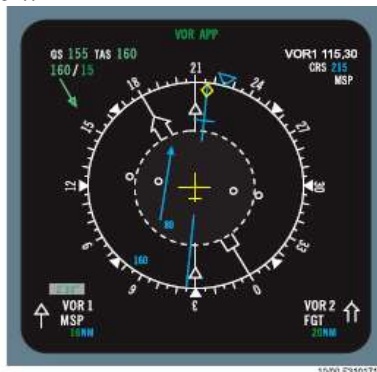
The ROSE VOR mode provides a VOR display similar to a conventional HSI⁶¹ as well as additional VOR information.

Figure 11: ROSE VOR Mode⁶²

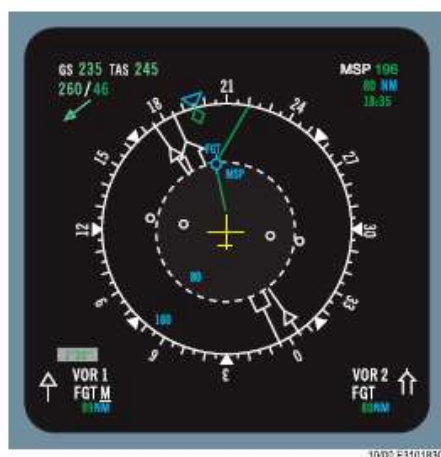
Five different types of flight plans can be displayed. Each type of flight plan can be recognized by the color used to depict the flight plan segment. The color of the ND flight plan corresponds to the color of the MCDU flight plan segment. The flight plane types are the:

Figure 12: ROSE NAV Display⁶⁴

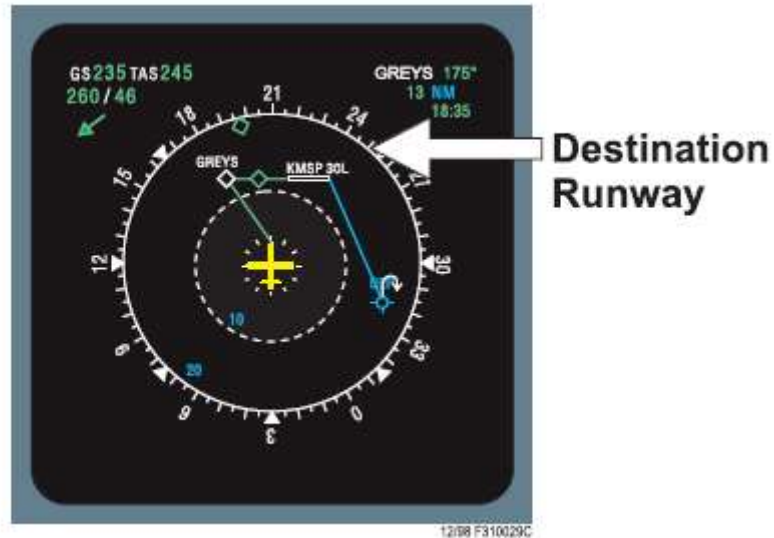
Destination Runway – When entered via the MCDU, the destination runway and the runway identifier are depicted in white. In some cases, parallel or crossing runways are also depicted.

Figure 13: ROSE NAV Display with Runway⁶⁵

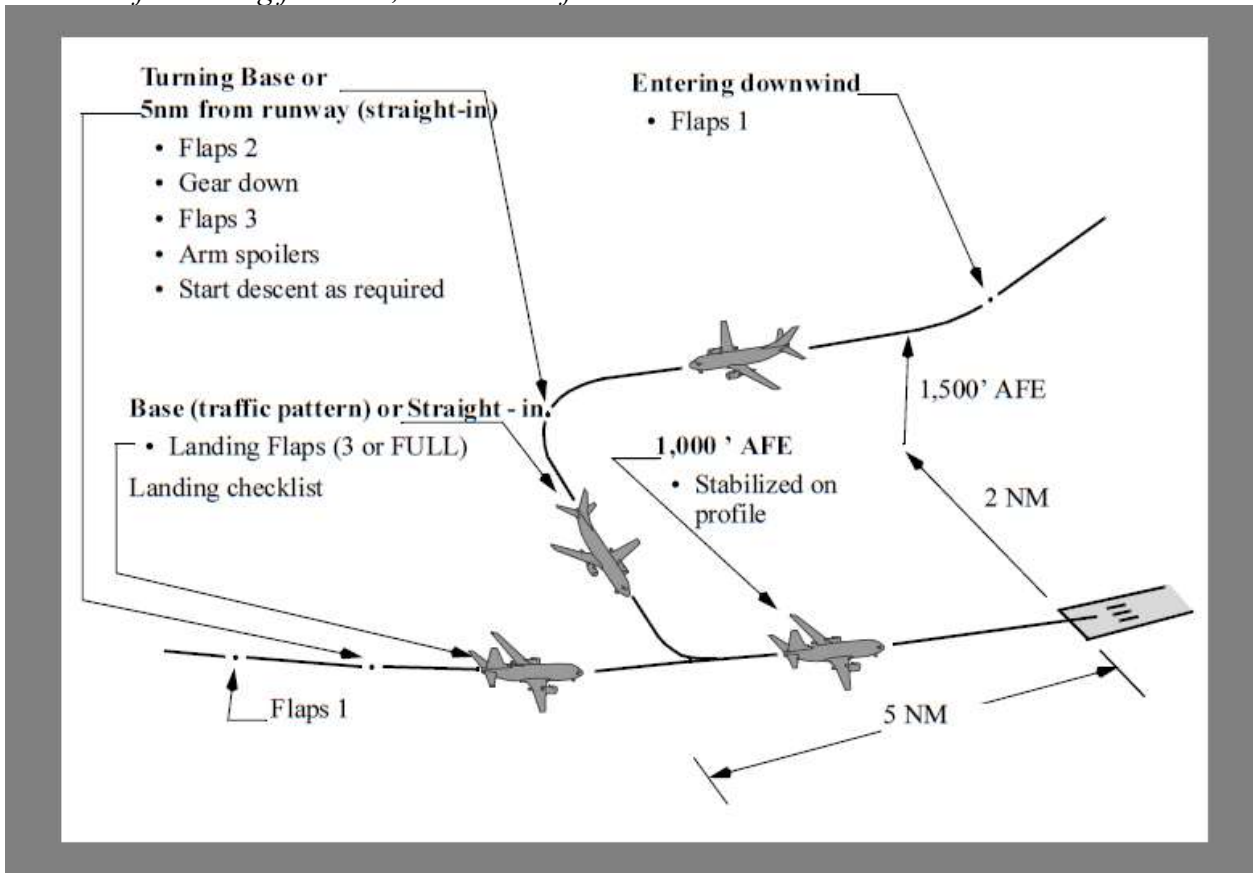
Figure 15: Visual Approach Procedures⁷⁴

The recommended landing approach path is approximately 3°. Once the final approach is established, the aircraft configuration remains fixed and only small adjustments to the glide path and approach speed are necessary. This results in the same approach profile under all conditions.
