NATIONAL TRANSPORTATION SAFETY BOARD

Operational Factors Group Chairman's Factual Report

OPERATIONAL FACTORS

DCA18MA142

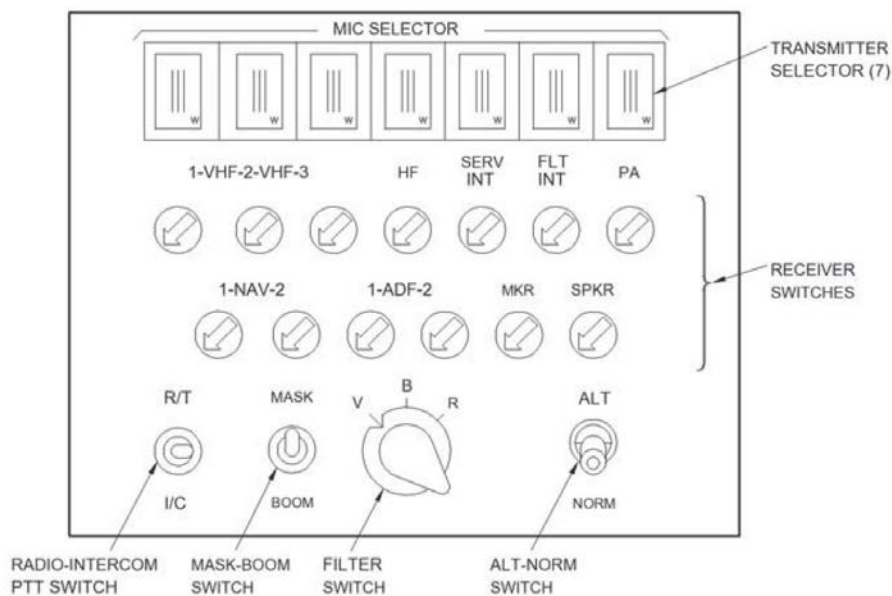
Each pilot was provided an audio control panel (ACP) which allowed crewmembers to select both what audio sources they were listening to and to where they were transmitting. See Figure 1, below.

Figure 1: B737-700 Audio Control Panel

The flightdeck crew was provided with two sets of switches on the ACP. The transmitter selector switches allowed each crewmember to select where his transmission was going. To speak over the VHF radio for example, one of the three VHF transmitter switches would be selected. To speak with the cabin crew, the service interphone (SERV INT) switch would be selected, and to make an announcement to the passengers, the public address (PA) switch would be selected. Only one transmit switch could be selected at a time. The Receiver switches allowed the pilot to select one or more sources to listen to. Selecting a transmit switch also enabled the listening function for that selection; it was not necessary to select the corresponding receiver switch. After selecting a destination for the transmission, to begin transmitting, the crewmember could use either a push-to-talk (PTT) switch on the control wheel, or the R/T – I/C switch on the ACP. The R/T – I/C switch was spring loaded to the center (off) position. When held to the R/T position, the crewmember would be transmitting over the selected transmitter. The I/C position allowed the crewmember to speak over the interphone system with other crewmembers. The control-wheel mounted switch provided similar functionality but could be latched in the intercom position to facilitate continuing communication over the interphone. When this switch was latched in the I/C position, ACP transmit settings were not changed.

Each crewmember was provided with an oxygen mask containing a microphone to allow communications while the mask was worn. The ACP (Figure 1) for each crew member had a switch which activates the microphone in the mask. The switch had two positions; “BOOM” and “MASK.”. When this switch was placed in the “MASK” position, the microphone in the crewmember’s oxygen mask would be activated, and the crewmember wearing the mask would be able to communicate through the VHF radio system, the airplane’s interphone system, or over the PA system to make announcements to the passengers. In the “BOOM” position, the crewmember would be able to speak into any other microphone connected to the system, either a
