# Aviation Investigation Final Report

<b>Location:</b>	Bellefontaine, Ohio	<b>Occurrence Number:</b>	ENG22LA004
<b>Date &amp; Time:</b>	November 12, 2021, 09:02 Local	<b>Registration:</b>	N9035Q
<b>Aircraft:</b>	Beech F33	<b>Aircraft Damage:</b>	Minor
<b>Defining Event:</b>	Sys/Comp malf/fail (non-power)	<b>Injuries:</b>	1 None
<b>Flight Conducted Under:</b>	Part 91: General aviation - Personal

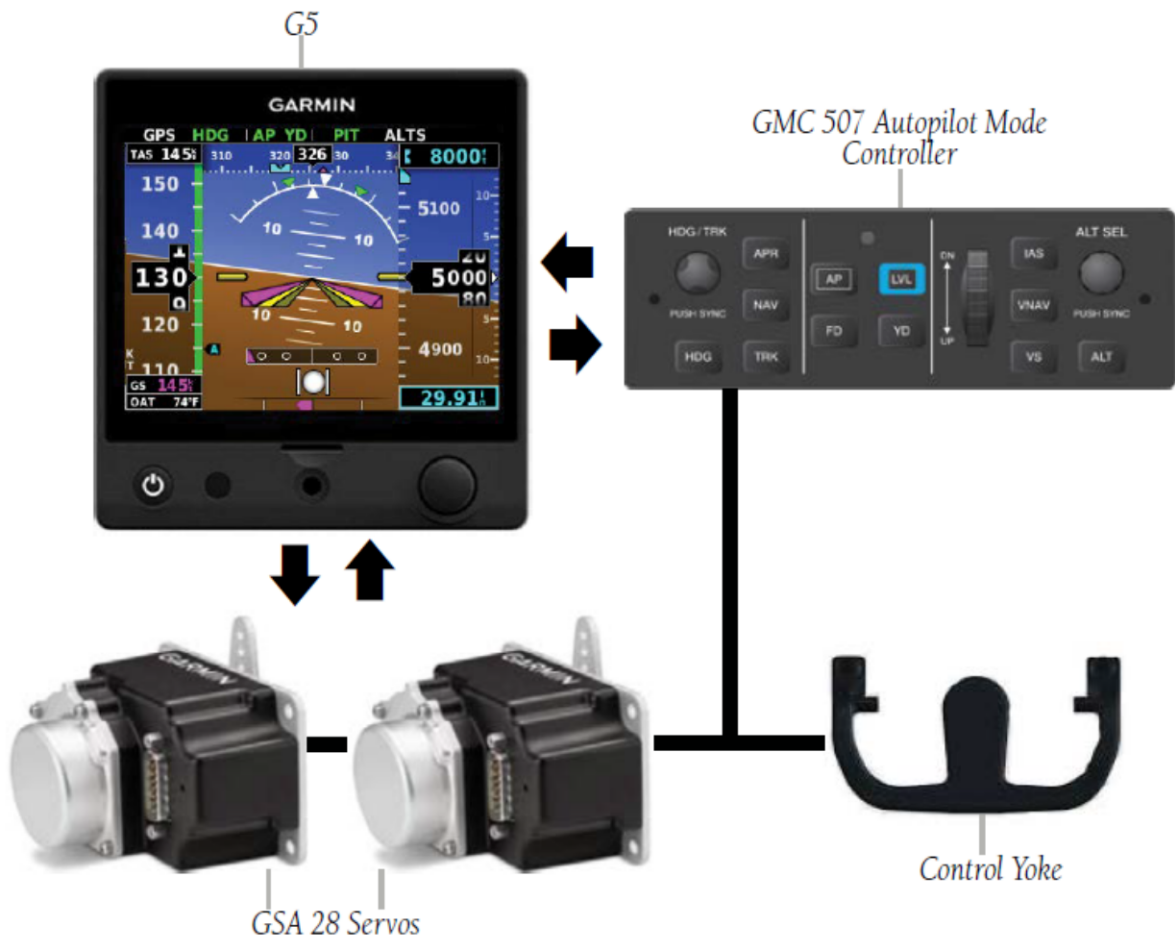
**Figure 1.** Garmin 500 Auto Flight Control System general schematic (courtesy of Garmin, taken from the G5 Electronic Flight Instrument Pilot's Guide for Certified Aircraft).

The airplane was fitted with a Garmin GFC 500 Autopilot System. The system included the Garmin G5 Electronic Flight Instrument, the GMC 507 Auto Pilot Mode Control Panel, and four GSA 28 servo actuators. The G5 can function as either an attitude display indicator and/or horizontal situation indicator. See Figure 1.

The airplane had the four GSA 28 servo actuators installed in the pitch, pitch trim, roll, and yaw positions. The pitch servo actuator was connected to the elevator surface while the pitch trim servo actuator was connected to the elevator trim surface. The servo actuators are linked via a Controller Area Network (CAN) bus. When the autopilot is engaged, the pitch trim servo will act based on information reported by the primary pitch servo received via the CAN bus.
