NATIONAL TRANSPORTATION SAFETY BOARD Office of Aviation Safety Washington, DC 20594

ATC GROUP FACTUAL REPORT

NYC05MA039

- **Location:** Oxon Hill, Maryland
- **Date/Time:** January 10, 2005, 2311 eastern standard time January 11, 2005, 0411 coordinated universal time¹
- Aircraft: N136LN, Eurocopter 135

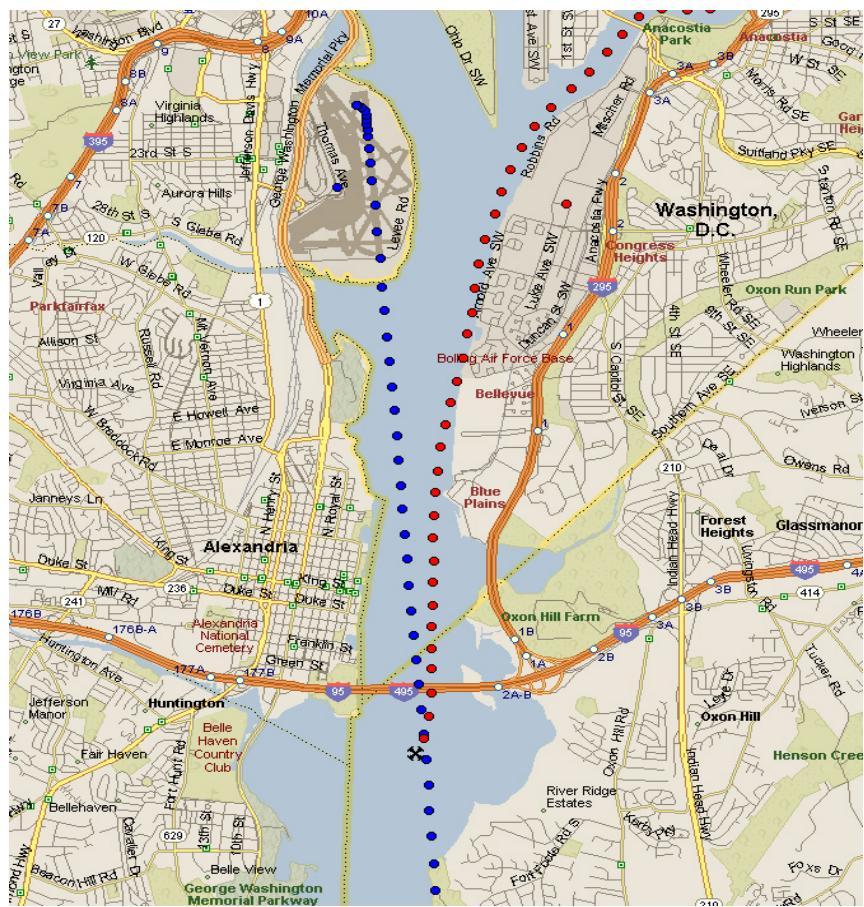
Figure 2. Flight tracks of N136LN (red dots) and CAA666 (blue dots). Maltese cross represents the accident site.

At 0414:46, LC advised LifeEvac 2 "frequency change approved." There was no response from the flightcrew. (For more detailed radar information see the Aircraft Performance Study.)
