NATIONAL TRANSPORTATION SAFETY BOARD

17 - GPS Factual Report

Specialist's Factual Report by Bill Tuccio

Location:Hailey, IdahoDate:November 29, 2011, 1900 Mountain Standard Time (MST)Aircraft:Piper PA-32RT-300TRegistration:N36824Operator:PrivateNTSB Number:WPR12LA048

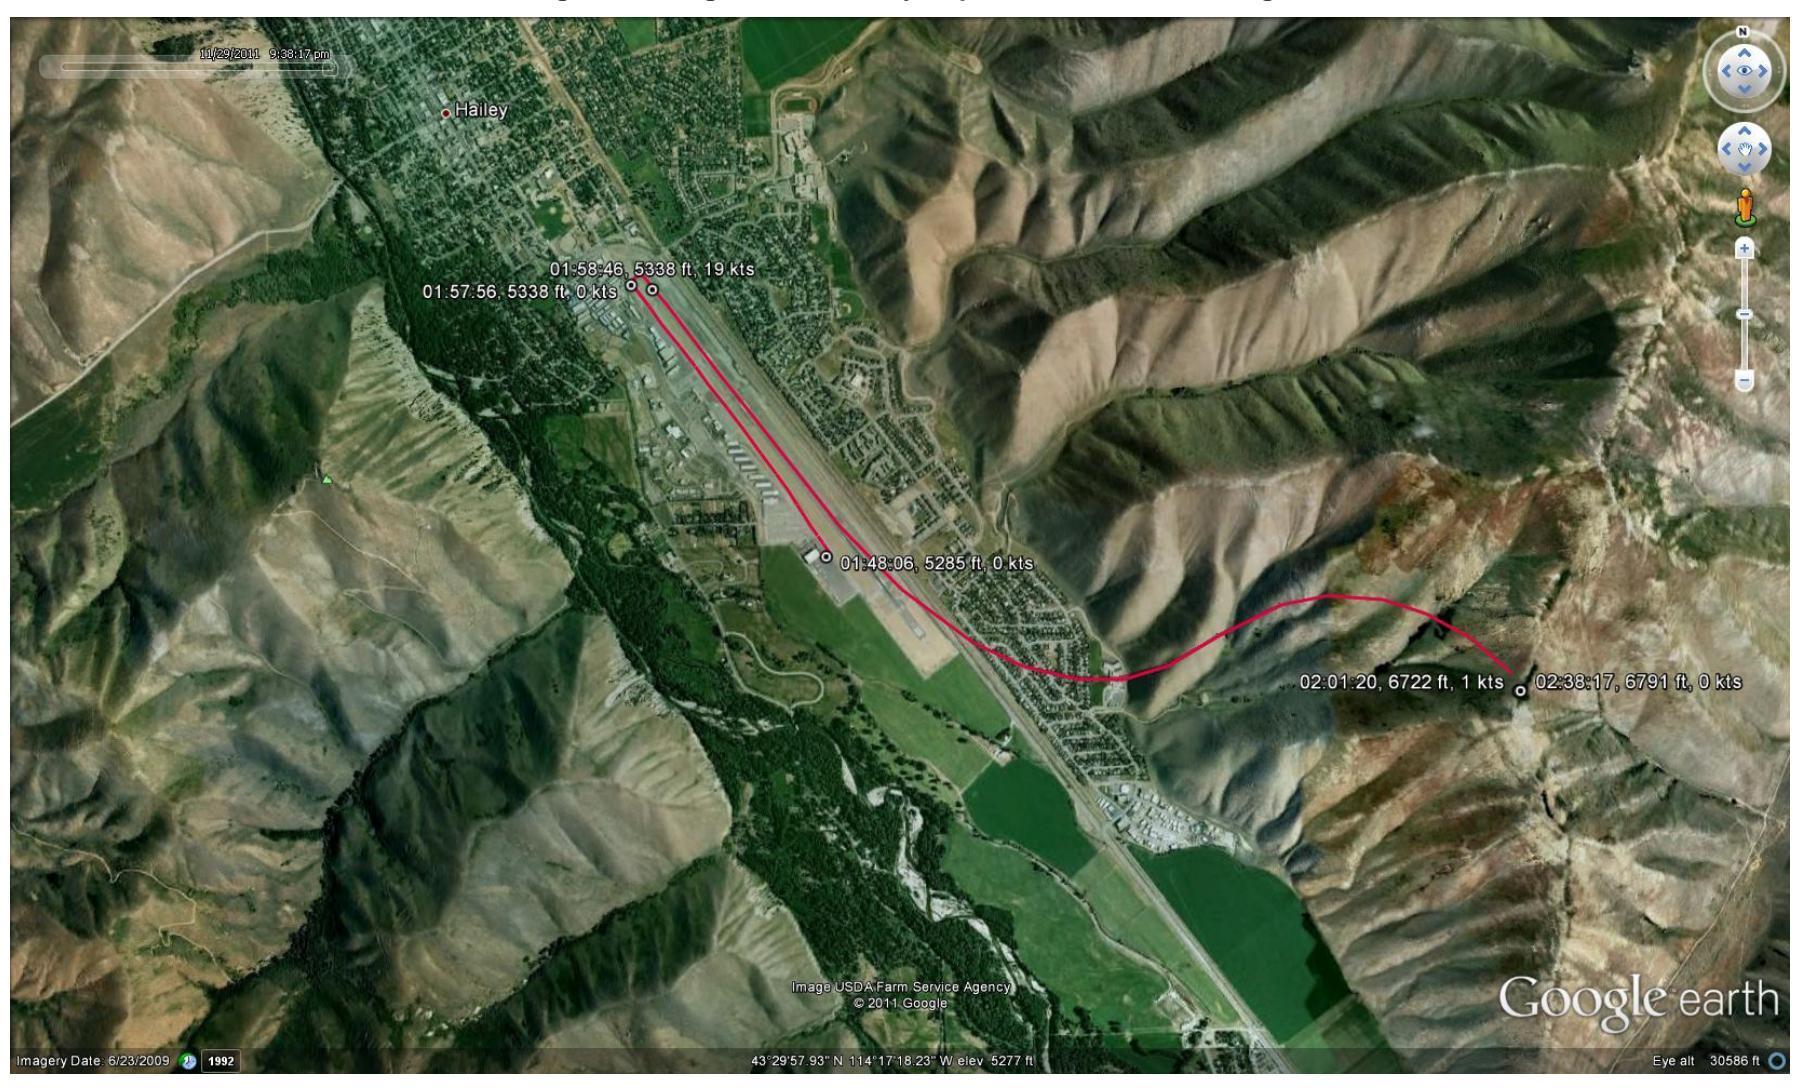
Figure 1 is a graphical overlay generated using Google Earth showing a planview of select points of the accident flight. The first recorded point was at 0148:06 in the ramp area. At about 0157:56, the aircraft was stationary in the runup area adjacent the runway. At about 0158:46, the aircraft began its takeoff. The last point recorded consistent with the aircraft in motion was at about 0201:20. Points after 0201:20 through 0238:17, are consistent with the GPS recording a stationary position after impact.

Figure 1. Google Earth overlay — planview track of last flight.

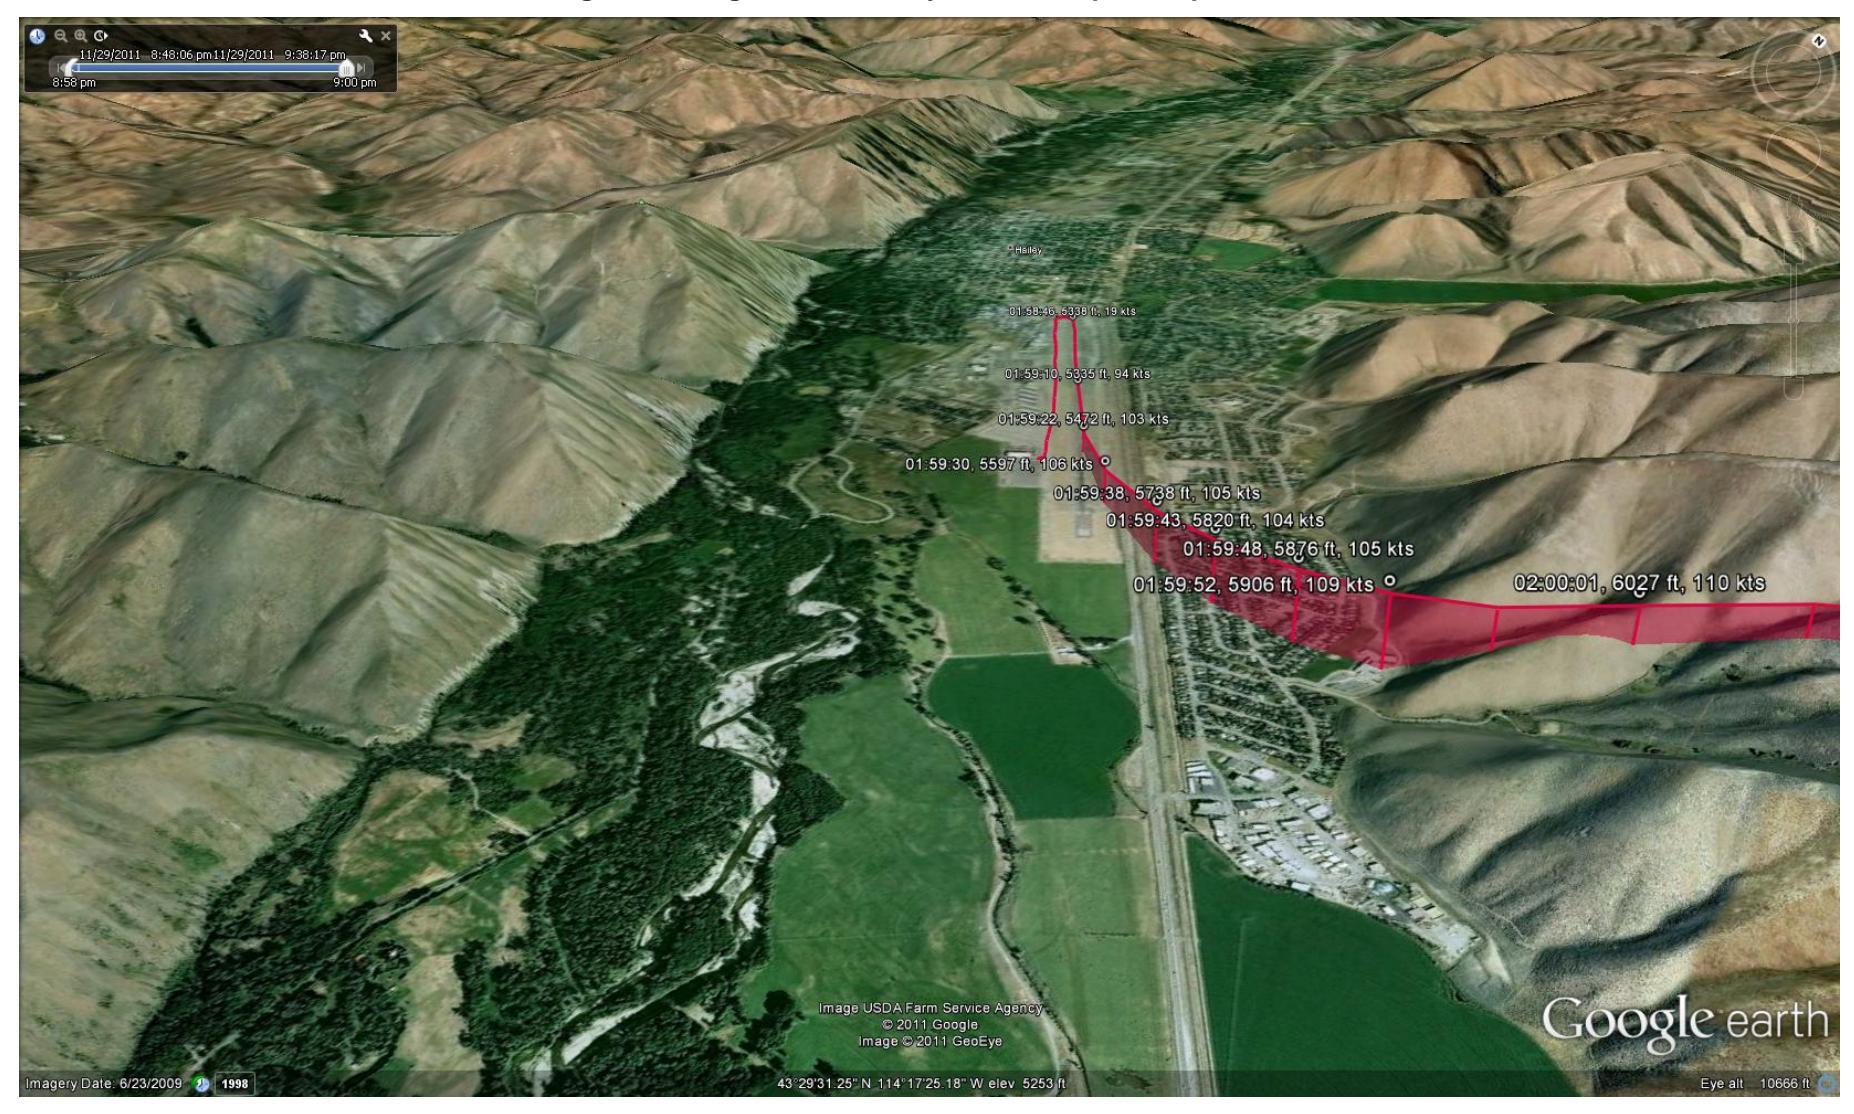
Figure 2 is a graphical overlay generated using Google Earth showing the departure and deviation from centerline. At about 0159:10, the calculated track was about 145 degrees, true. At about 0159:30, the calculated track had started to change to about 138 degrees and continued in a left turn. At about 0200:01, the aircraft had reached its most northeasterly calculated track of about 61 degrees; after which the track began to turn right, towards the south.

Figure 2. Google Earth overlay — initial departure path.

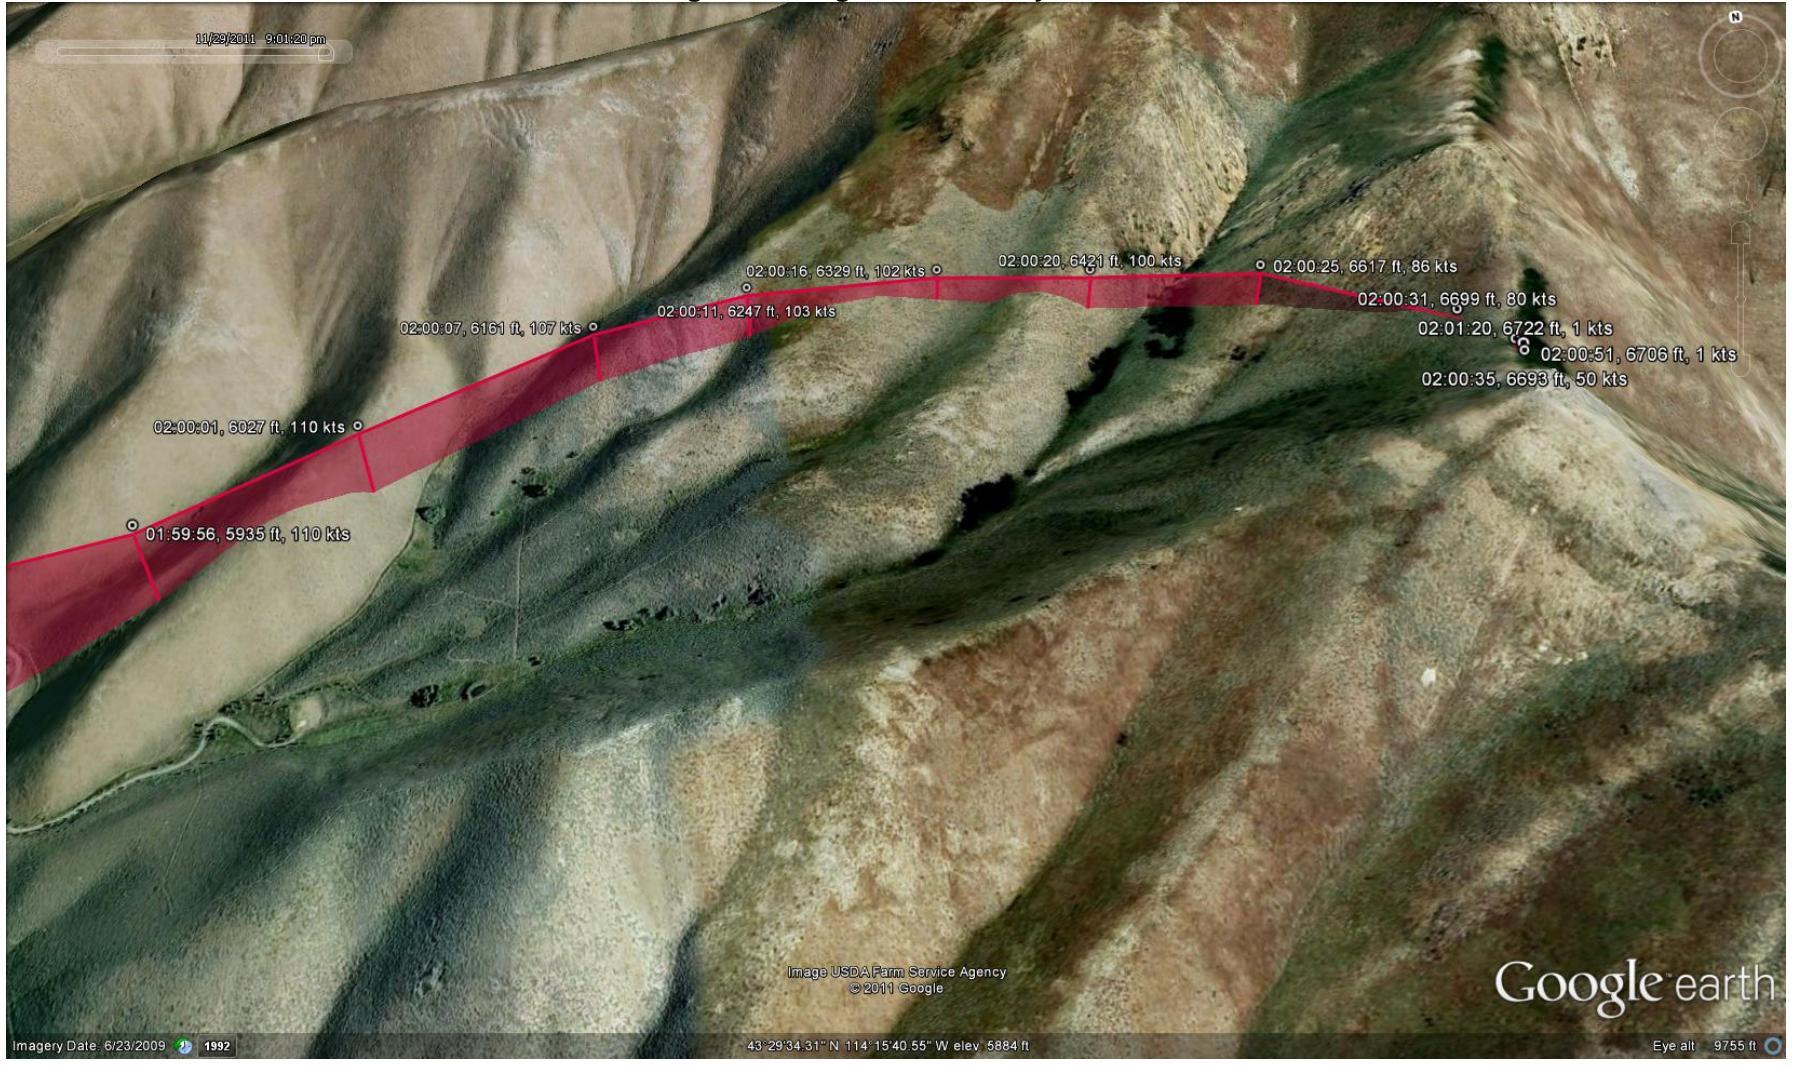
Figure 3 is a graphical overlay generated using Google Earth showing the final recorded points of the flight. The recorded track shows the aircraft over rapidly rising terrain with decreasing airspeeds coincident with the right hand turn after 0200:01. The last three points recorded at 0200:35, 0200:51, and 0201:20 approximate the time of the crash.

Figure 3. Google Earth overlay — crash.
