NATIONAL TRANSPORTATION SAFETY BOARD

Global Positioning System Device

Specialist's Factual Report By Ben Hsu

Location:	Williamsport, Indiana
Date:	January 27, 2018
Aircraft/ID:	Cessna 172F
Registration:	N8559U
Operator:	Private
NTSB Number:	CEN18FA088

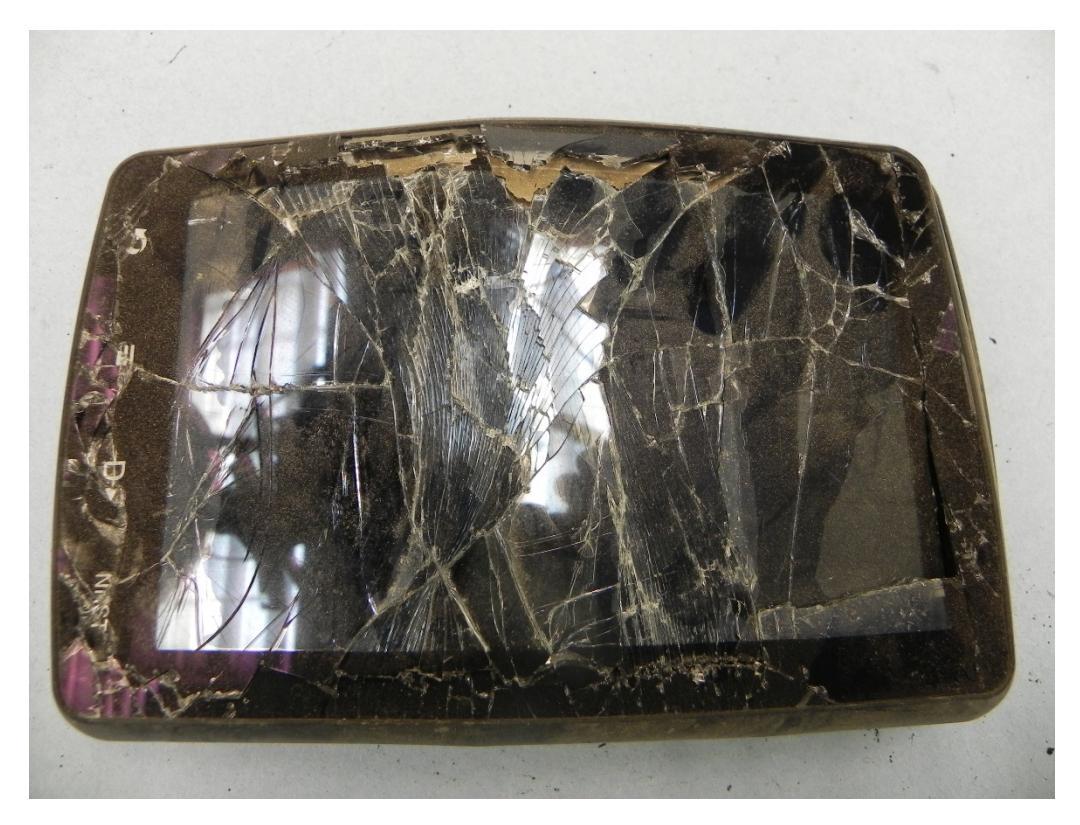
Figure 1 shows the condition of the device as it arrived in the laboratory. The device exhibited substantial damage due to impact forces and fire. The device's internal memory component was removed, imaged, and decoded using laboratory hardware and software.

Figure 1. Photo of Garmin GPSMAP 796
