NJ TRANSIT CONTRACT NO. 13-007 BRIDGE AND RAILWAY ENGINEERING

HOBOKEN TERMINAL BUMPER BLOCK INSPECTION TRACK 5 REHABILITATION RECOMMENDATION

SUBMITTED TO: NJ TRANSIT SUBMITTED BY: HNTB CORPORATION

DECEMBER 15, 2017

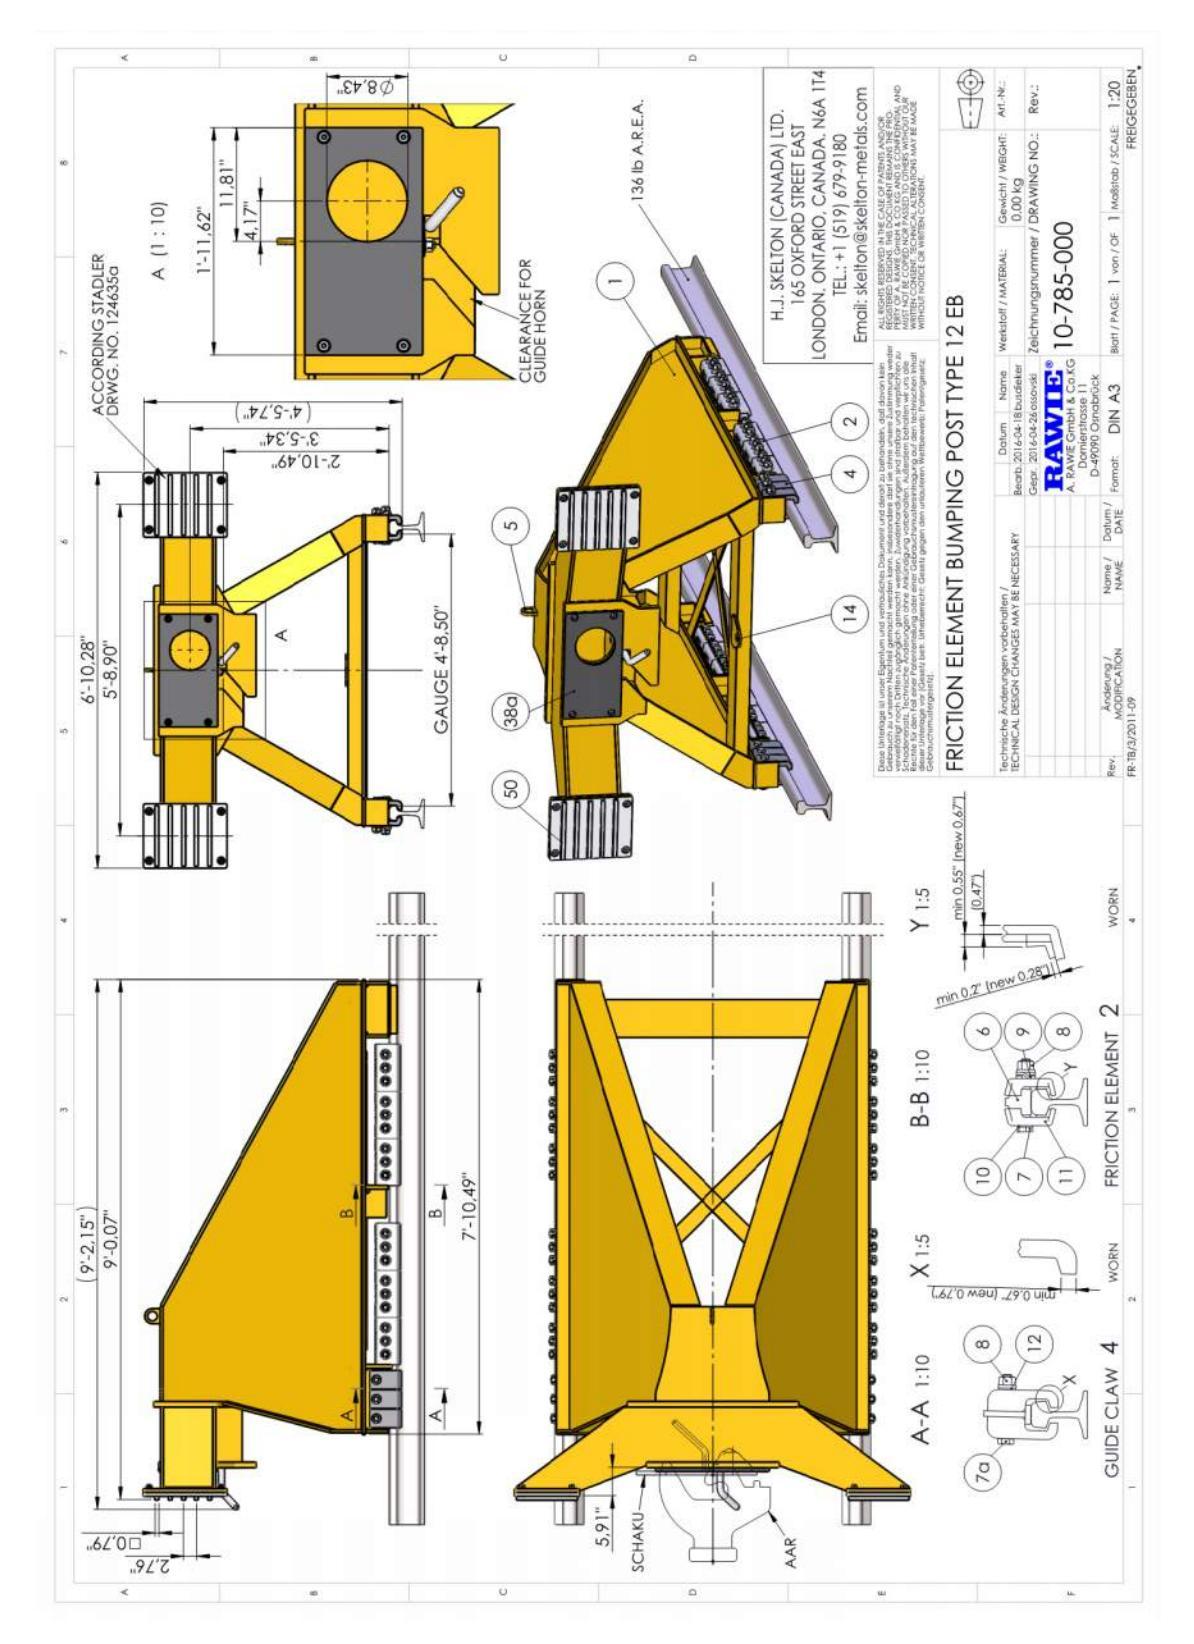
Figure 1 Example 12-shoe sliding friction bumper

Drawings of example sliding friction bumpers provided by Rawie are shown in Figure 1 and Figure 2. Figure 1 shows a 12-shoe bumper without auxiliary rails. Figure 2 shows a 20-shoe element with auxiliary rails. All bumpers suppled for the Hoboken project would be built with a head designed for NJ TRANSIT's push-pull and EME equipment, similar to what is currently on Track 15, shown in Appendix A.

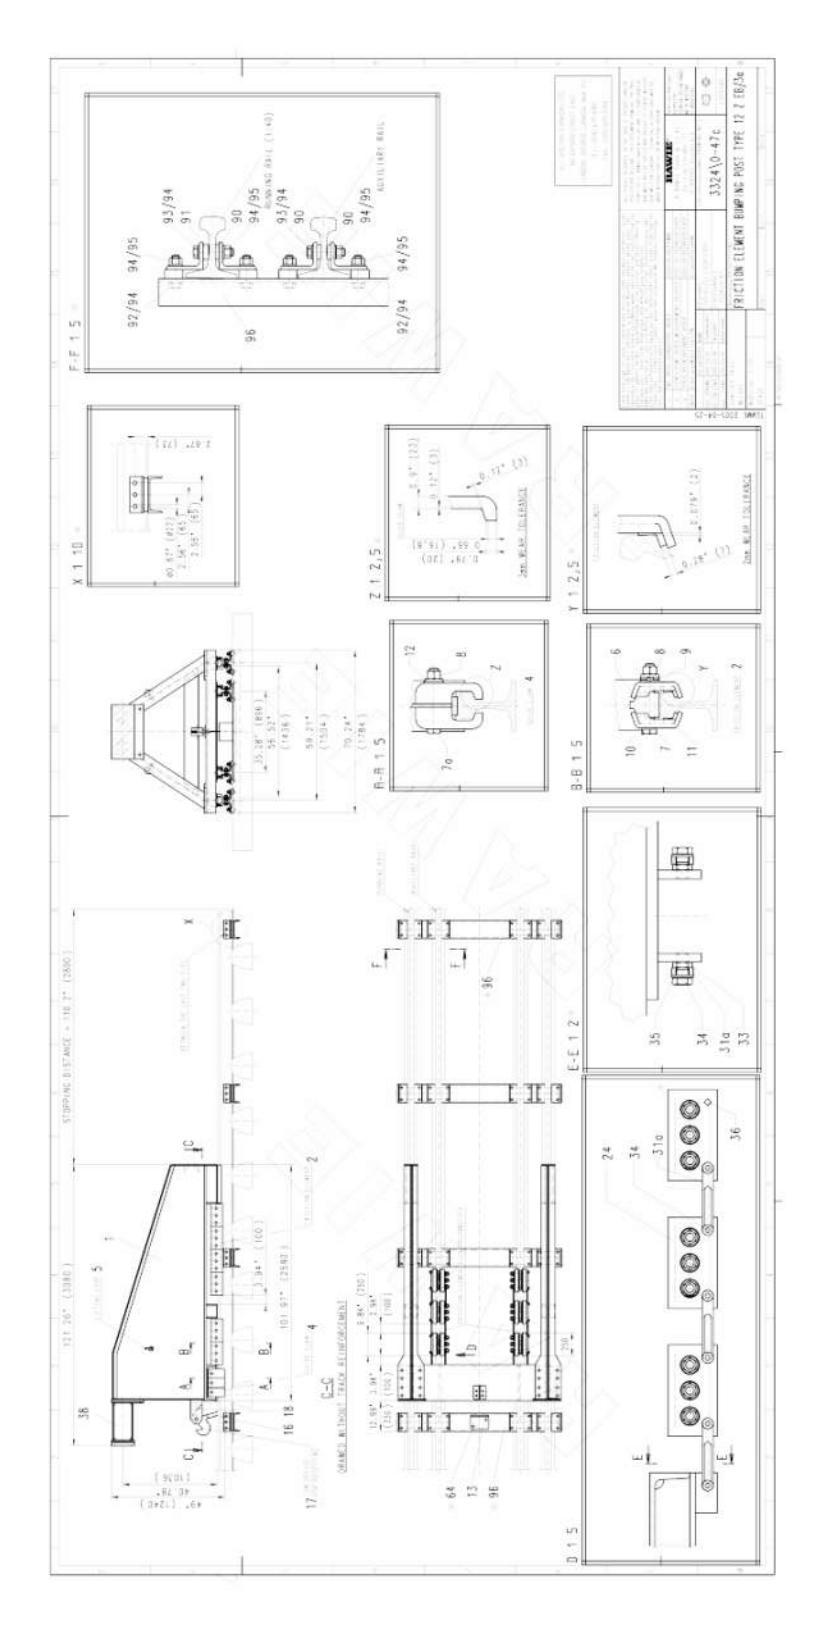
Figure 2 Example 20-shoe sliding friction bumper with auxiliary rails

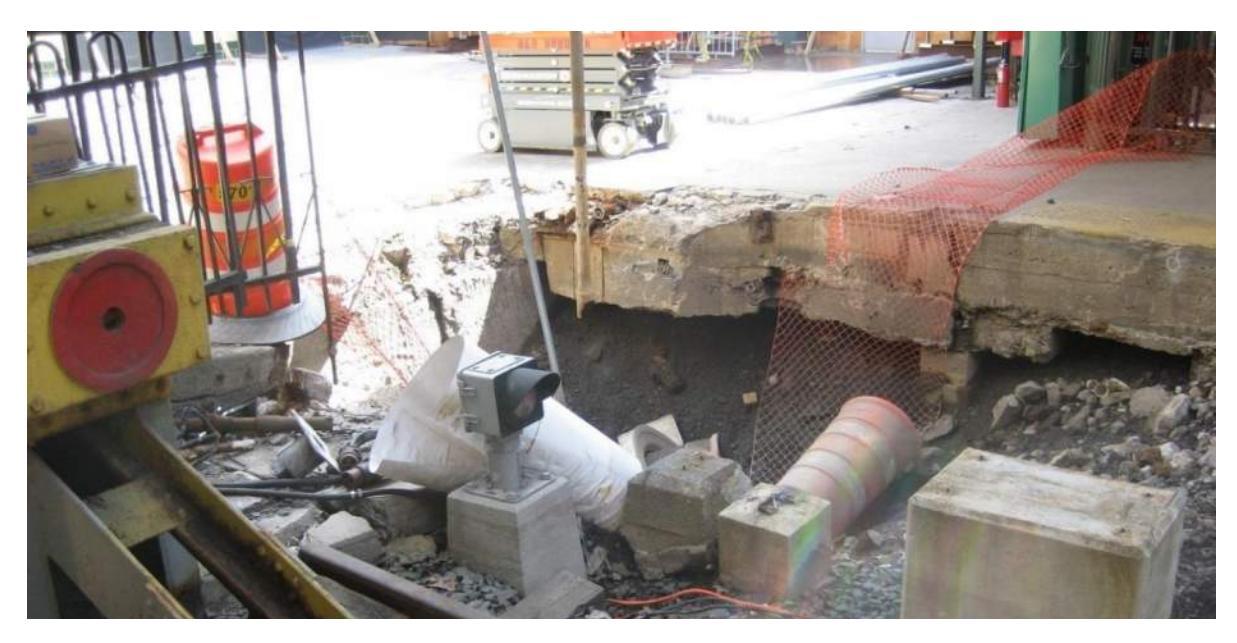
Photo 1 – East End of Track 5, taken March 21, 2017

During the week of March 20, 2017, HNTB inspected each of the existing bumping blocks and the last 100 feet of each revenue terminal track. HNTB also measured the length of each platform and the distance to the departing insulated joints (IJs) at the west end of the platform. The bumper on Track 5 was damaged and removed from the facility and was not inspected. Photo 1 shows the east end of Track 5 after removal of the bumping post. Photo 2 shows ballast and track that was installed in place of the former bumper.

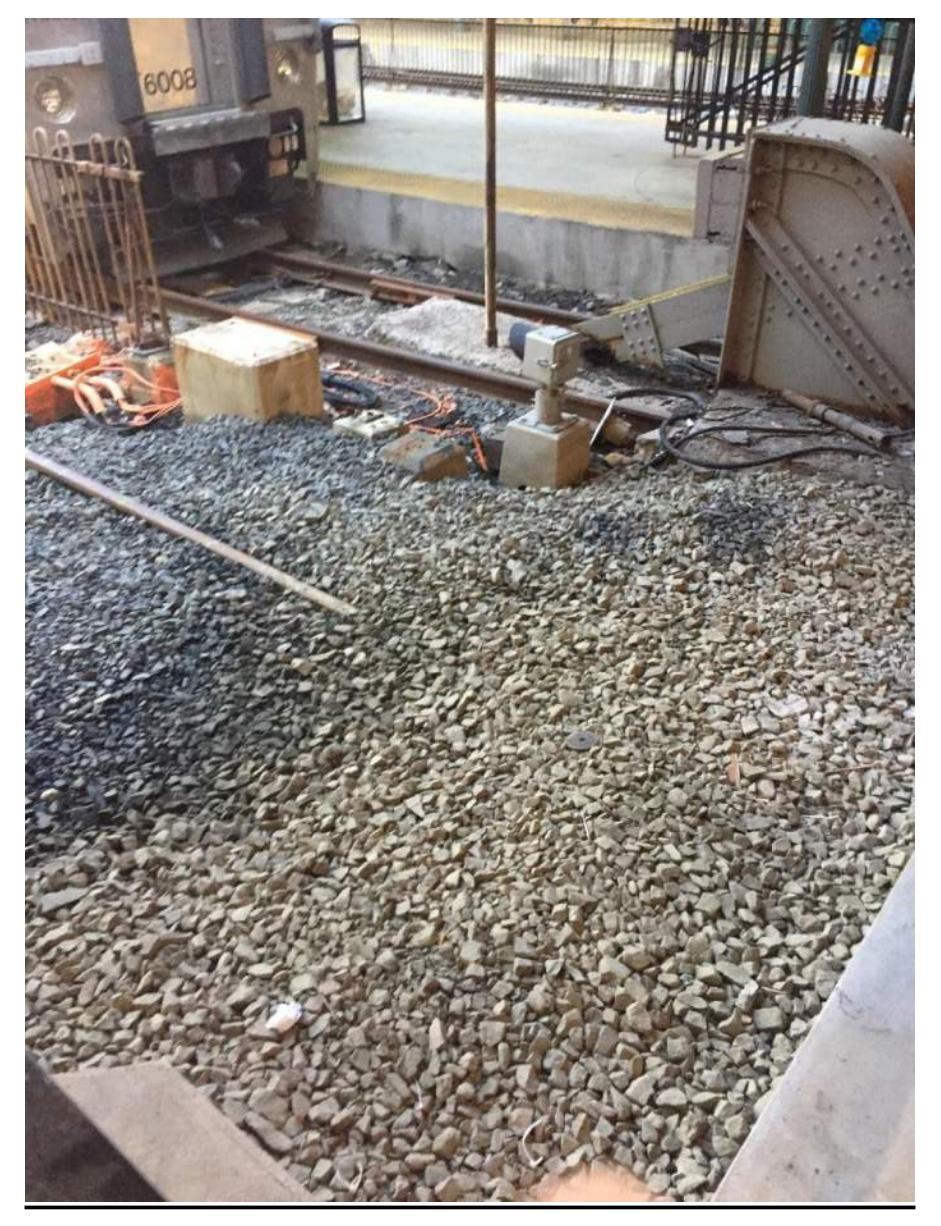
Photo 2 – Track 5 Ballast added, taken May 31, 2017

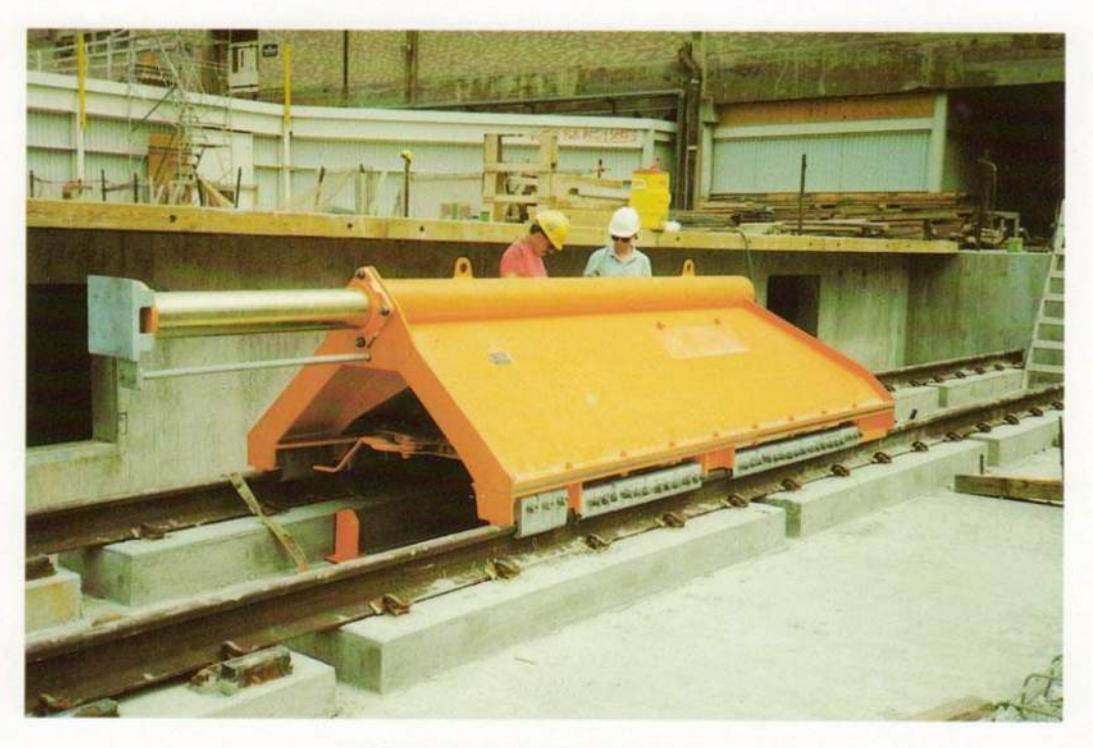
Figure 3 MBTA Bumper

Friction Element Bumping Post

Type 20 EB (insulated) with Jarret BCLR 600V3 Shock Absorber

M.B.T.A. Boston, Mass.

Design Criteria:

Train weight: 1,158,940 LB (525.7 Tonnes)

AT 3 M.P.H. (4.8 K.P.H.) The shock absorber arrests the train without the sled moving. AT 10 M.P.H. (16.09 K.P.H.) The combined shock absorber and sled will safely arrest the train when the sled has moved 22' 8'' with a maximum deceleration of 0.15 G.

The hydraulic element can either be the primary means of absorbing energy mounted to a fixed foundation or it can be mounted to a sliding friction bumper. In the latter case, the hydraulic element can be designed to absorb energy from a low speed impact without sliding the friction elements. This is particularly useful for constrained terminal conditions where trains will routinely stop close to the bumper face; occasional low-speed impacts with the bumper can be accommodated without having to reset the friction elements. The bumping posts installed at NJ TRANSIT's Atlantic City terminal are an example of a combined sliding and hydraulic bumper and can be seen in Photo 5. Another example, from Boston, is shown in Figure 3.

Rawie hydraulic and sliding friction bumpers are installed at MBTA's North Station in Boston. They are designed to stop a 1,159,000 pound train from 10 mph with a maximum deceleration rate of 0.15 g. See Figure 3.

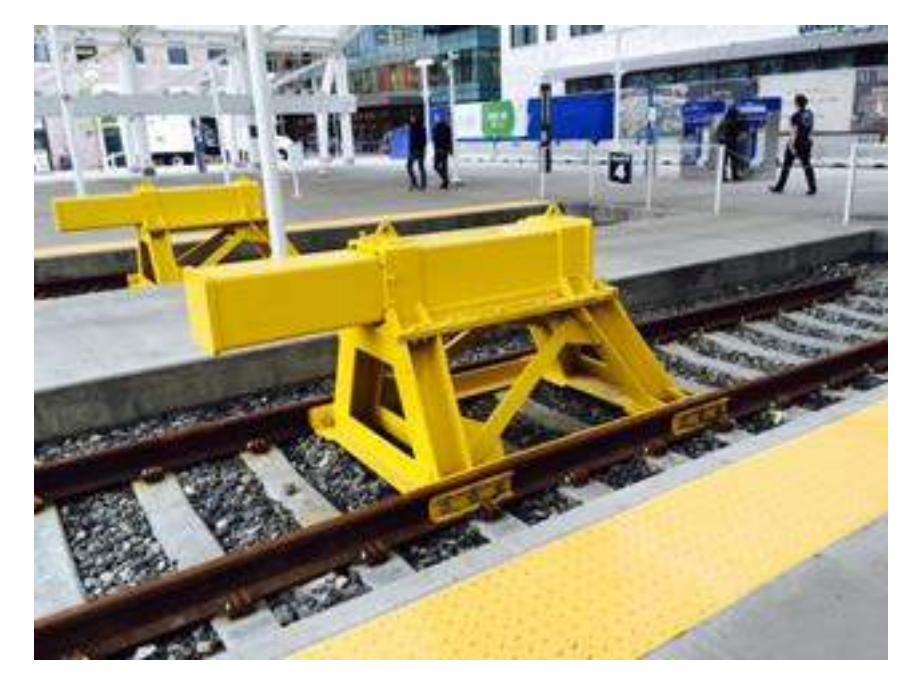
Photo 3 WCH Hydraulic Bumper Denver

Terminal tracks in Denver use hydraulic Western-Cullen-Hayes bumpers (see Photo 3) with a rated capacity of 1,000,000 foot-pounds over 30 inches of travel. Chicago Union Station has a hydraulic bumper on some tracks (see Photo 4) with approximately three feet of travel. Although the design speed is not known, both bumpers would be limited to below 5 mph given the short stopping distances provided by the hydraulic element.

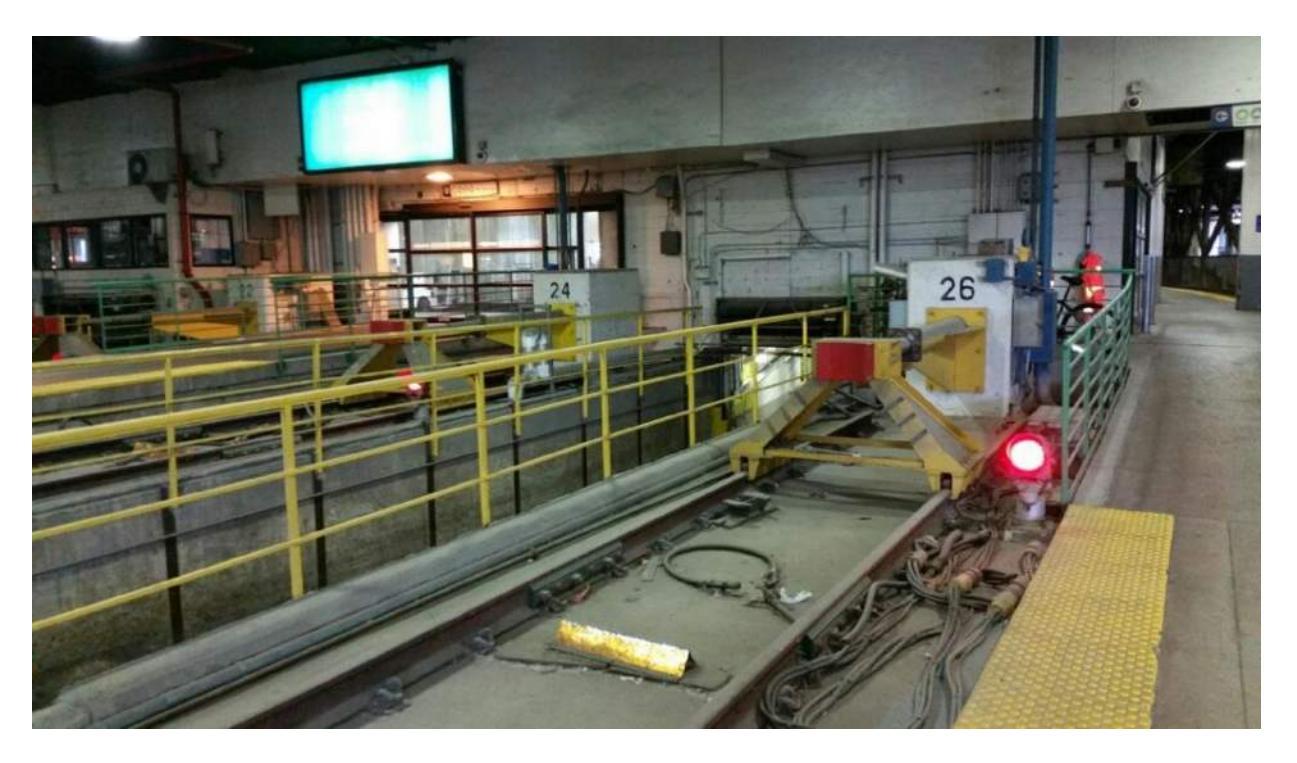
Photo 4 - Chicago Union Station Hydraulic Bumper

Hydraulic bumpers use a cylinder that slides with a known force. Different type and capacity cylinders are available to accommodate trains of different length and weight. Sliding friction bumpers typically can have a higher capacity than hydraulic bumpers because the stopping distance for hydraulic bumpers is limited to the length of the cylinder which is typically no longer than three to nine feet. Photo 4 shows a hydraulic bumper found in Chicago Union Station.

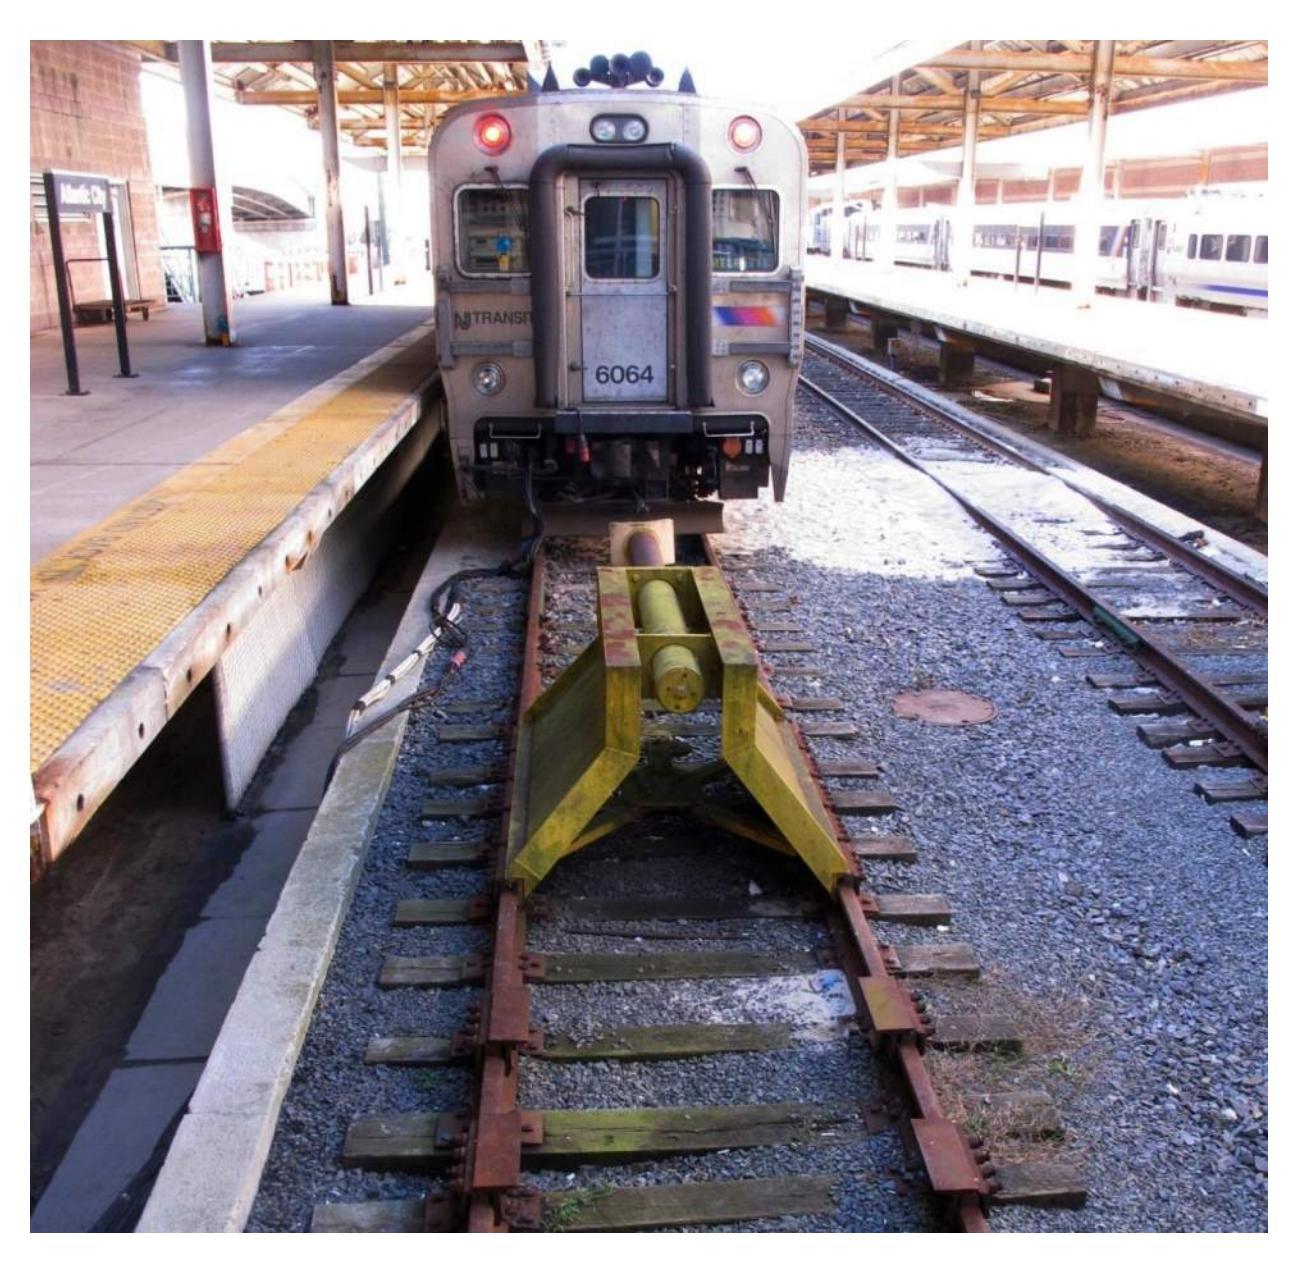
Photo 5 NJ TRANSIT Atlantic City Terminal Bumper
