NATIONAL TRANSPORTATION SAFETY BOARD

Group Chairman's Factual Report

METEOROLOGY

ERA12FA385

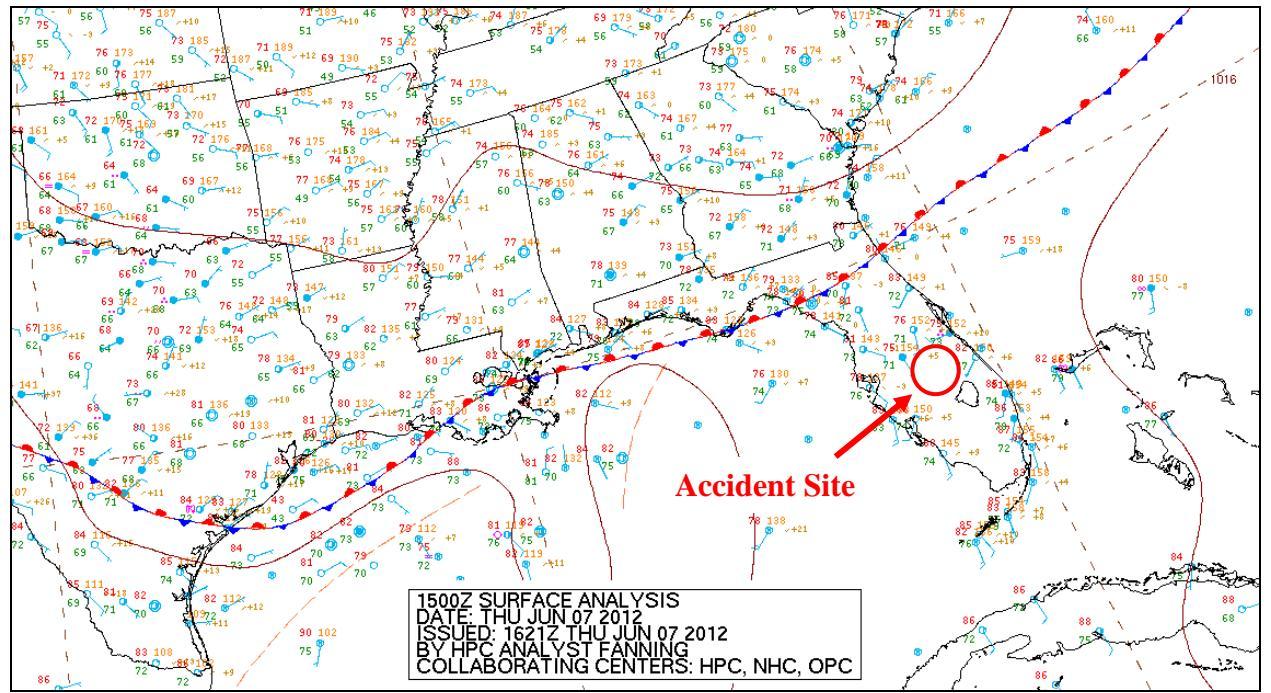
Figure 1- NWS Surface Analysis Chart for 1100 EDT on June 7, 2012

The south east section of the NWS Surface Analysis Chart for 1100 EDT (1500Z) on June 7, 2012 is included as figure 1 with the approximate accident site within the red circle. The chart depicted high pressure ridge extending over the Bahamas into central and southern Florida with a stationary front extending along the Gulf coast across northern Florida and into the Atlantic. The accident site was located south of the stationary front which extended along the intended route of flight, with a weak pressure gradient over the area.

The station models on the surface analysis chart depicted a general anticyclonic wind flow south of the front with winds from the south to southwest at 5 to 10 knots, variable cloud cover, with temperatures in the 80's degrees Fahrenheit (F), and dew point temperatures in the 70's.

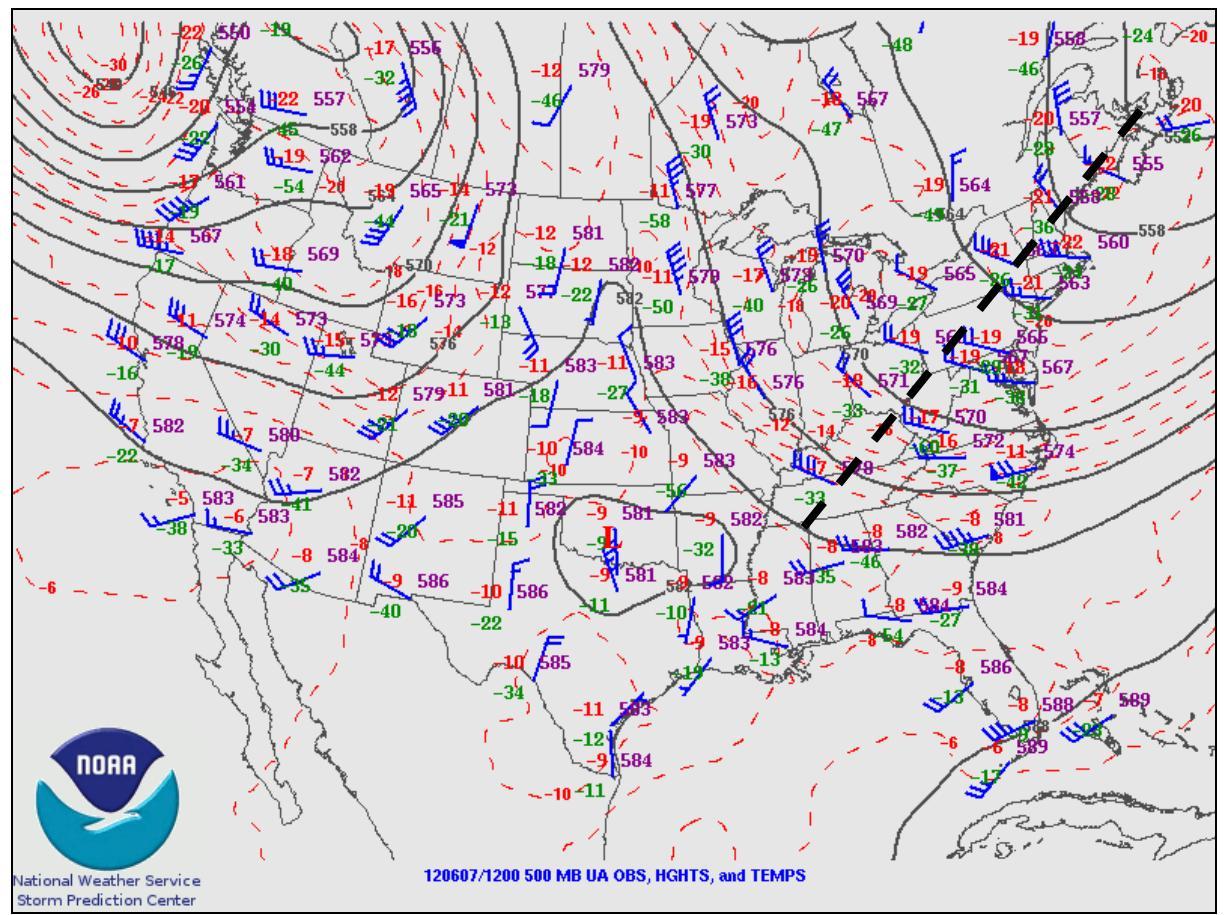
Figure 2- NWS 500-hPA upper air chart for 0800 EDT

The NWS 500-hPA archive upper air chart for 0800 EDT on June 7, 2012 depicting the mean atmosphere at approximately 18,000 feet is included as figure 2. The chart depicted an upper level low over Newfoundland with a long-wave trough extending southwestward along the east coast into Tennessee to another cut off upper level low over Oklahoma. A general convergent flow existed over the west coast of Florida with westerly winds over the northern portion of state and southwesterly winds over the southern portion. This confluent flow with the low level warm moist air supported rising motion and thunderstorm growth.

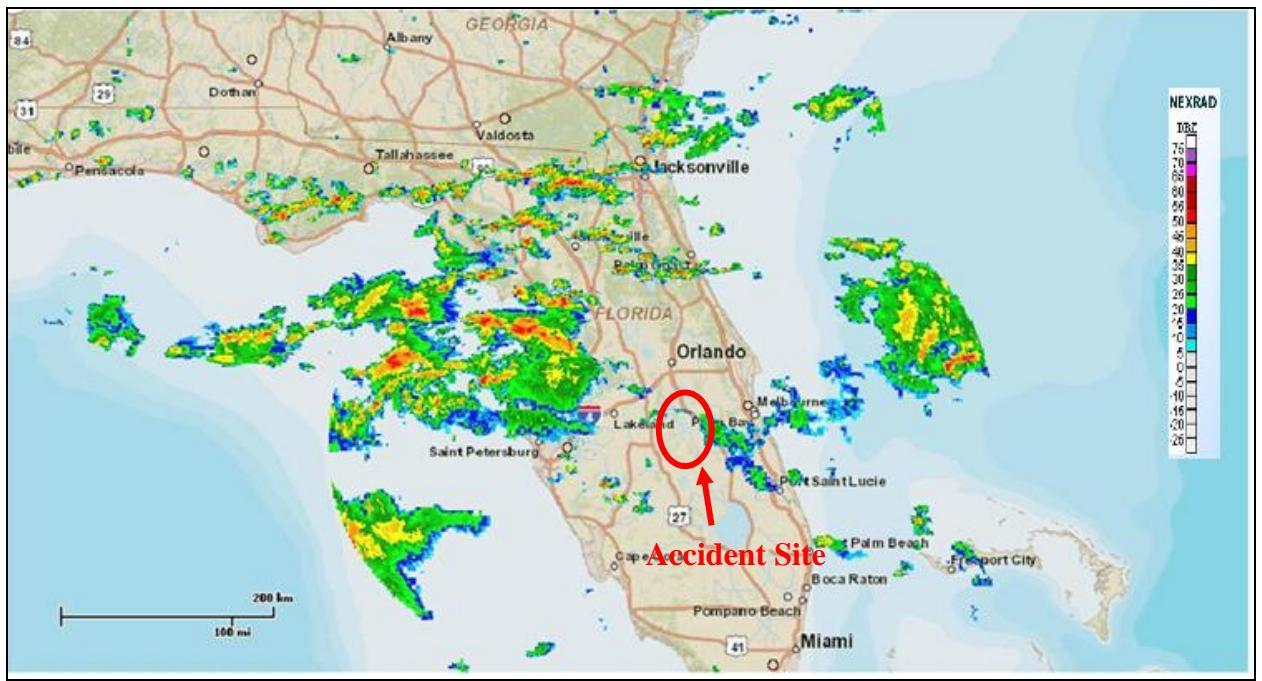
Figure 3- NWS Radar Mosaic image for Florida at 1235 EDT

The NWS regional radar mosaic for 1235 EDT on June 7, 2012 is included as figure 3, with the approximate accident site marked within a red circle. The radar mosaic chart depicted a large area of scattered echoes with reflectivity's over 50 dBZ across northern and western Florida west through north of the accident site. A small band of echoes on the range of 30 dBZ extended from the Port Saint Luce to the Lake Wales area and into the Melbourne area, with no defined areas of high reflectivity echoes typically associated with thunderstorms identified at the time of the image.

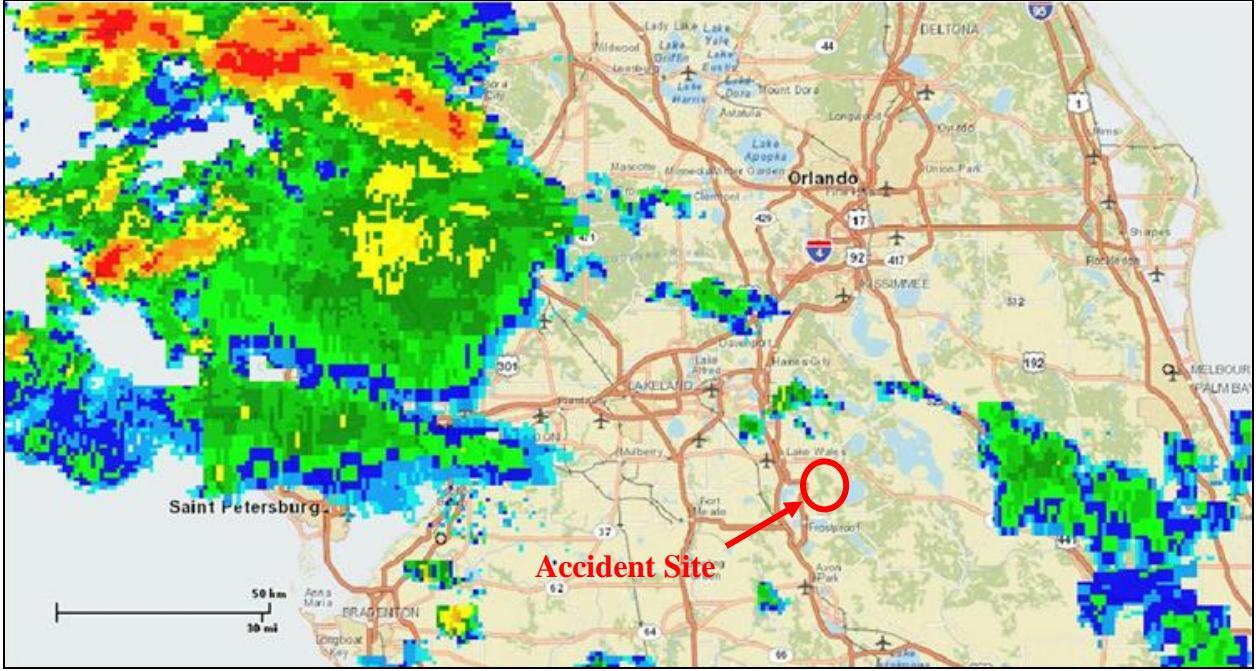
Figure 4- Enlarged radar mosaic over the Lake Wales area

Figure 4 is a close up of the NWS radar mosaic centered over the accident site with a red circle placed over the accident site. Several small areas of reflectivity are identified in the area to the north of the accident site with echoes near 30 dBZ. An area of echoes of 30 to 35 dBZ extended east of the accident site to the Port Saint Lucie area and was partially over the route of flight. To the west of the accident site over the Tampa area a large area of echoes with maximum reflectivity's of 50 dBZ or intense echoes were identified associated with thunderstorms. No significant echoes were identified over the accident site; however, the radar mosaic is typically created by the NWS utilizing the lowest 0.5° base reflectivity image and may not reflect the conditions at the accident airplanes cruising level prior to the in-flight breakup or loss of control. Section 5.0 of this report will document the closest weather radar data and look at the potential of echoes along the flight track in further details.

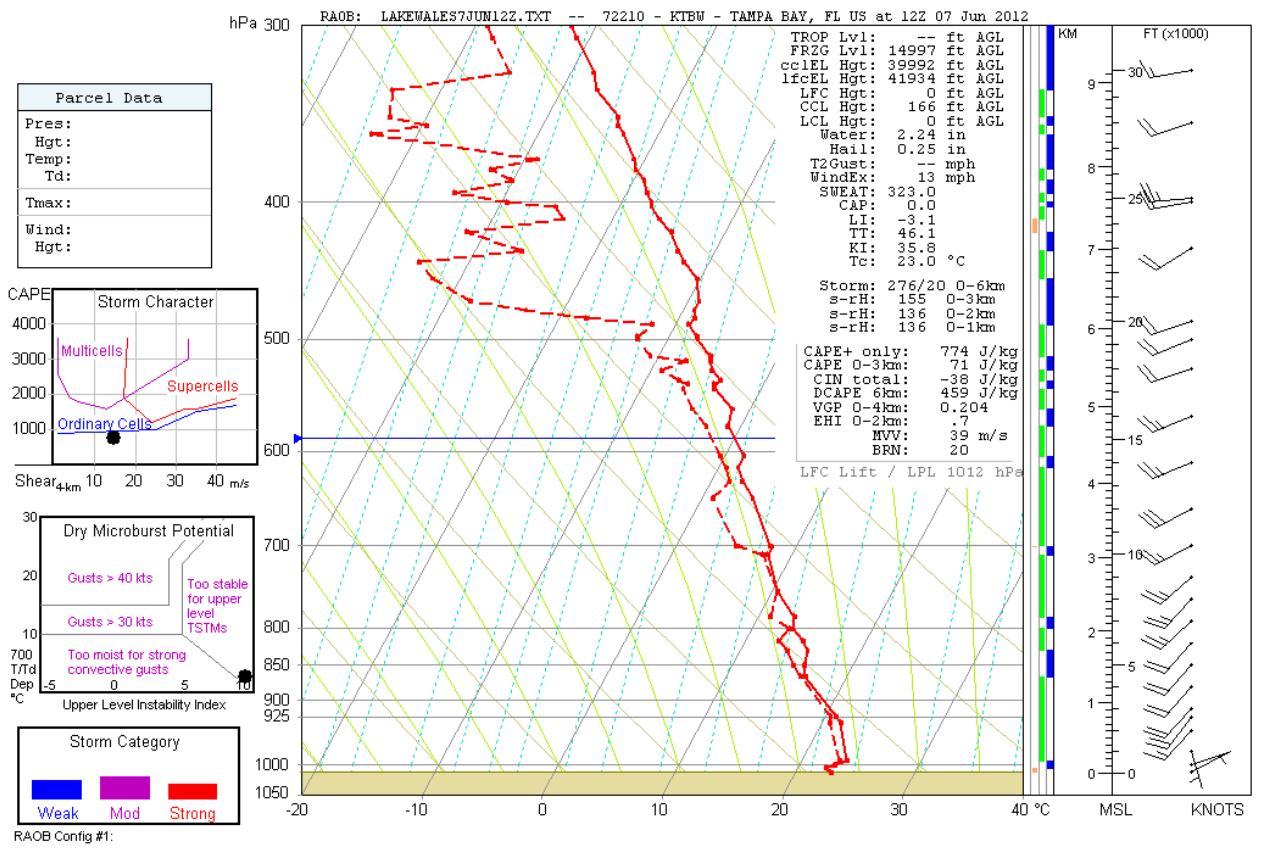
Figure 5 - Tampa 0800 EDT sounding

standard Skew-T log P diagram² utilizing RAOB³ software is included as figure 5 from the surface to 300-hPa or 30,000 feet. The sounding was saturated with 100 percent relative humidity at low levels due to precipitation and provided unrepresentative critical levels. A review of the most unstable conditions provided a level of free convection (LFC)⁴ at 2,700 feet agl, with an equilibrium level (EL)⁵ or expected top of convective clouds was at 44,500 feet with the tropopause at approximately 42,000 feet. The sounding had a relative humidity of 75 percent or more from the surface through 18,000 feet which resulted in a precipitable water value of 2.25 inches. The freezing level was identified at approximately 15,000 feet.

The stability indices of the KTBW sounding indicated a Lifted Index of -3.1, a most unstable (MU) LI at -4.8, and a K-Index of 35.8, which indicated an unstable atmosphere with an 80 percent probability of airmass type thunderstorms. The mean vertical velocity of convective updrafts was 39 meters per second (m/s) or near 78 knots, with the most unstable value of 59 m/s or 118 knots. The addition of deep layer of moisture and low LFC favored storm development.

The wind profile indicated surface wind from the south veering to the southwest and west with height through the troposphere. The level of maximum wind was identified above the tropopause at 47,000 feet with a wind from 305° at 63 knots. The mean 0 to 6 kilometer (18,000 feet) wind was from 234° at 21 knots. At the accident airplanes cruising altitude of 25,200 feet the wind was from approximately 265° at 23 knots, with a temperature of -18° C.

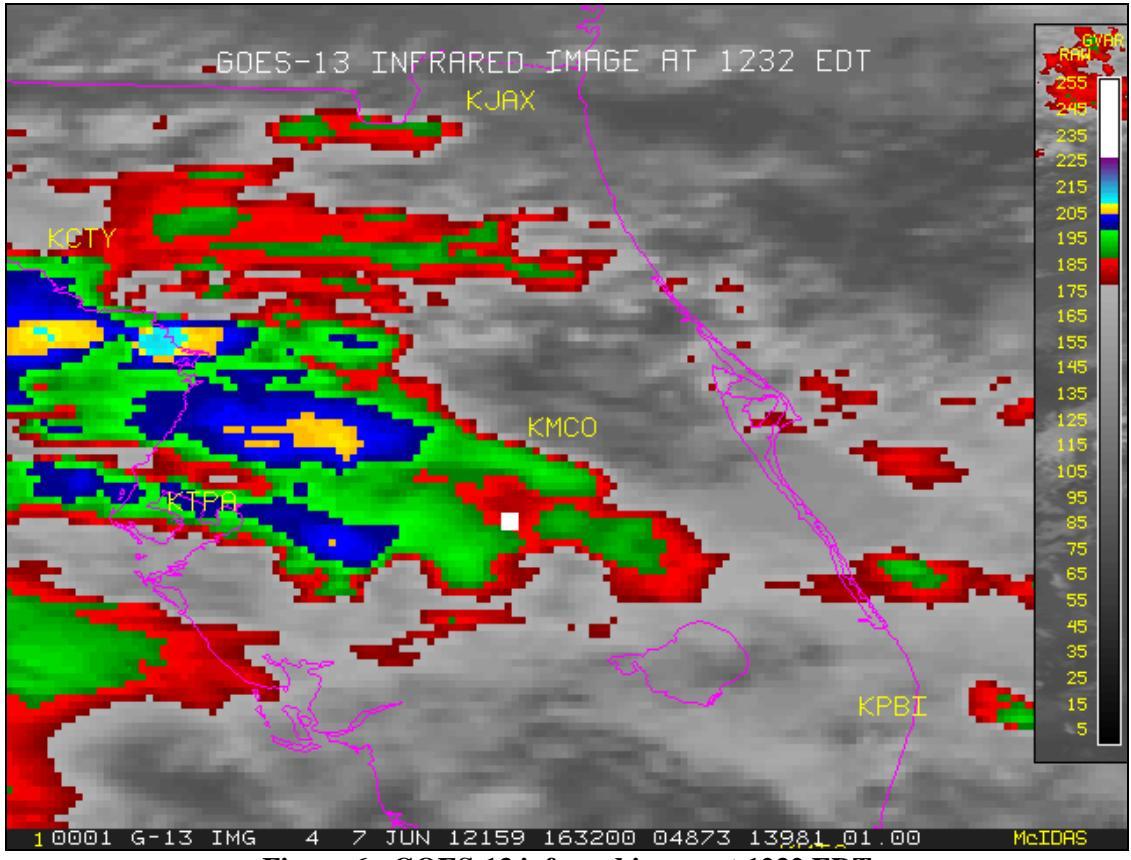
Figure 6 - GOES-13 infrared image at 1232 EDT

Figure 6 is the GOES-13 infrared image at 1232 EDT (1632Z) at 2X magnification with a standard EMB temperature enhancement curve applied to high light the higher and colder cloud tops typically associated with deep convection. The accident site is also marked by a white square. The depicted the accident site on the eastern side of an area of enhanced cloud cover associated with high level cirrus clouds potentially from anvil from cumulonimbus clouds located to the west depicted by the enhanced areas in blue to yellow. The radiative cloud top temperature over the accident site was 235° kelvin or -38.16° C, which corresponded to cloud tops near 34,000 feet.

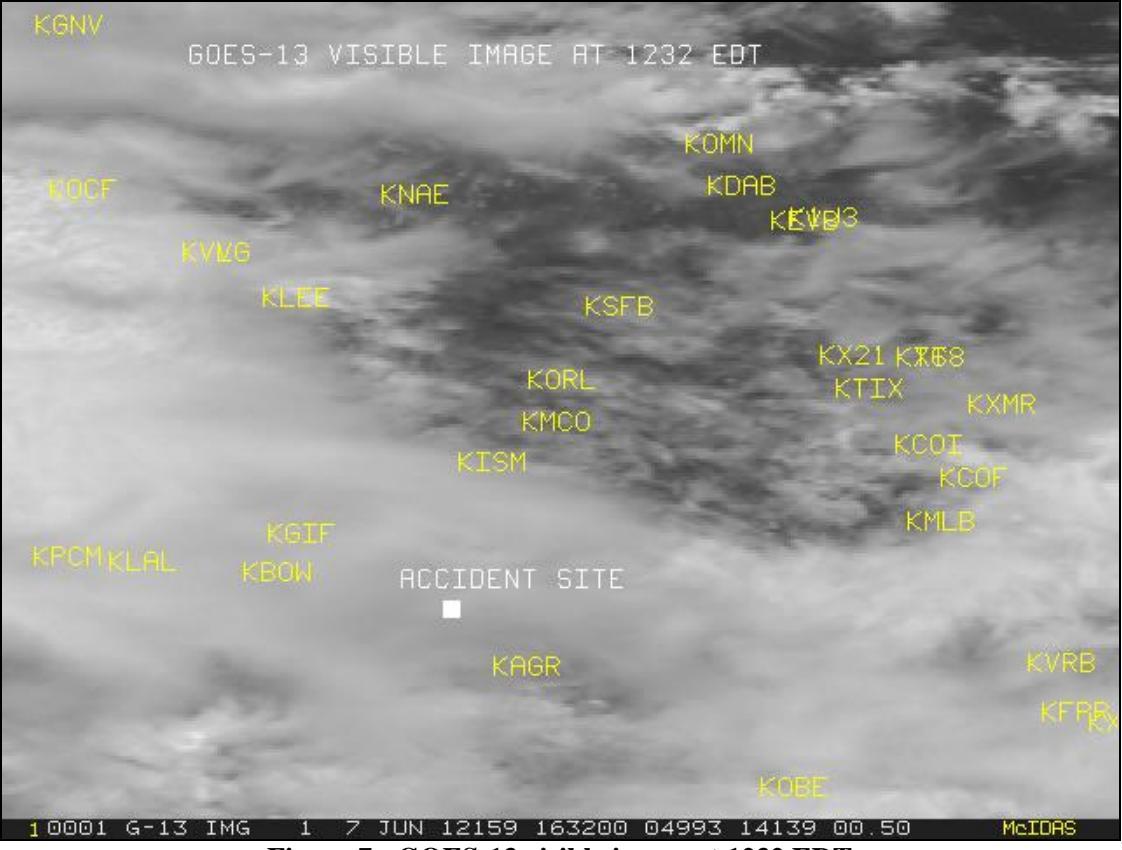
Figure 7 - GOES-13 visible image at 1232 EDT

Figure 7 is the GOES-13 visible image for 1232 EDT at 2X magnification with the accident site marked. The image depicts multiple layers of clouds over the accident site producing a broken to overcast layer of clouds over the accident site. No defined cumulonimbus clouds are observed within 20 miles of the accident site; however, cumulonimbus clouds are observed to the west through northwest between Plant City (KPCM) and Ocala (KOCF), Florida, with cirrus outflow clouds or remains of the anvil from these storms extending over the accident site, with lowering cumulus clouds below.

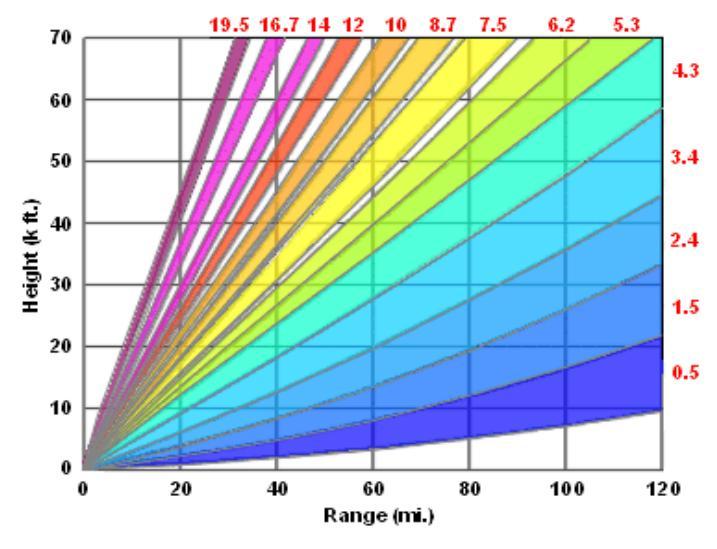
Figure 8- VCP-11 precipitation mode scan

The WSR-88D operates in several different scanning modes, identified as Mode A and Mode B. Mode A is the precipitation scan and has two common scanning strategies. The most common is where the radar makes 9 elevation scans from 0.5° to 19.5° every six minutes. This particular scanning strategy is documented as volume coverage pattern 21 (VCP-21). Mode B is the clear air mode, where the radar makes 5 elevation scans during a ten minute period. During the period surrounding the accident the KMLB WSR-88D radar was operating in the quickest operational precipitation mode (Mode A, VCP-11), where the radar made 14 elevation scans every 5 minutes. The following chart (figure 8) provides an indication of the different elevation angles in this VCP, and the approximate height and width of the radar beam with distance from the radar site.

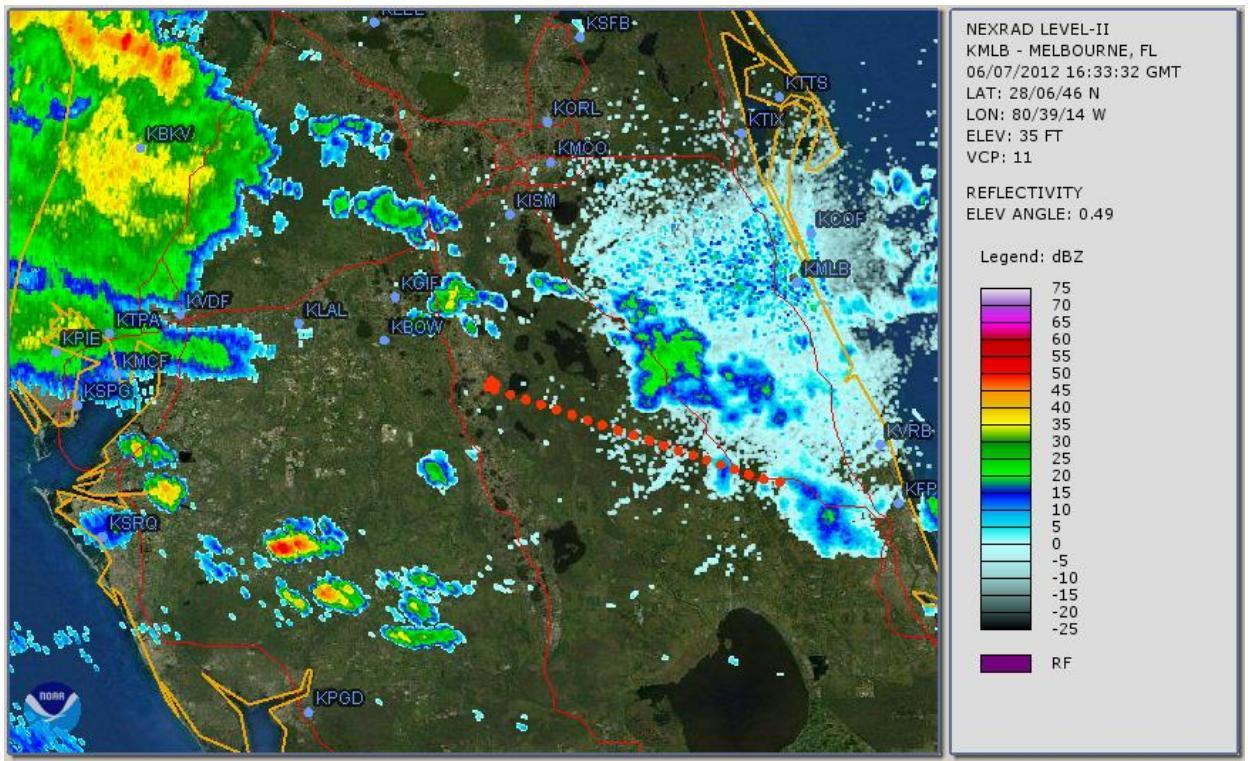
Figure 9 - KMLB WSR-88D 0.5° base reflectivity image at 1233 EDT

The KMLB base reflectivity image for 0.5° at 1233 EDT (1633Z) on June 7, 2012 is included as figure 9 with the accident airplanes flight track overlaid. As in the regional radar mosaic images in figures 2 and 3 of this report, only light intensity echoes were depicted over the flight path prior to the accident. No defined high reflectivity cores that may have been associated with thunderstorms were depicted in the immediate vicinity of the flight track or accident site.

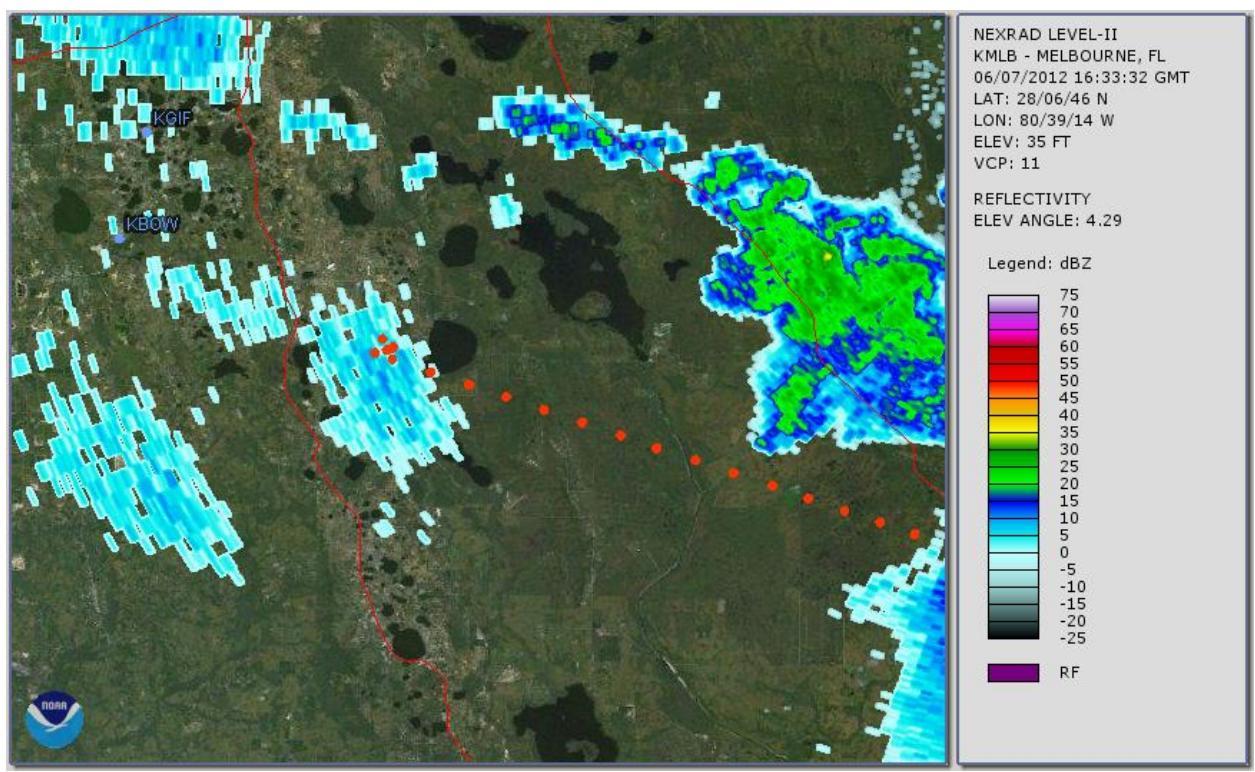
Figure 10 - KMLB WSR-88D 4.3° base reflectivity image at 1233 EDT

Figure 10 is the KMLB WSR-88D 4.3° base reflectivity image at 1233 EDT. The image depicts reflectivities of 0 to 15 dBZ over the flight track indicating the accident airplane was likely operating in clouds or instrument meteorological conditions at the time of the loss of control. Figure 11 is the Tampa's (KTBW) WSR-88D 4.3° base reflectivity⁹ image which depicted similar reflectivity's of 0 to 15 dBZ over the route.

Based on the radar height calculations, the 4.3° elevation scan depicts the conditions encompassing the altitude between 21,080 to 25,920 feet and best depicted the conditions at the accident airplanes altitude at the time the airplane departed control flight.

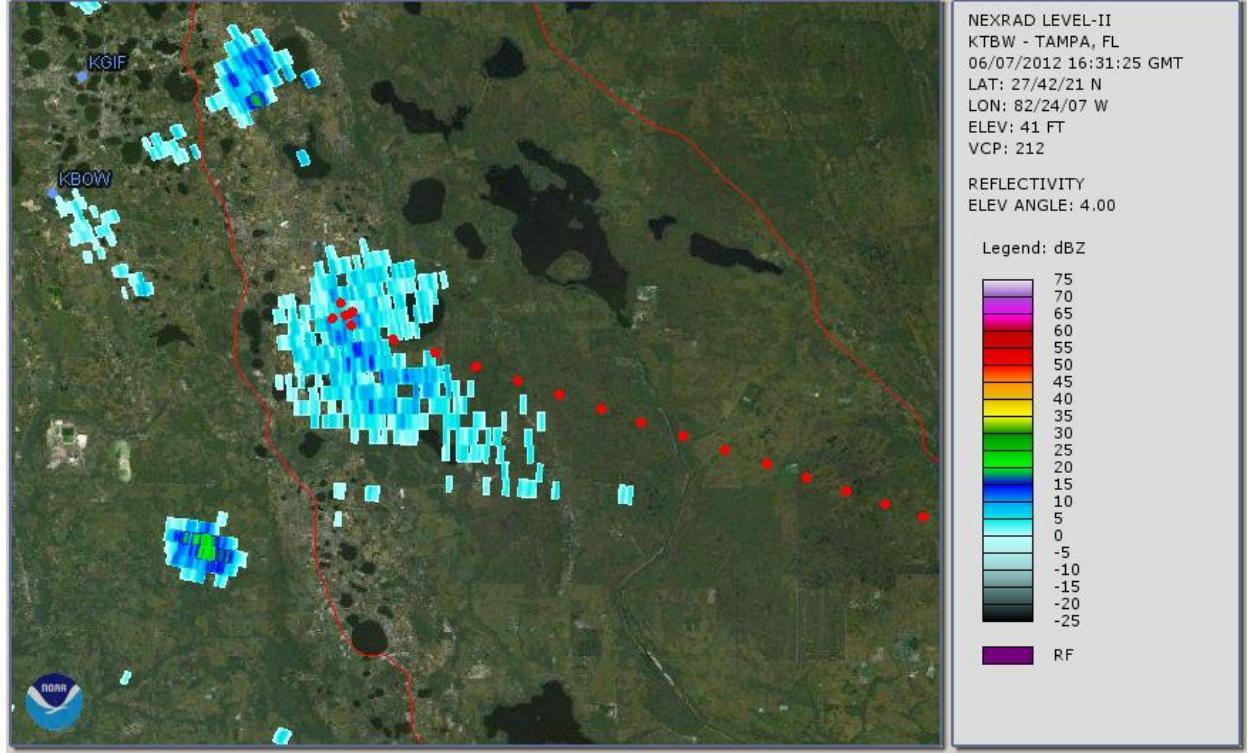
Figure 11- KTBW WSR-88D 4.0° base reflectivity image at 1231 EDT

⁹ KTBW WSR-88D was located 49 miles from the accident site with the 4.3° beam extending from 21,550 to 26,490

feet over the accident site.

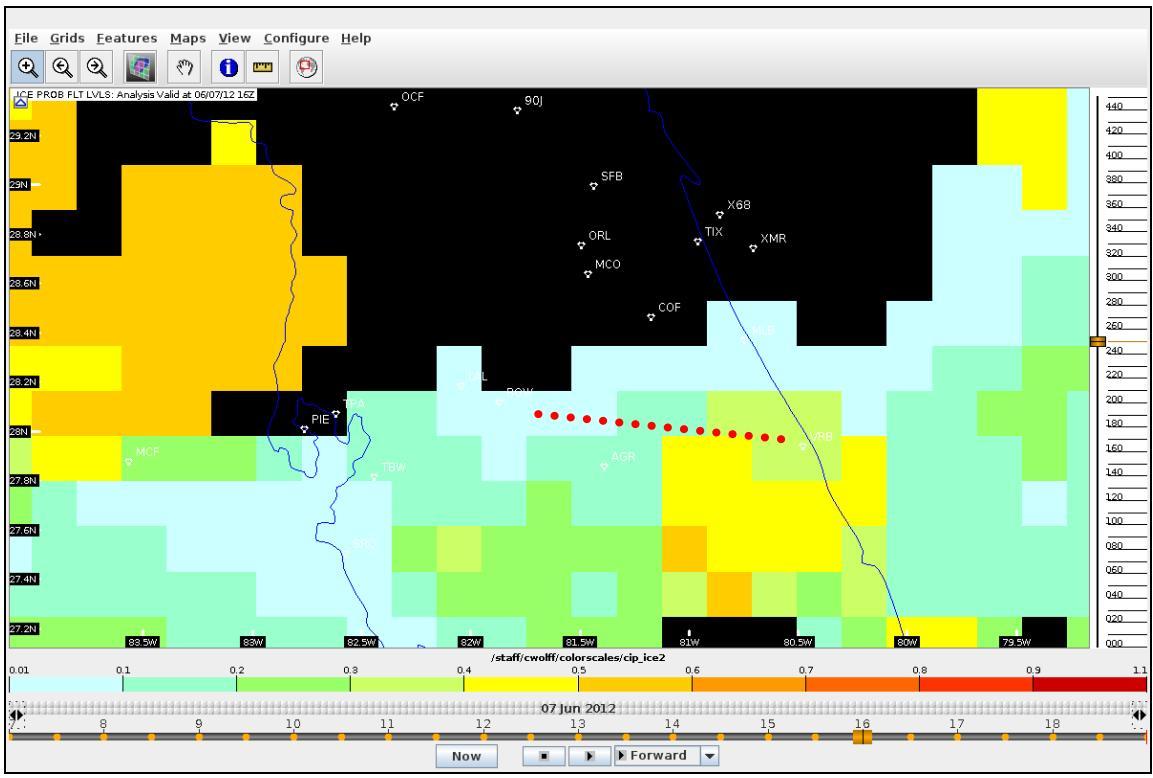
Figure 12- NWS CIP for 1200 EDT at 25,000 feet

The NWS Current Icing Product (CIP) was obtained from the National Center for Atmospheric Research (NCAR) who developed the product. The CIP supplemental product provides a computerized probabilistic forecast of icing conditions at specific flight levels based on observed data including WSR-88D radar, satellite, pilot weather reports, surface weather reports, lightning and Rapid Update Cycle (RUC) numerical model output from the NWS. The CIP probability of icing conditions for 1200 EDT (1600Z) and 1300 EDT (1700Z) on June 7, 2012 at 25,000 feet are provided as figures 12 and 13 below. The images depicted a small pocket of 40 to 50 percent probability of icing immediately after departure and less than 20 percent probability of icing over the accident site.

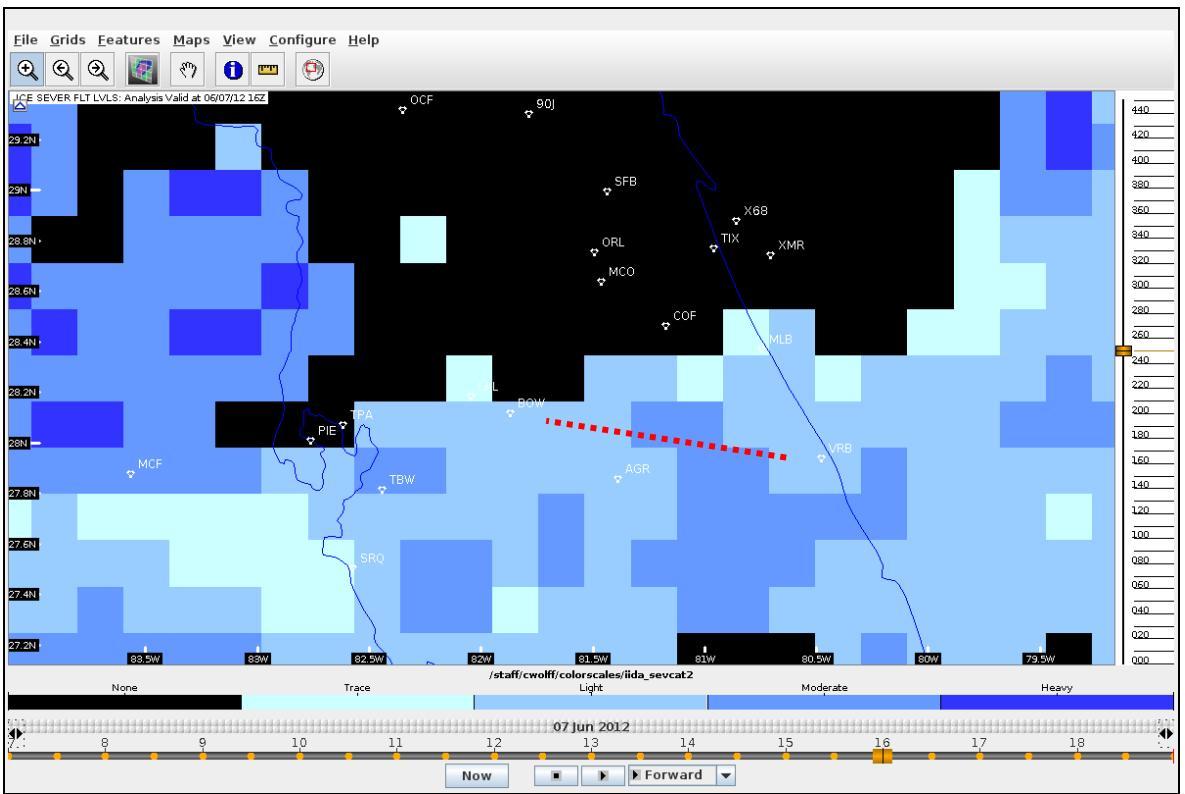
Figure 14 - NWS CIP Icing Severity for 1200 EDT at 25,000 feet

The CIP icing severity for 1200 and 1300 EDT are included as figures 14 and 15 respectively. The images depicted the best category of icing as light to moderate at 25,000 feet during the period.

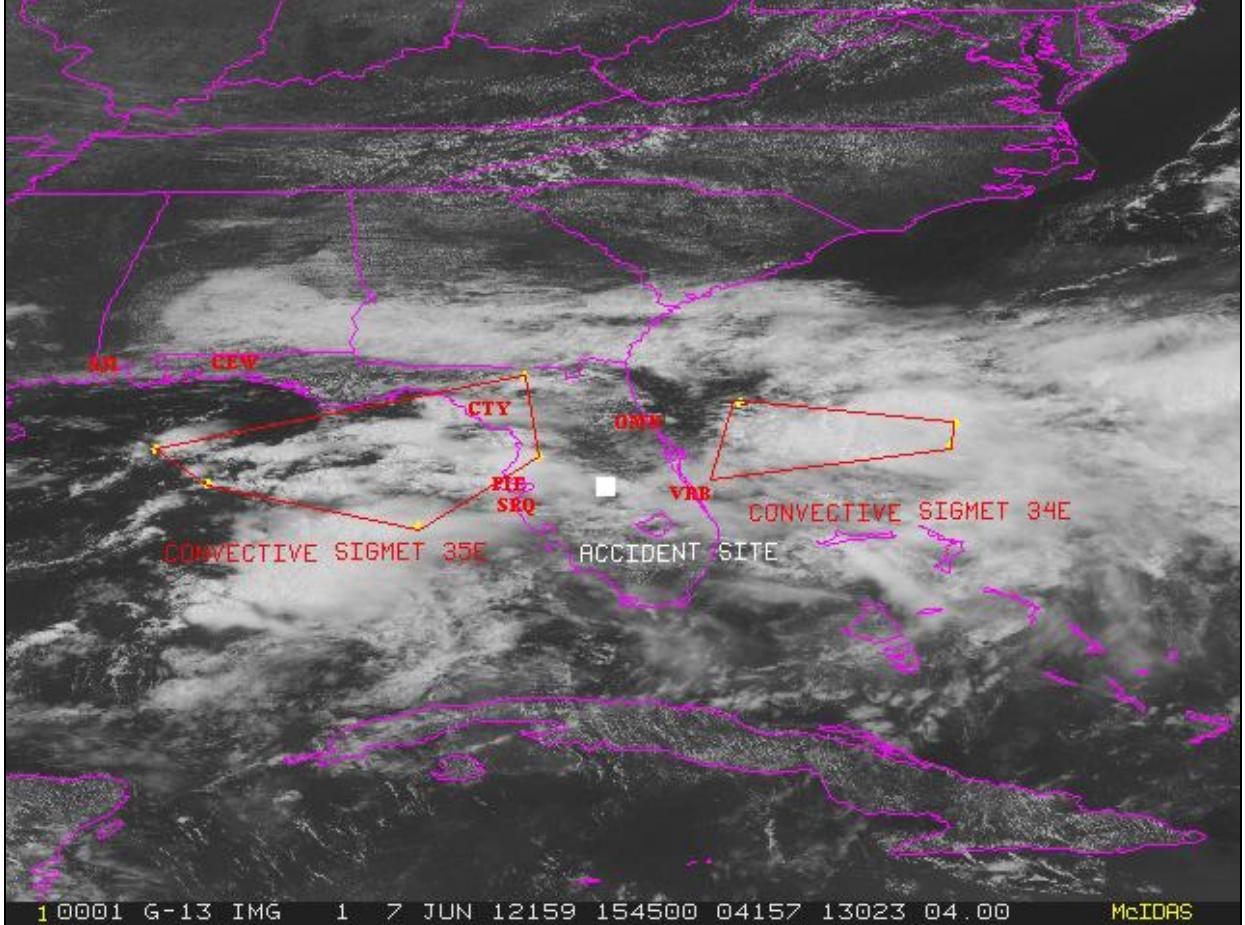
Figure 16- Convective SIGMETs issued at 1155 EDT

CONVECTIVE SIGMET 35E VALID UNTIL 1755Z FL AND CSTL WTRS FROM 50NNE CTY-40NNE PIE-70WSW SRQ-170S CEW-130SSE SJI-50NNE CTY AREA TS MOV FROM 23025KT. TOPS TO FL450.
