PPG Aerospace Transparencies ***Failure Analysis Report***

RE: Evaluation of a Right Hand, Main Windshield for Beech E-90; P/N 50-420069-32 CHG.A; S/N 95061H3863; CA125920

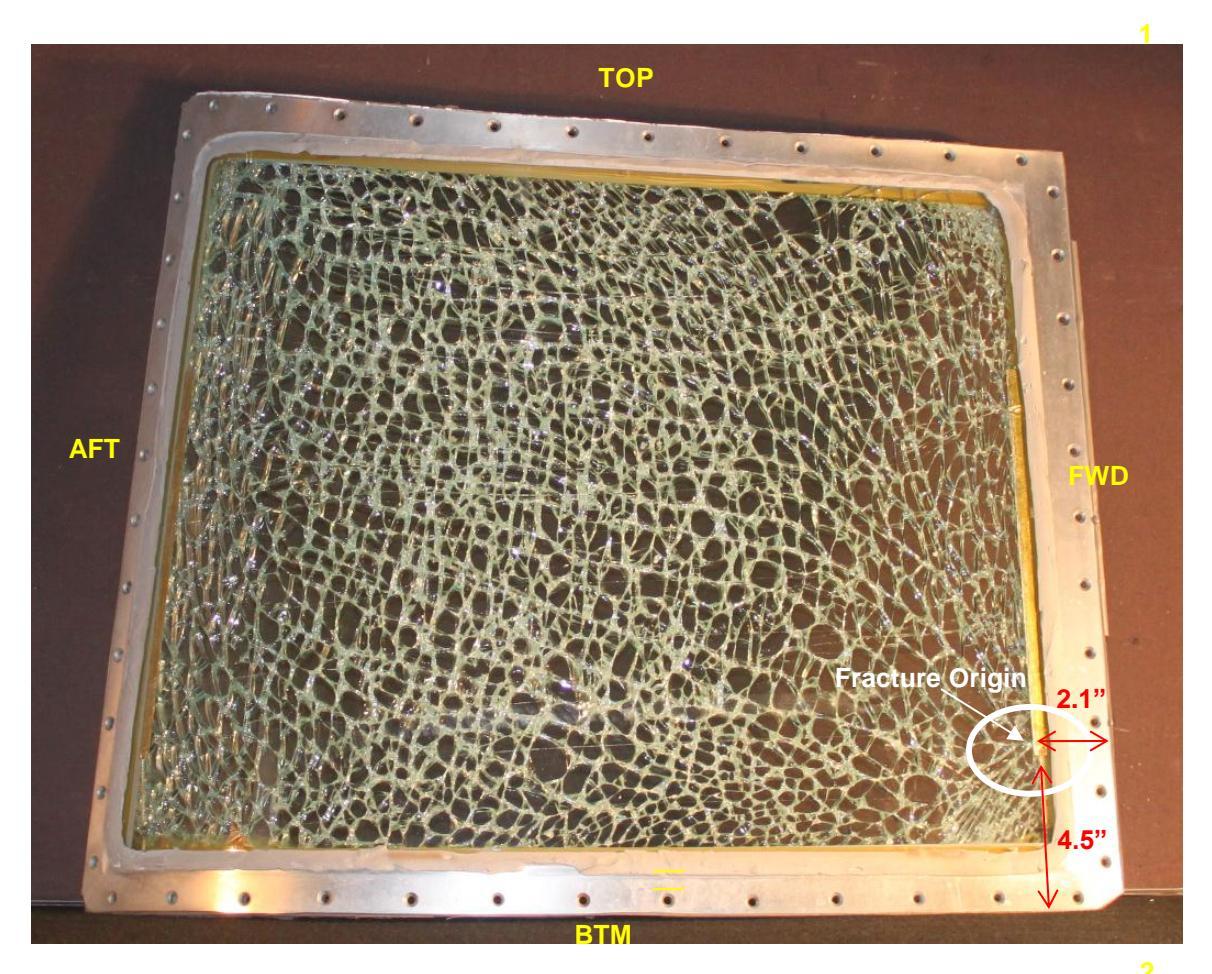
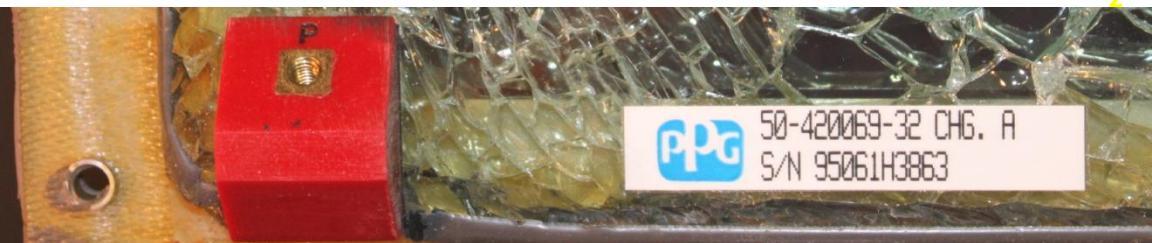
Figure A: The outboard overall view of the windshield as received.

- 1. Failure origin of the inner glass ply.
- 2. Close up of the trademark label showing the PN and SN.

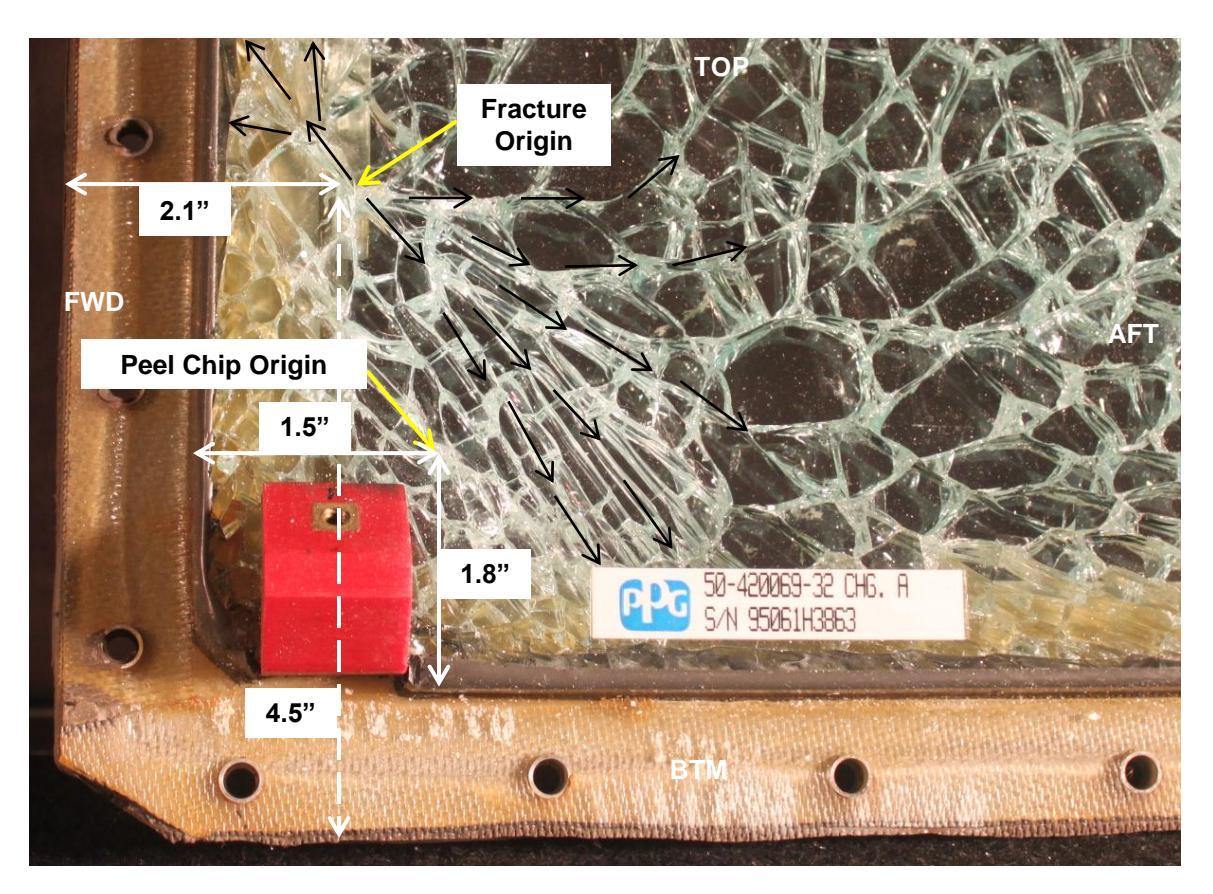
Figure B: Magnified inboard view of the glass fracture and peel chip origin. The fracture origin was identified using Wallner lines on the fracture face of the glass. The black arrows indicate the propagation direction of the fracture. The peel chip cannot be recognized in this view however the location is shown for point of reference.

- The peel adhesion chip originated 1.5" (38 mm) from the forward glass edge and 1.8" (45 mm) from the bottom edge of the windshield (see Figure B for view with measurements).
- The inner glass ply failed with the fracture origin located 2.1" (53 mm) from the forward edge of the unit and 4.5" (114 mm) from the bottom edge (see Figure A and Figure B for view with measurements).
- The moisture seal appears to have been eroded and repaired around the entire periphery of the windshield

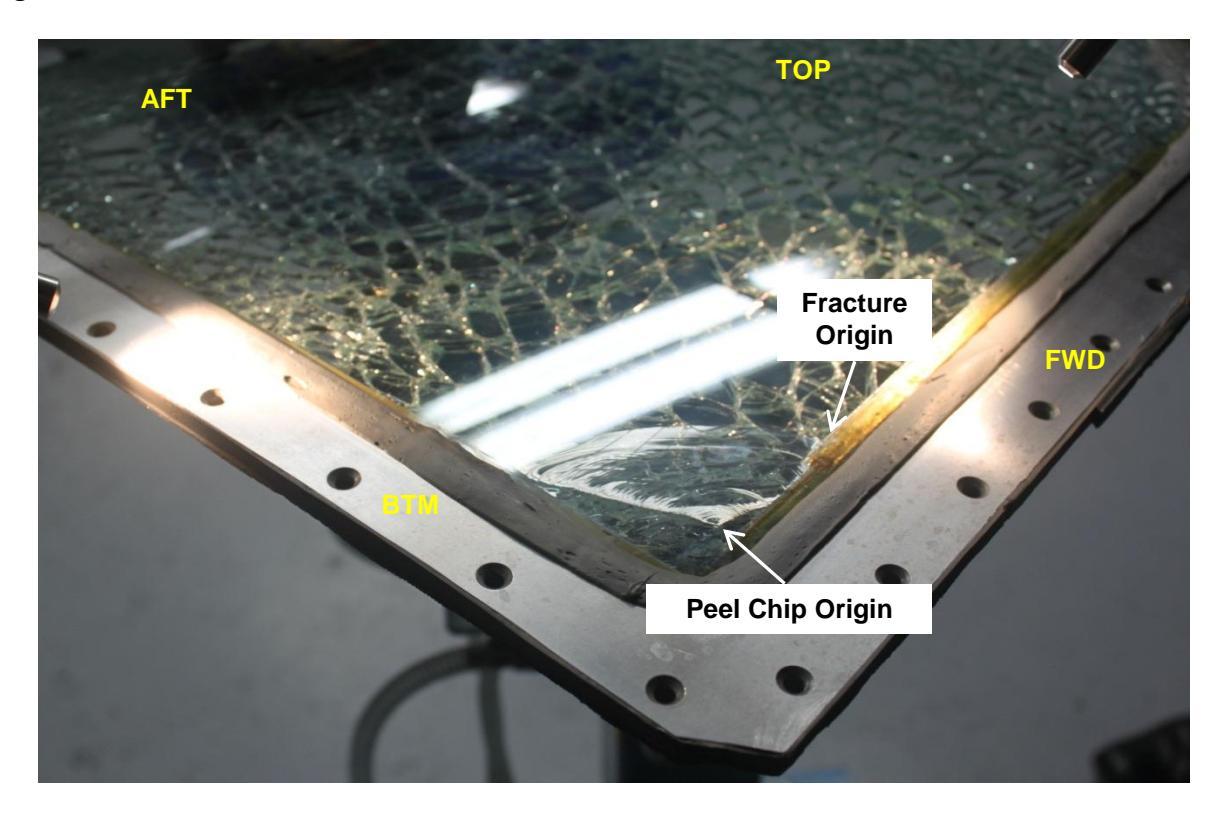
Figure C: Outboard view of the bottom edge of the windshield. The appropriate lighting was necessary to achieve the photo of the peel chip. As noted in the description, the peel chip originated outside of the heating area.

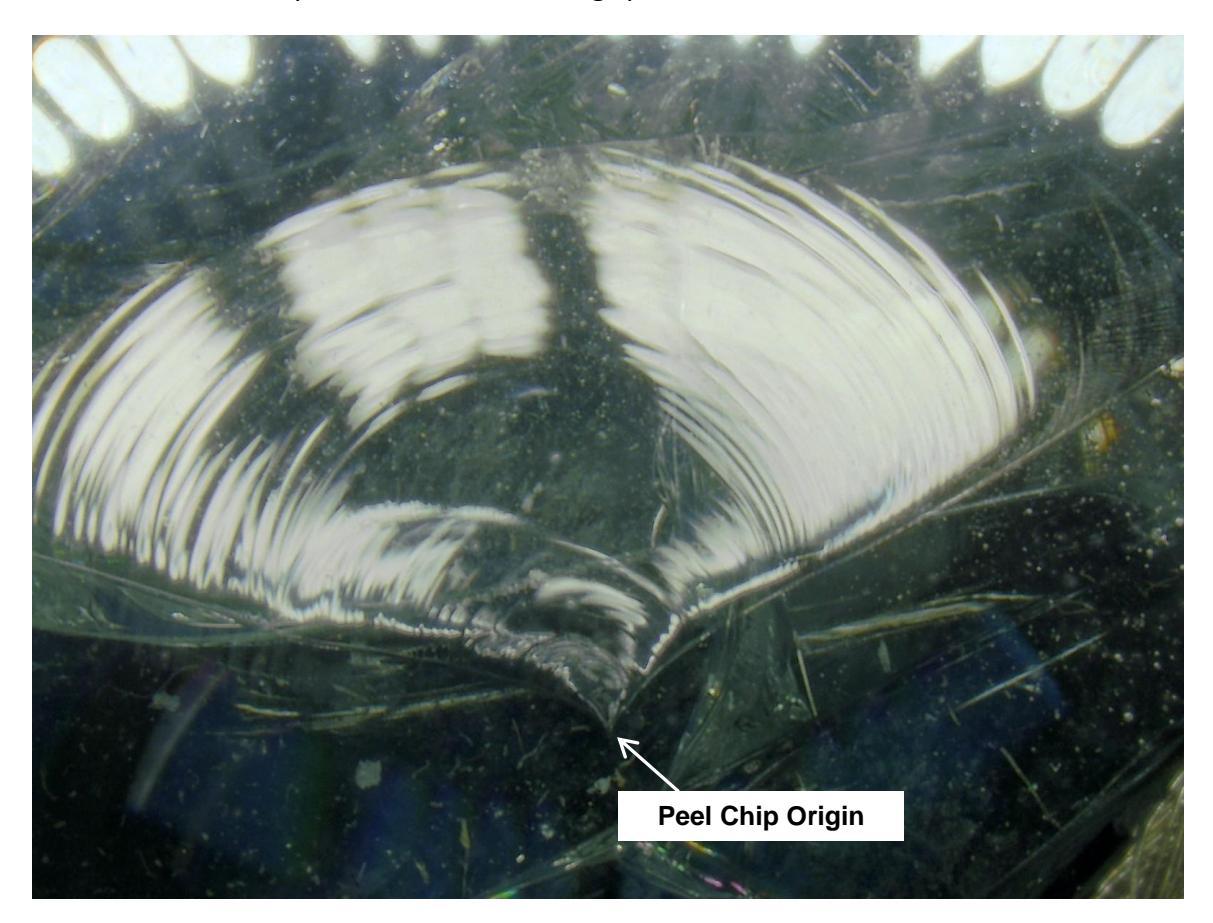
Figure D: Magnified 20X view of the peel chip origin. This view shows the peel chip origination point and progressively getting wider and deeper due to mechanical and thermal stress encountered in service, until the center tension was penetrated that causing spontaneous fracture.

The inboard glass ply fractured due to a peel chip that formed on the inner surface of the glass. The peel chip developed outside of the heated area and localized adhesion of the vinyl interlayer initiated a chip in the glass surface as a result of the differences in coefficient of expansion between the inboard glass ply and vinyl interlayer. The peel adhesion chip propagated, becoming wider and deeper due to mechanical and thermal stress encountered in service, until the center tension of the thermally tempered glass was penetrated causing spontaneous fracture. The windshield design was improved in 2001.

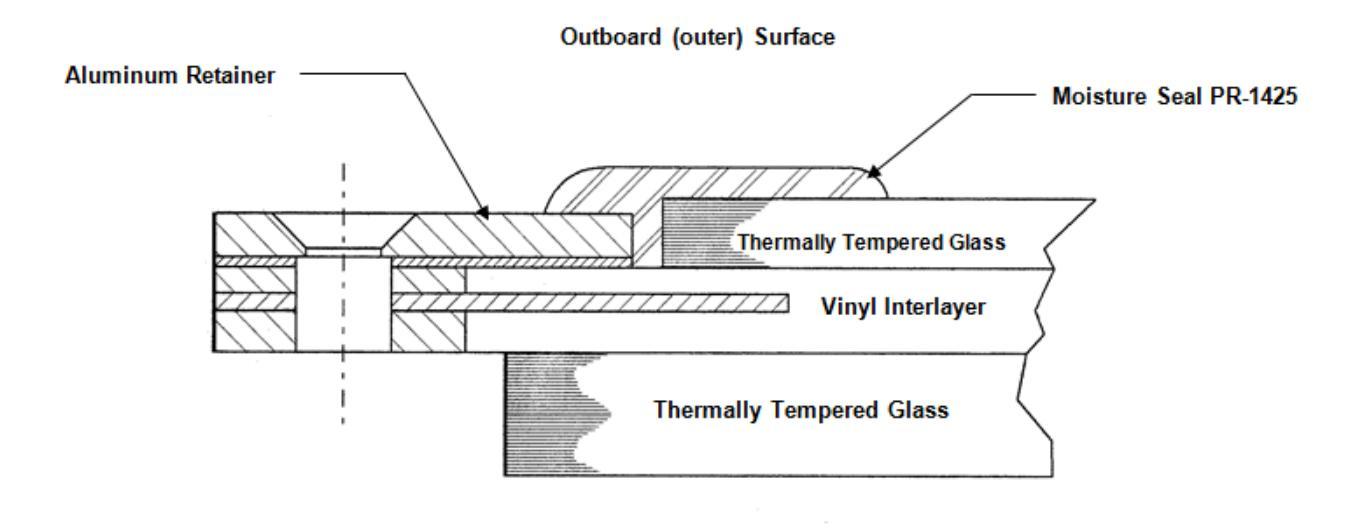
Figure E: Cross-sectional view of the windshield with related key components identified. The subject windshield is an all glass design. The cross section of the windshield from the inboard (inner) surface consists of Herculite glass/ vinyl/ Herculite glass.
