NATIONAL TRANSPORTATION SAFETY BOARD

Personal Electronic Device (PED)

Specialist's Factual Report By Nick Swann

Location: Date: Aircraft: Operator: NTSB Number: Moose, Wyoming 06/09/2018 LET L 23, N317BA Teton Aviation Center CEN18FA217

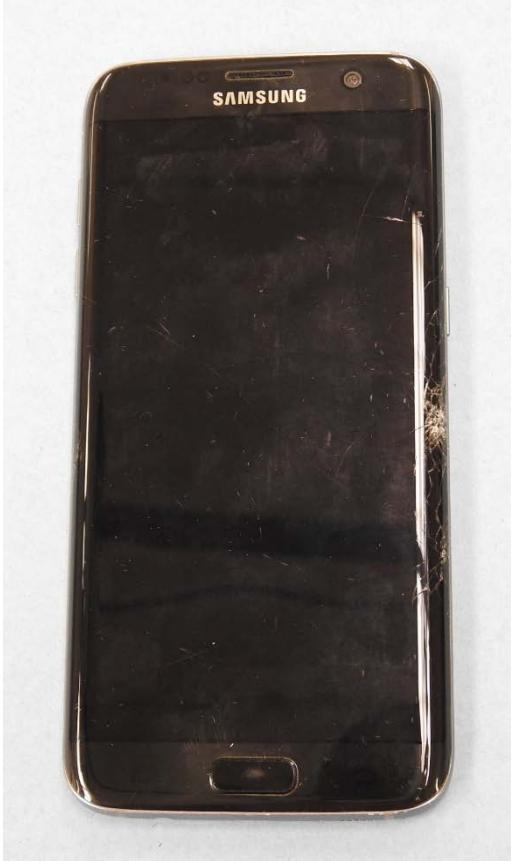
Upon arrival at the NTSB Vehicle Recorder Division, it was evident that the PED had sustained minor impact damage and the video and audio information was extracted from the device normally, without difficulty. Figure 1 below shows the damage to the PED.

Figure 1. Minor impact damage to PED

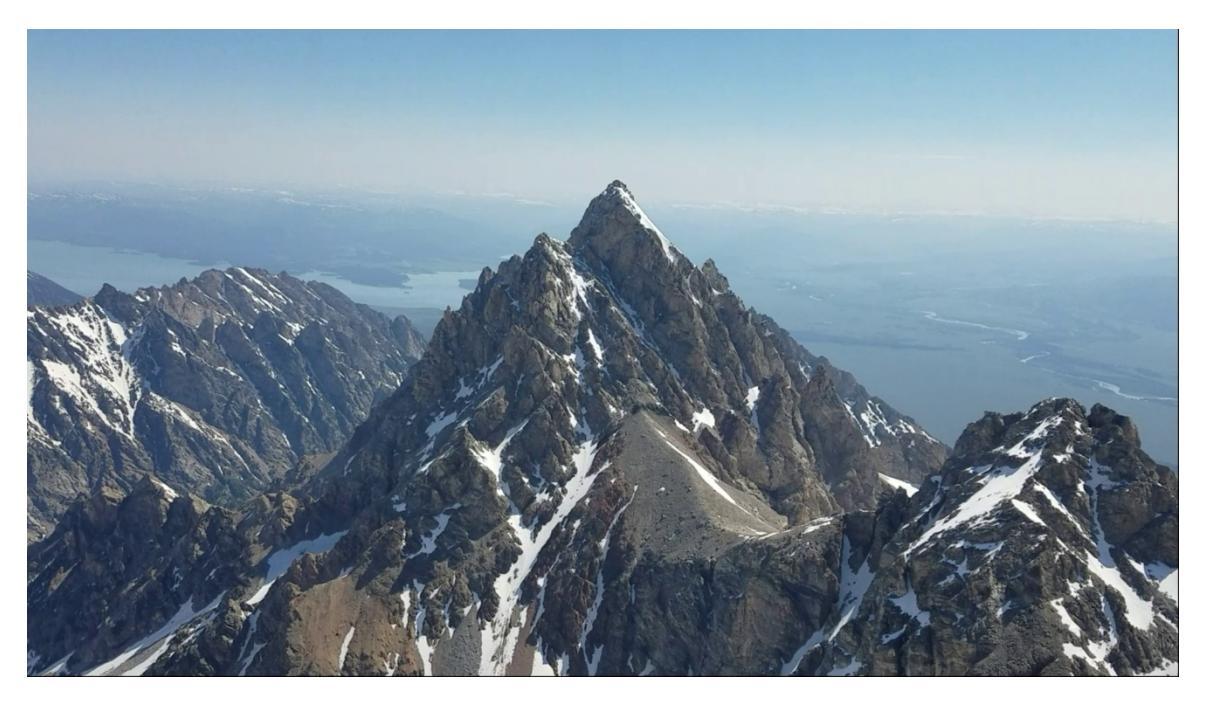
The video began with a view of the mountains off the left side of the aircraft. The range is identifiably the Teton range and the aircraft was on the west side of the range. The camera panned up at 00:06 to show one large peak (identified as Grand Teton), the top of which was roughly the same altitude as the aircraft. This view is shown in Figure 2. The sky showed no clouds but a slight haze was visible at a great distance.

Figure 2. Image from timestamp 00:06 showing Grand Teton and the initial heading

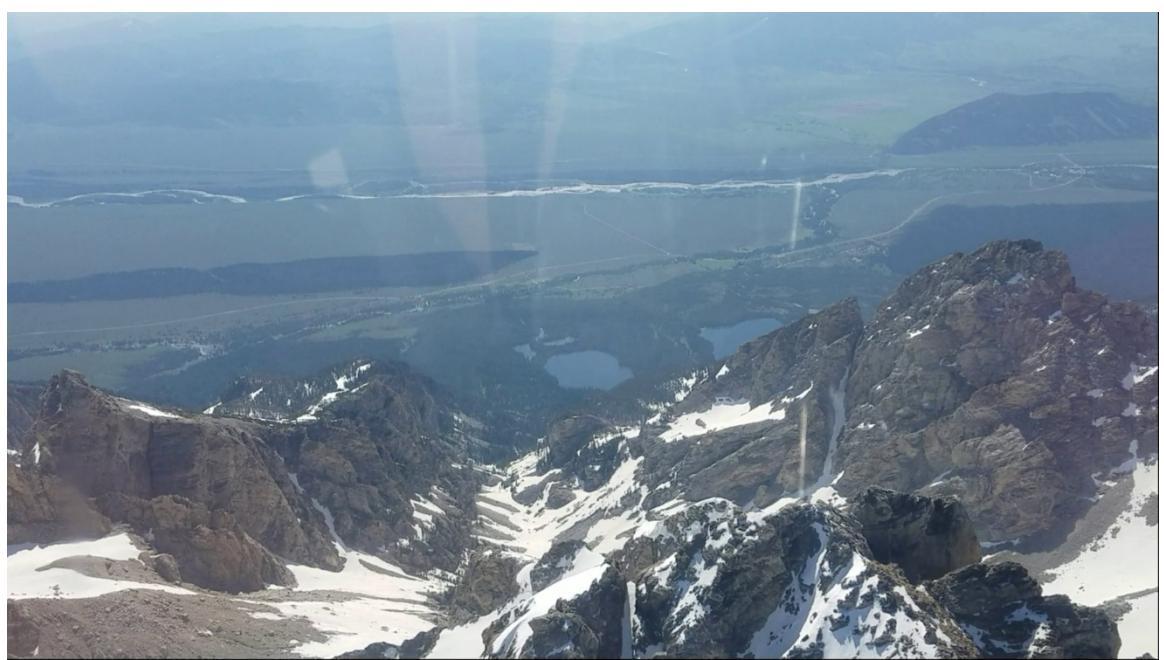
At 00:49, the frame pans to the right and then showed the smaller peak that was just passed as shown in Figure 3. It additionally shows the valley between Grand and Middle Teton. Visible in the recording was the flat land located to the east of the Teton Range. As the camera pans back forward at 00:56 elapsed, the peak of Grand Teton was above the altitude of the aircraft and off to its right side. The frame followed this peak as the aircraft passes on the west side of Grand Teton.

Figure 3. Image from timestamp 00:49 showing Middle Teton and the valley between Grand and Middle Teton

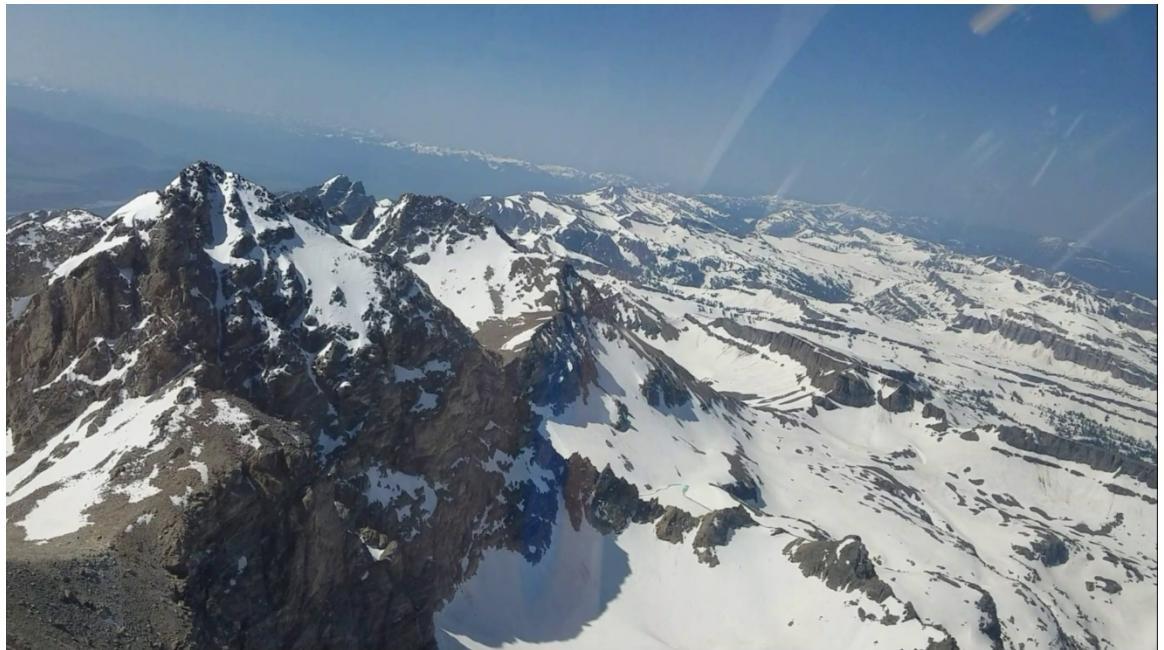
After passing Grand Teton, the aircraft entered a left turn. The camera panned back to the front of the aircraft and the instrument panel was once again visible. At 01:29 elapsed, the airspeed indicator showed roughly 42 knots, the turn coordinator ball was in the center as was the yaw string, and the vertical speed indicator showed 6 knots down. At 01:33 the camera panned up to show in front of the aircraft in its new southward path as shown in Figure 4.

Figure 4. Image from timestamp 01:33 showing Middle Teton and the southward heading of the aircraft

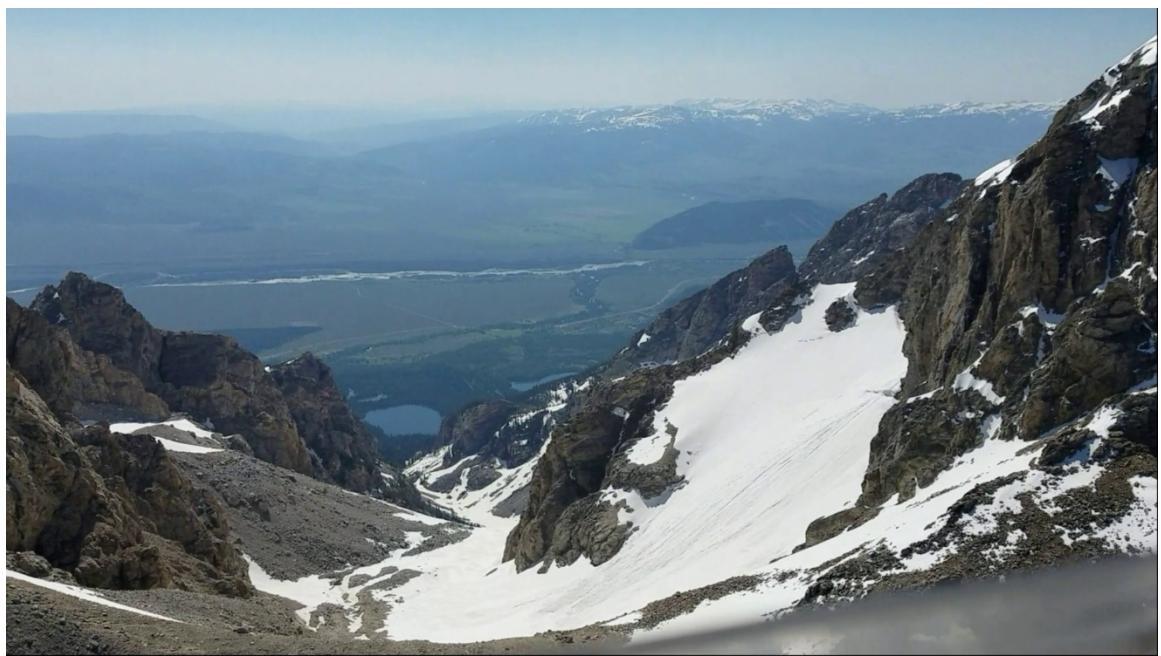
At 01:37 elapsed, the camera has panned back over to the left side of the aircraft to show the large peak that had just been passed. After the roughly 180 degree turn, the peak was on the left side of the aircraft and the aircraft appears to have lost altitude in the turn. As such, the aircraft was then traveling south and was still on the west side of the Teton Range. The glider then began to descend. At 1:54, the valley between Grand Teton and Middle Teton was visible and the aircraft had approached the opening of the valley. At 02:06, the descent appeared to stop and the camera panned back toward the front of the aircraft but the instrument panel was not visible. The yaw string, however, was pointing straight. Middle Teton was in front of the aircraft and off to the left. At 02:09 the pilot can be heard saying "this is not good." The top of Middle Teton was at or above the current altitude of the aircraft. The glider then banked slightly right at 02:13 to be parallel to the ridgeline of Middle Teton, now off to the left side of the aircraft. The camera panned to the left to show the valley between Grand and Middle Teton passing off the left as shown in Figure 5 (showing the land to the east of the Teton Range) and remained there until Middle Teton is prominently visible at 02:28 elapsed.

Figure 5. Image from timestamp 02:19 showing the valley between Grand and Middle Teton

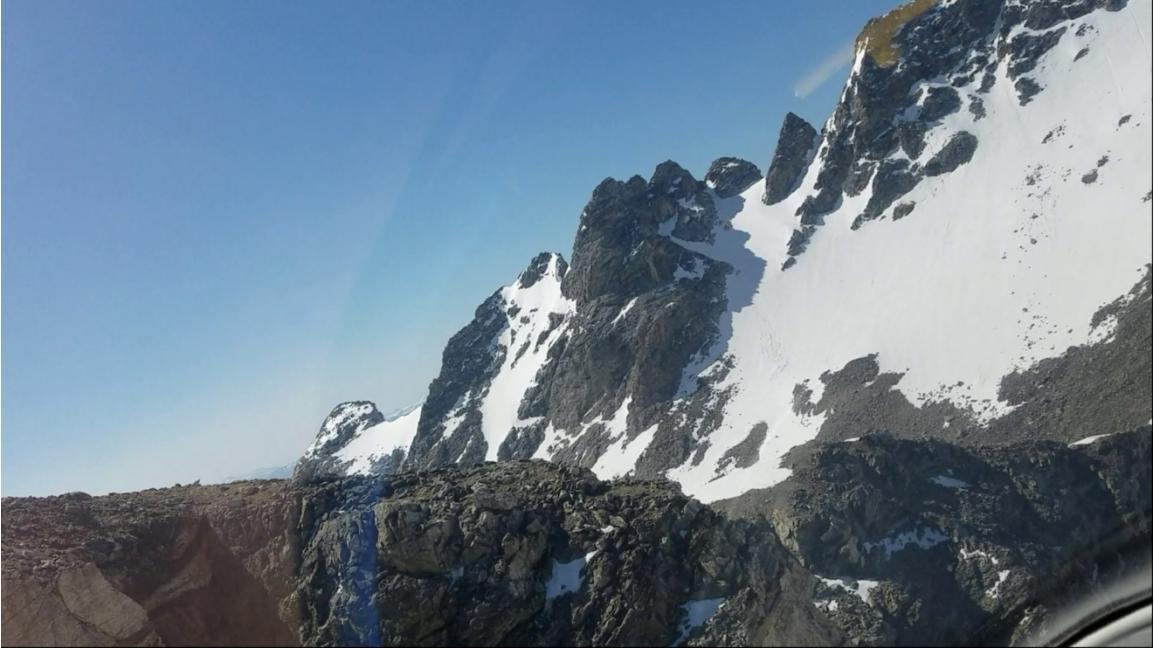
In the last frame where the airspeed indicator was visible at 02:40, it showed an indicated airspeed of roughly 42 knots. The camera panned left and the ridge line being passed was visible. The top of the ridge line was above the altitude of the aircraft. From 02:48 to 02:52 the occupant recording made several exclamations of surprise. At 02:57 the aircraft then appeared to enter a steep descent, shown in Figure 6. The ridgeline to the left of the aircraft was coming to a downward slope and the peak of the ridge was once again at the same altitude as the aircraft. At 02:58 the pilot can be heard saying "this is not good." At 03:00, the aircraft appeared to exit the steep descent as it passes by a cliff marking the end of the left ridgeline it was following. The aircraft then appeared to enter another steep descent. At 03:03 elapsed, the yaw string was visible on the front of the aircraft, it was blown straight. At this time the pilot can also be heard saying "I'm in trouble." The camera panned forward and at 03:06 elapsed the aircraft returned to a neutral pitch attitude but appeared to still be descending, as shown in Figure 7. The yaw string began blowing to the right. The aircraft was traveling along the ridge that comprises the valley between Middle Teton and South Teton. As the aircraft descended, it was pointing toward the ridge line. The peak of the ridge is roughly the same altitude as the glider. In the last frame the yaw string was seen blowing to the right roughly at 45 degrees. At 03:09 elapsed, the recording ends.

Figure 6. Image from timestamp 02:57 showing the glider's position as it passed Middle Teton

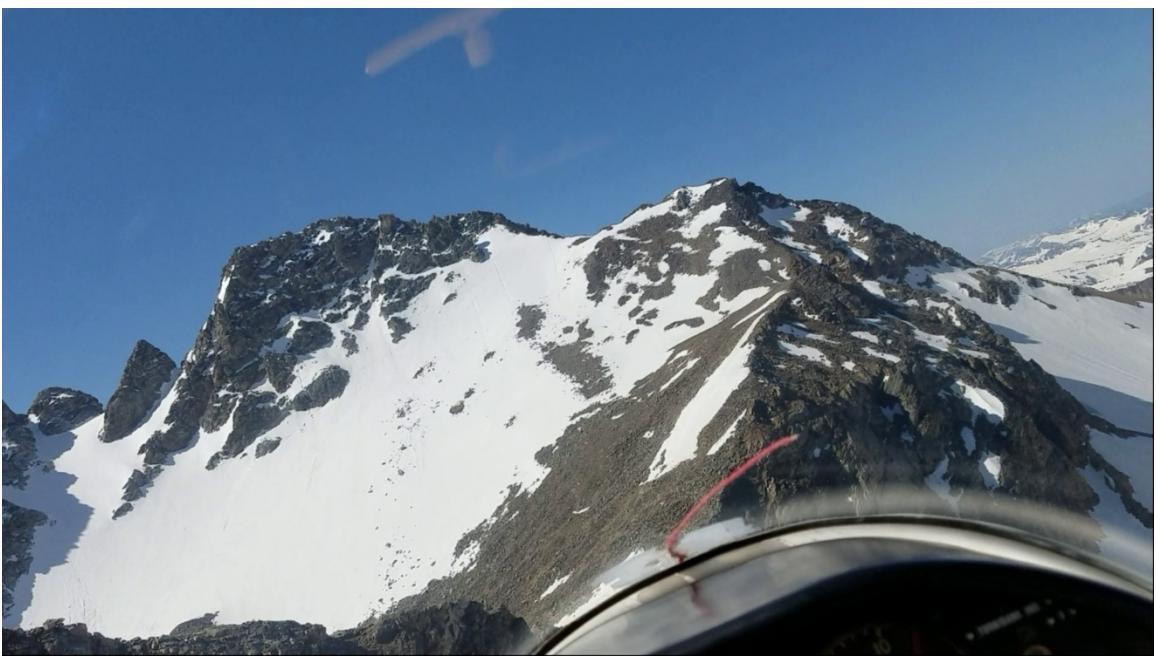
Figure 7. Image from timestamp 03:06 showing the glider's trajectory before the end of the recording and the ridge between Middle and South Teton
