National Transportation Safety Board

Office of Aviation Safety Washington, D.C. 20594-2000 July 30, 2013 WEATHER STUDY ERA13FA273

Location: Manchester, Kentucky
Date: June 6, 2013
Time: about 2315 eastern daylight time (0315 UTC¹ on June 7, 2013)
Aircraft: Bell 206L-1, registration: N114AE

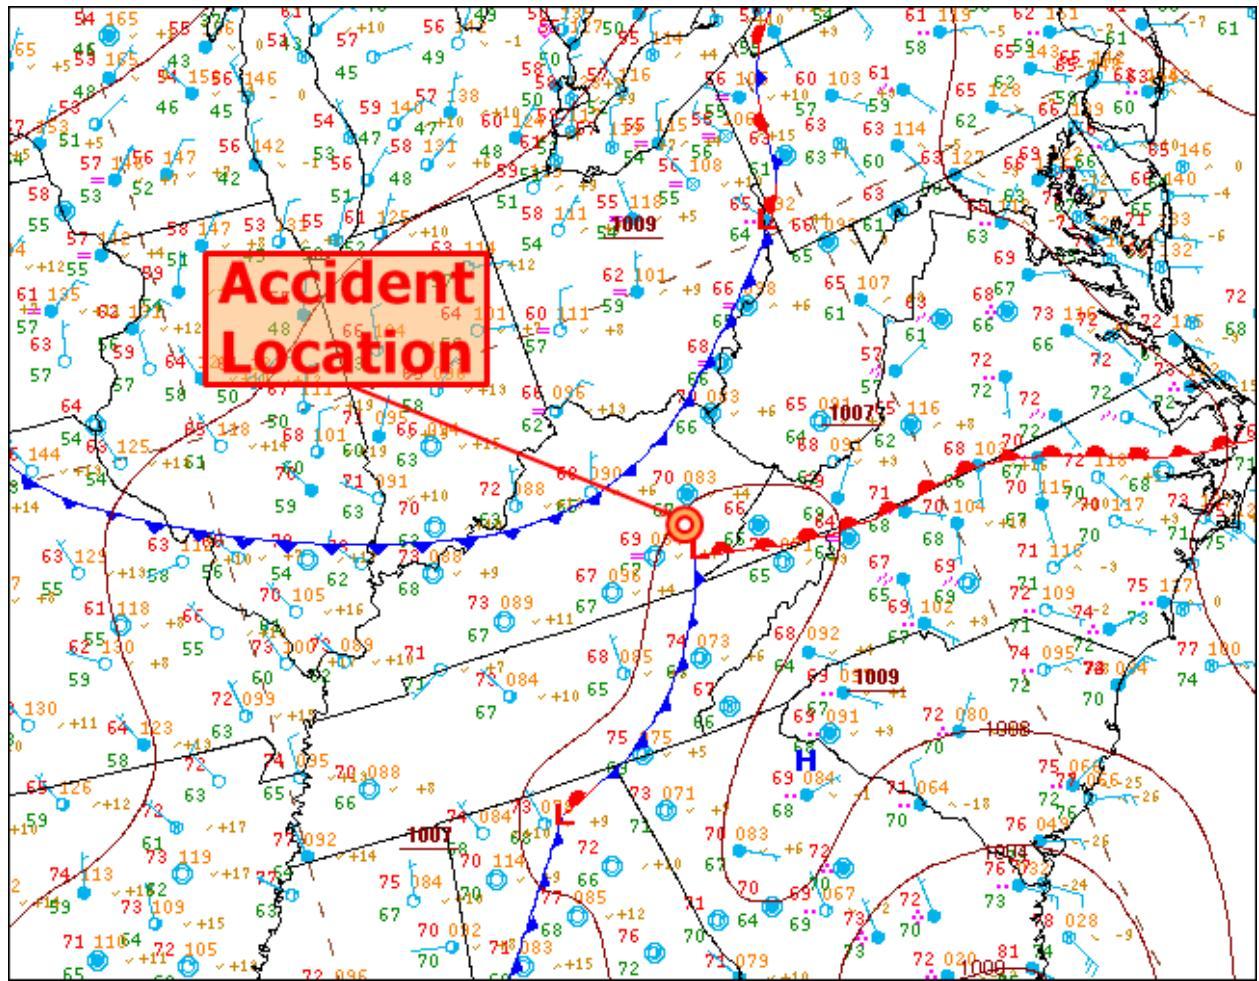
Figure 1 – NWS Surface Analysis Chart for 2300 EDT.

The NWS Surface Analysis Chart for 2300 EDT (figure 1) depicted a low-pressure center very near to the accident location, with a cold front extending southwest, and a warm front extending east from the low-pressure center. A separate cold front was advancing from the north through the northern portion of Kentucky. Surface temperatures in eastern Kentucky and eastern Tennessee were generaly in the high 60's° Fahrenheit (F). Dew point temperatures were in the mid- to high 60's°F. Station models depicted the wind as calm or light, with one station near the accident site reporting mist.

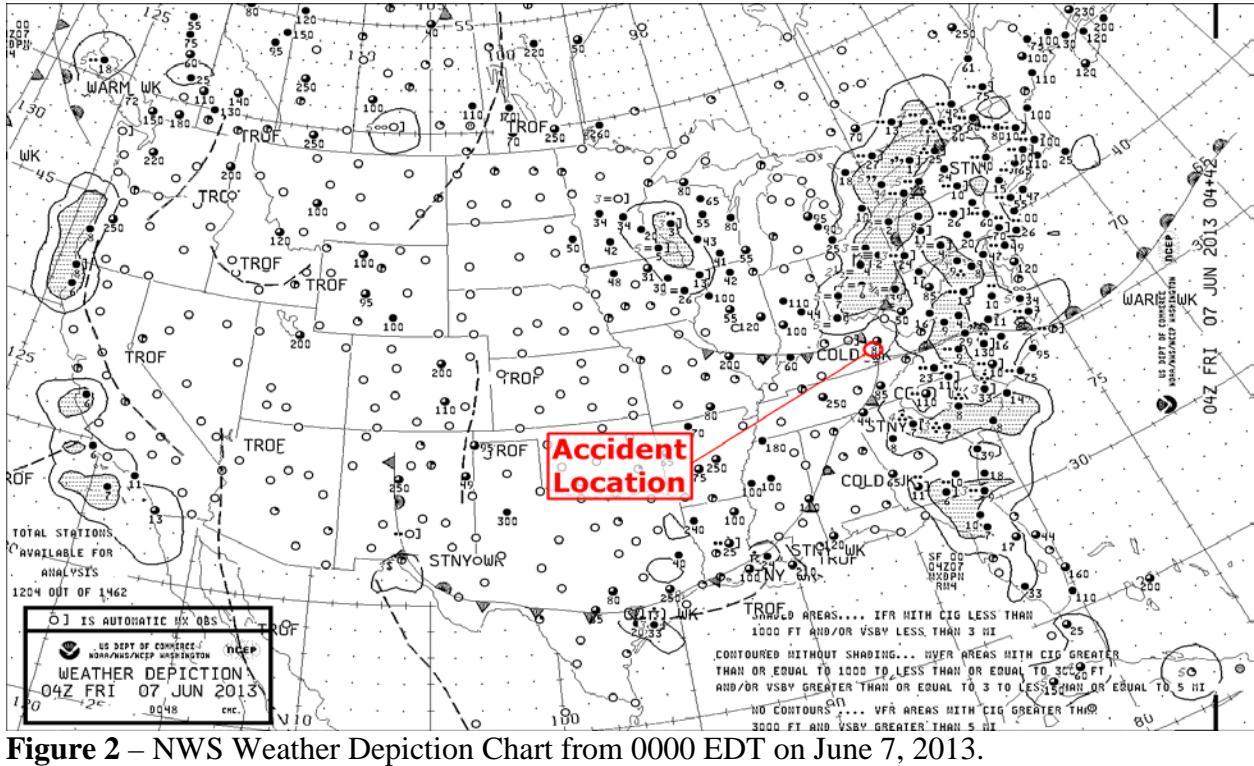
A NWS Weather Depiction Chart (figure 2) for 0000 EDT on June 7, 2013, depicted fronts in a similar fashion to the Surface Analysis Chart. In addition, the Weather Depiction Chart, which provides contours for areas of IFR^2 and $MVFR^3$ conditions, indicated the accident location was in an area of VFR^4 conditions with ceilings greater than 3,000 feet above ground level (agl) and a visibility greater than 5 miles.

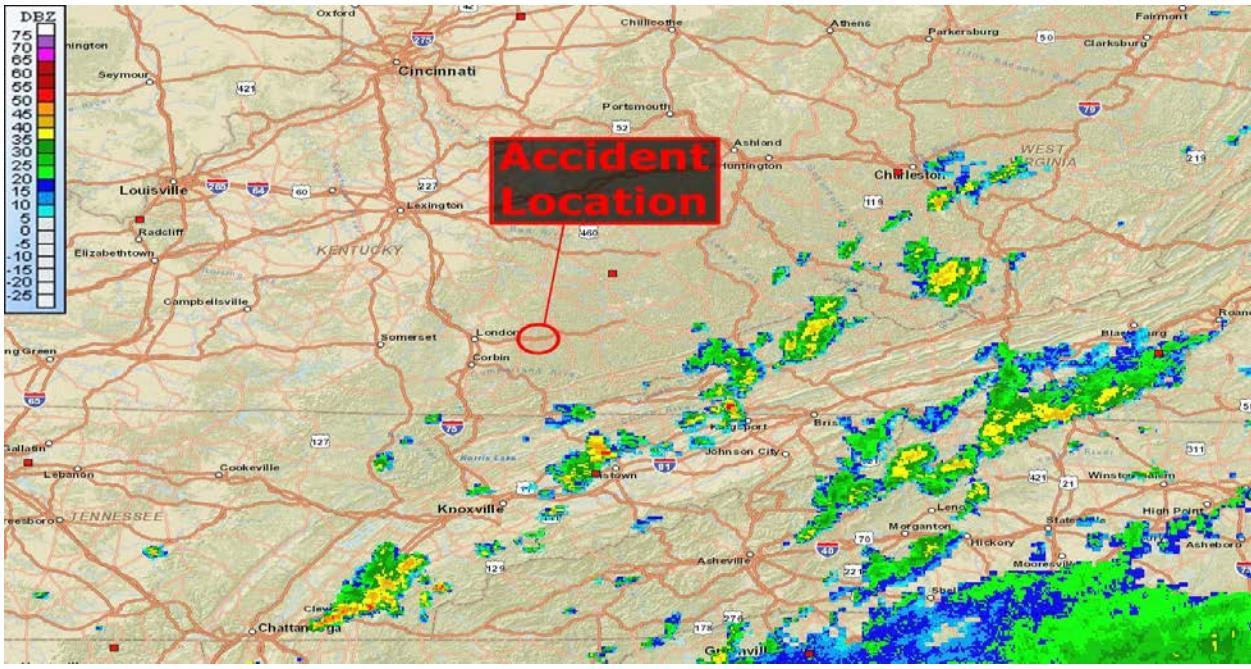
A regional Next-Generation Radar (NEXRAD) mosaic (figure 3) obtained from the NCDC for 2315 EDTdid not identify any radar returns in the area of the accident location.

Figure 3 – NCDC NEXRAD mosaic from 2315 EDT.

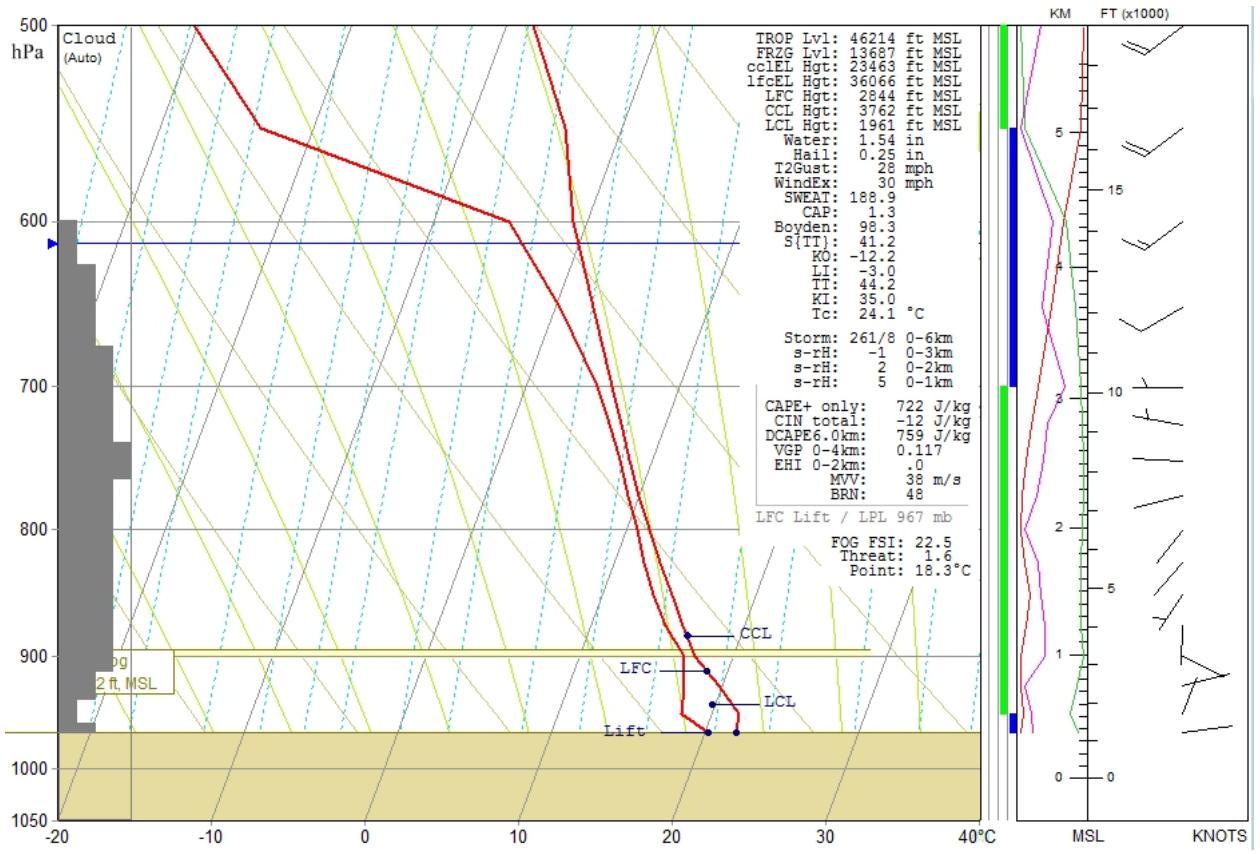
A North American Mesoscale (NAM) model sounding (figure 4) for the accident location at 2300 EDT was retrieved from NOAA's Air Resources Laboratory. The NAM model sounding indicated the layer between 3,000 and 9,000 feet was nearly saturated. Below 3,000 feet the atmosphere was somewhat drier, with higher relative humidities near the surface. No temperature inversions were noted. Winds near the surface were light and variable.

Figure 4 – NAM model sounding for the accident site in SkewT/LogP format for 2300 EDT, surface to 500 hPa.

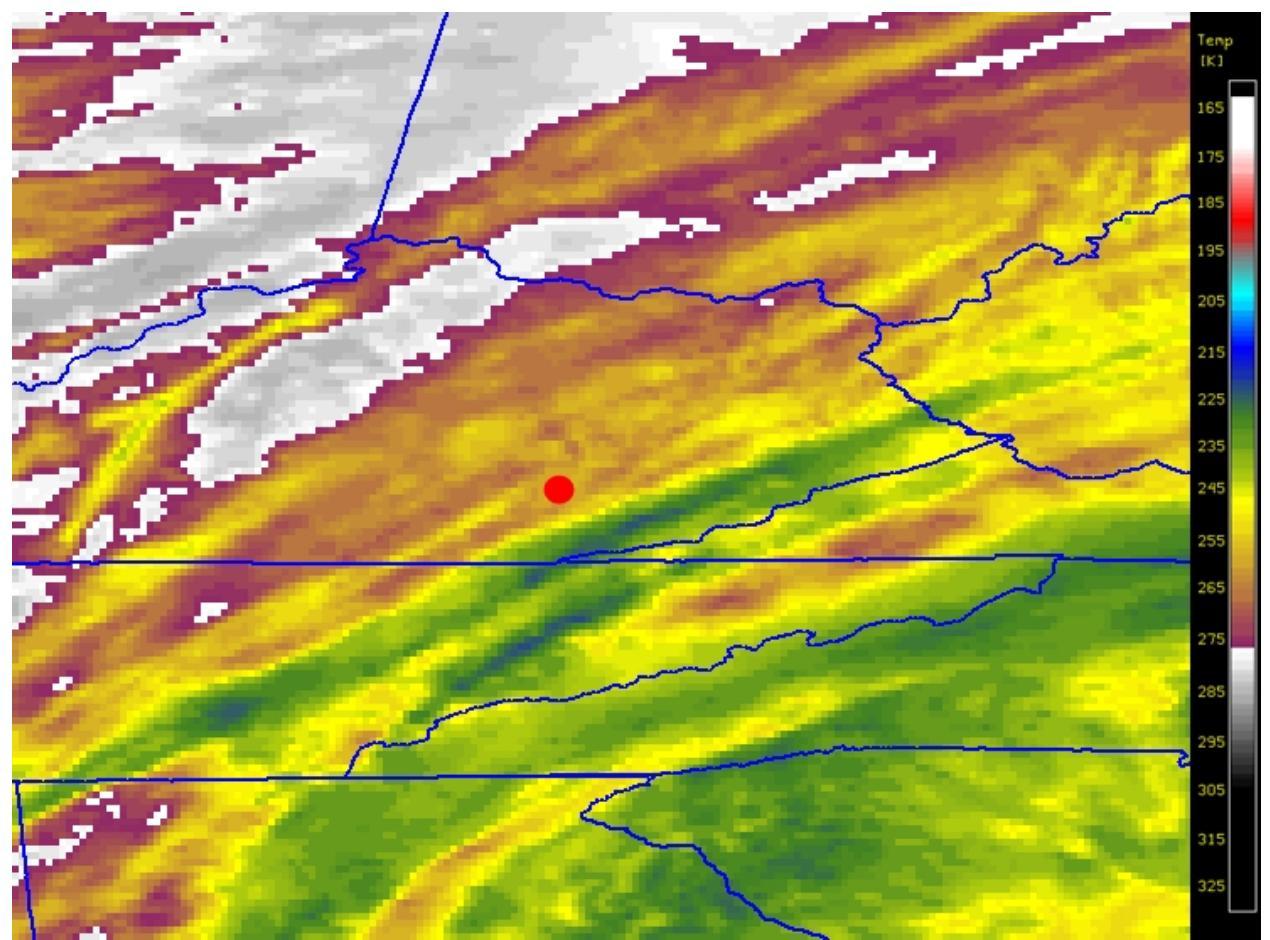
Geostationary Operational Environmental Satellite (GOES)-13 infrared (10.7µm) data were obtained from an archive at the Space Science Engineering Center (SSEC) at the University of Wisconsin-Madison (UW) in Madison, Wisconsin, and processed using the Man computer Interactive Data Access System (McIDAS). Imagery from 2315 EDT is presented in figure 5. The GOES-13 infrared imagery identified cloudy conditions at the accident location, with cloud-top temperatures varying between approximately -5°C and -50°C in the accident region. When considering the NAM model sounding, -5°C corresponded to a height of approximately 17,200 feet. It should be noted that all satellite data presented in this section have not been corrected for any parallax error.

Figure 5 – GOES-13 10.7 μ m (infrared) color-enhanced imagery from 2315 EDT. Red dot denotes accident location.
