National Transportation Safety Board

Office of Aviation Safety Washington, D.C. 20594-2000 June 5, 2015 WEATHER STUDY WPR15FA152

Location: Mt. Tom, Oregon
Date: April 21, 2015
Time: about 1700 Pacific daylight time (0000 UTC¹ on April 22, 2015)
Aircraft: Piper PA-28, registration: N1729J

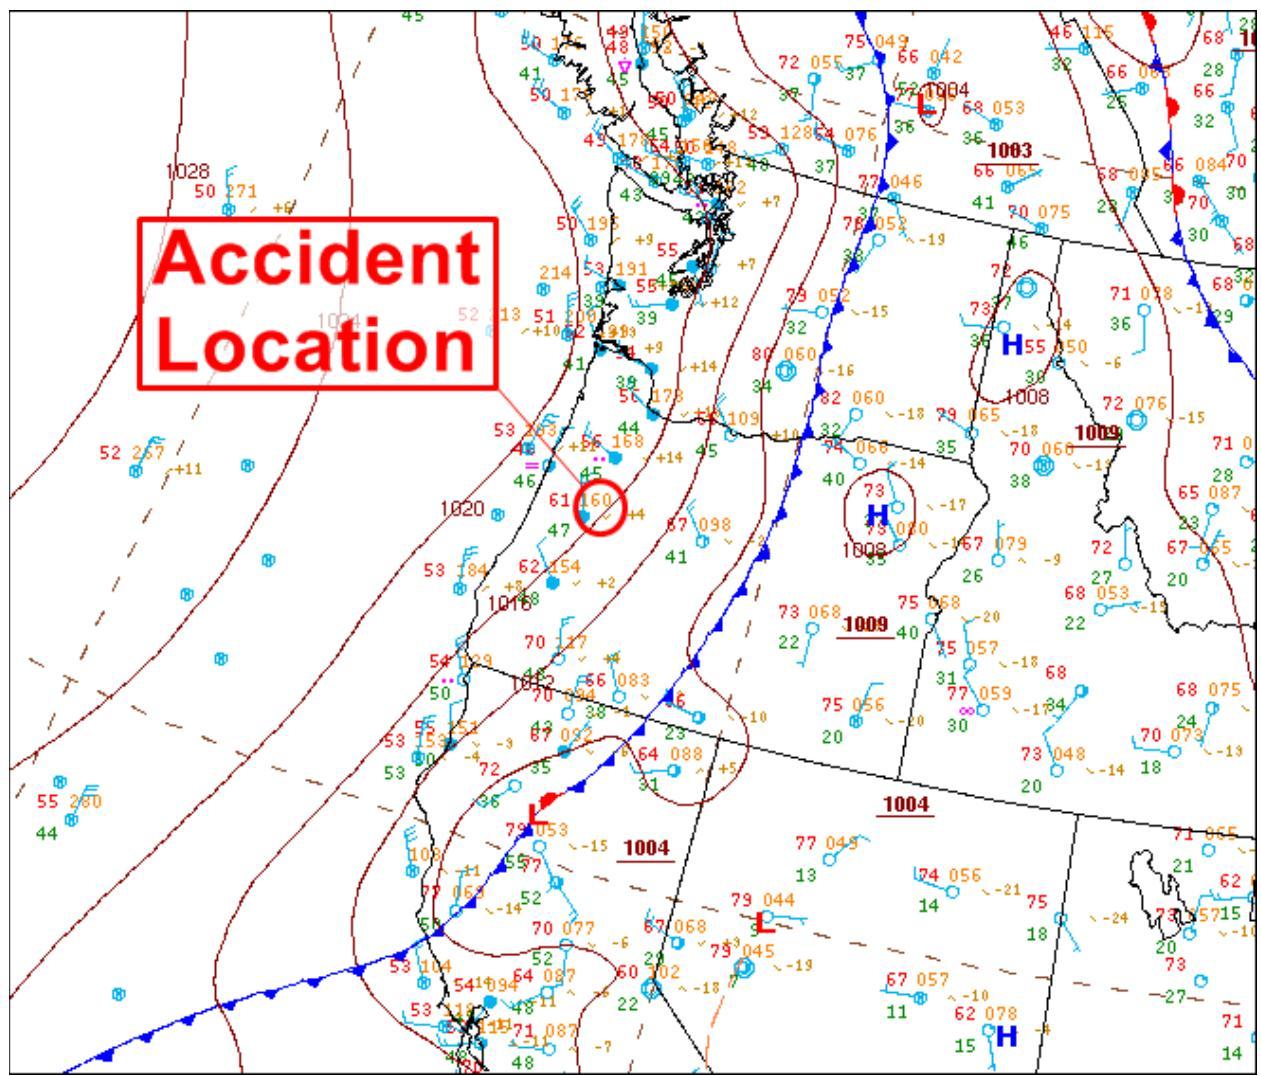
Figure 1 – NWS Surface Analysis Chart for 1700 PDT.

Figure 1 presents the National Weather Service (NWS) Surface Analysis Chart for 1700 Pacific daylight time (PDT). The chart depicted a north/south-oriented cold front stretching from the Washington-British Columbia border through central Oregon and into Northern California. Station models in western Oregon depicted a surface wind generally from the northwest at magnitudes between 5 and 15 knots. Dew point depressions east of the coastline were greater than 10 degrees Fahrenheit. Light rain was noted near the accident location.

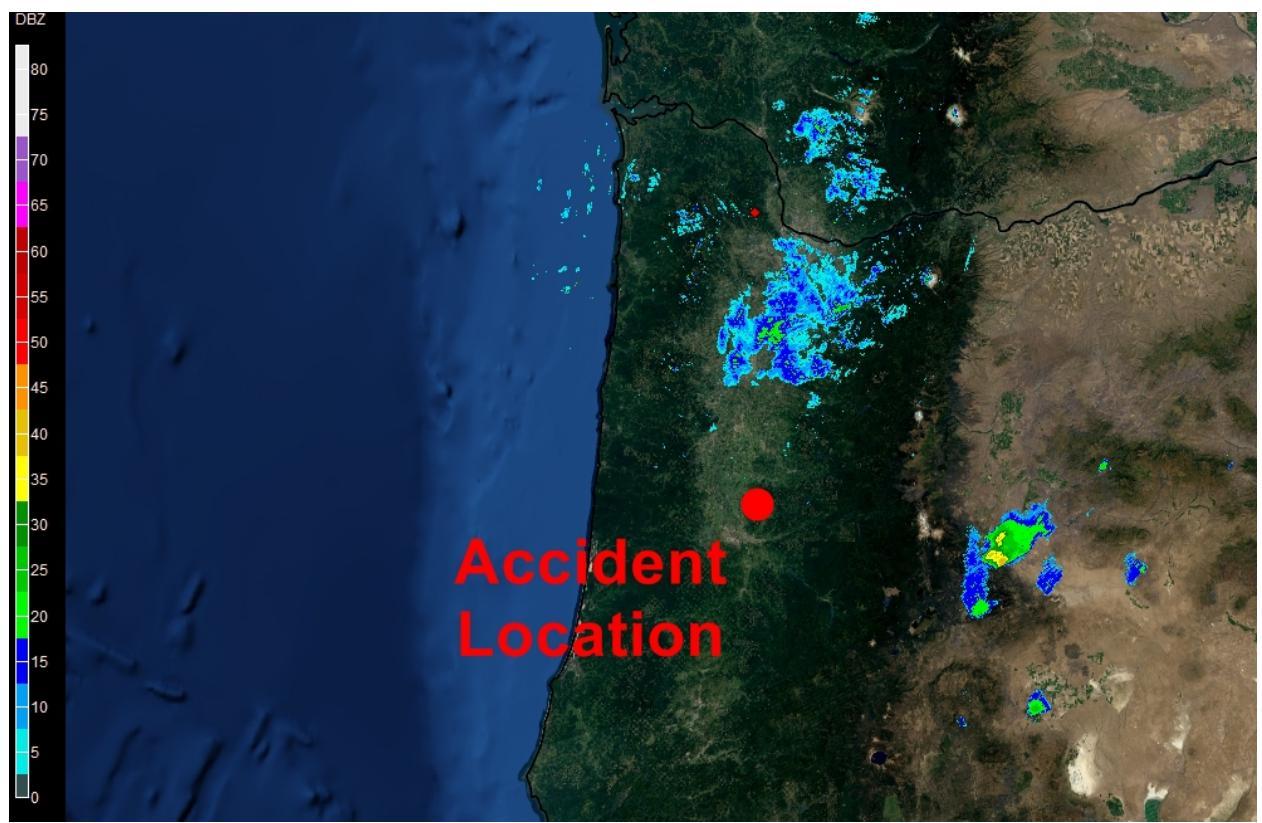
WSR-88D Level-II weather radar imagery from Portland, Oregon (KRTX), is presented in figure 2. KRTX was located approximately 90 miles north of the accident site at an elevation of 1,572 feet. Assuming standard refraction and considering the 0.95° beam width for the WSR-88D radar beam, the KRTX 0.54° tilt would have "seen" altitudes between about 7,550 and 16,600 feet above msl at the accident location.

The KRTX imagery from 1654 PDT did not depict any significant reflectivity patterns at or near the accident site. It should be noted that the radar could not see below about 7,550 feet, which was about 4,450 feet above the accident location elevation.

Figure 2 – KRTX 0.54° Level-II reflectivity product from 1654 PDT.

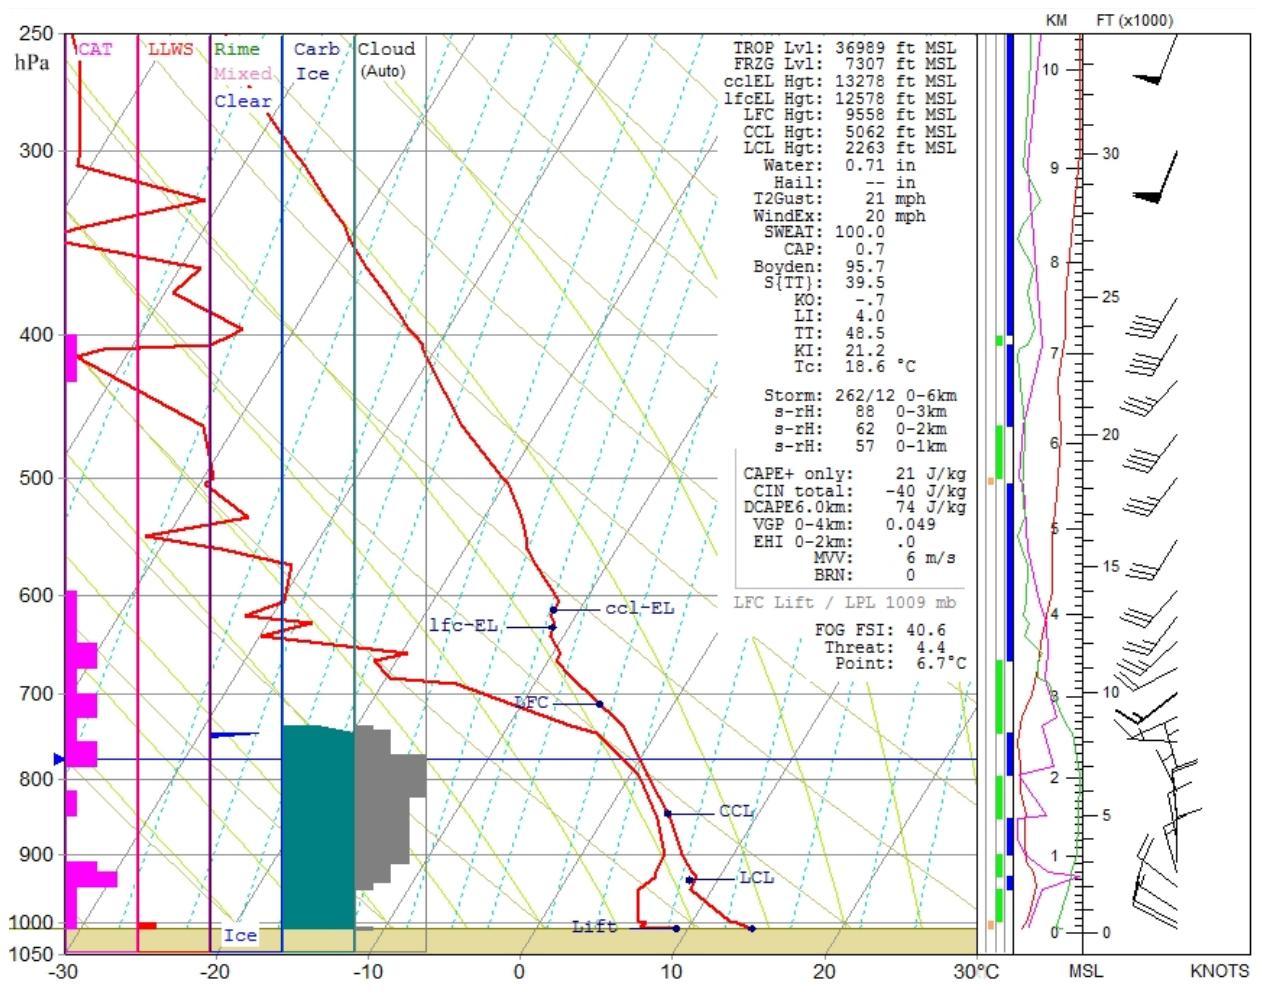
Atmospheric data were retrieved from a 1700 PDT rawinsonde launch from Salem/McNary, Oregon (rawinsonde station: SLE), where low-level meteorological data was likely retrieved beginning between 1600 and 1630 PDT. These data are presented in figure 3.

The SLE sounding identified relative humidities greater than 90 percent between about 3,000 and 7,500 feet. Near-surface wind was from the northwest at about 10 knots. Above this level through about 2,000 feet the wind remained from the northwest but increased in magnitude to about 20 knots. Above 2,000 feet the wind *veered* to a more northerly direction and decreased in magnitude to about 11 knots at 5,000 feet.

Figure 3 – SLE sounding data in SkewT/LogP format for 1700 PDT, surface to 250 hPa.

cloud-top temperatures varying between approximately $-4^{\circ}C$ and $-8^{\circ}C$ in the immediate accident region. When considering the SLE sounding, $-4^{\circ}C$ and $-8^{\circ}C$ corresponded to heights of approximately 9,200 and 10,600 feet, respectively. It should be noted that figures 4 and 5 have not been corrected for any parallax error.

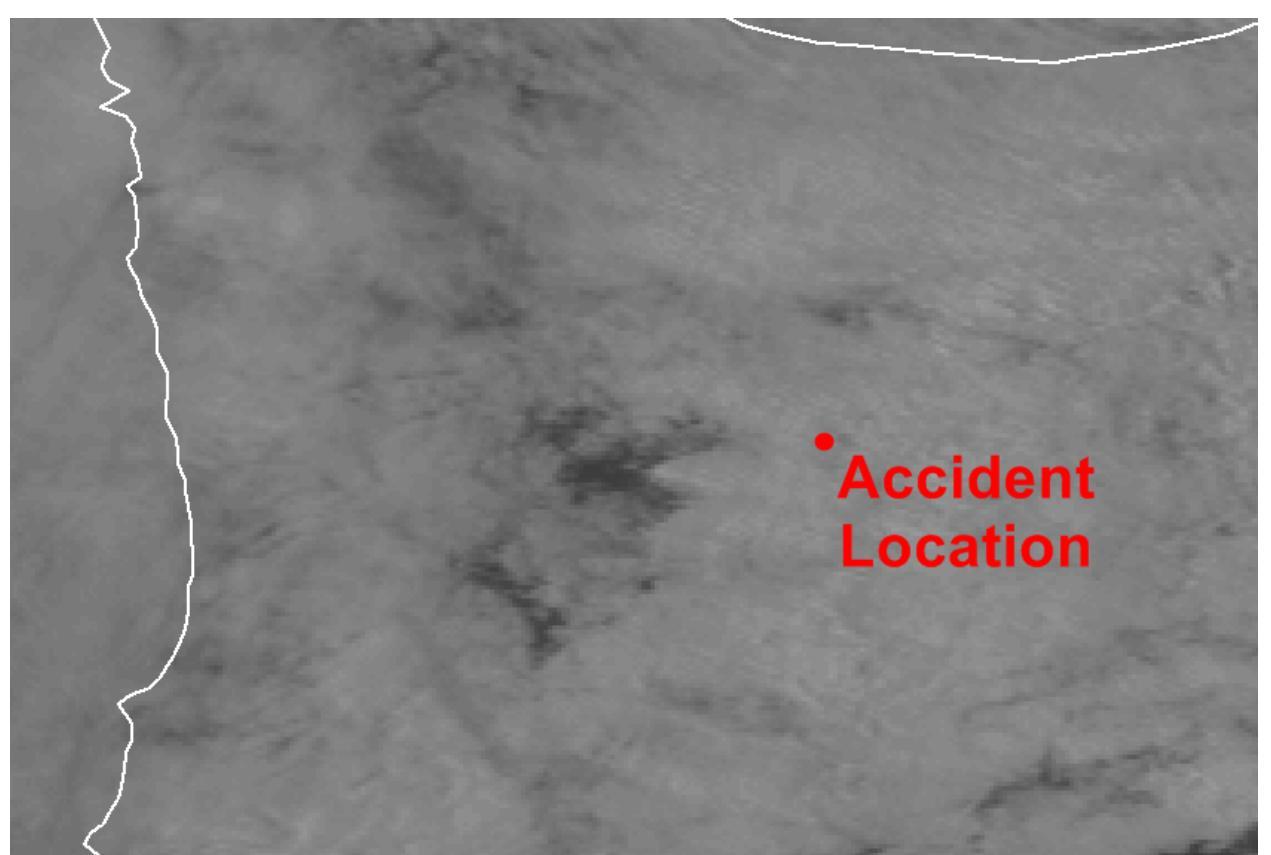
Geostationary Operational Environmental Satellite (GOES)-15 visible ($0.63\mu m$) and infrared ($10.7\mu m$) data were obtained from an archive at the Space Science Engineering Center at the University of Wisconsin-Madison. Imagery from 1700 PDT is presented in figures 4 and 5. The GOES-15 visible imagery identified cloudy conditions over the accident location, with infrared

Figure 4 – GOES-15 0.63 µm (visible) imagery from 1700 PDT.

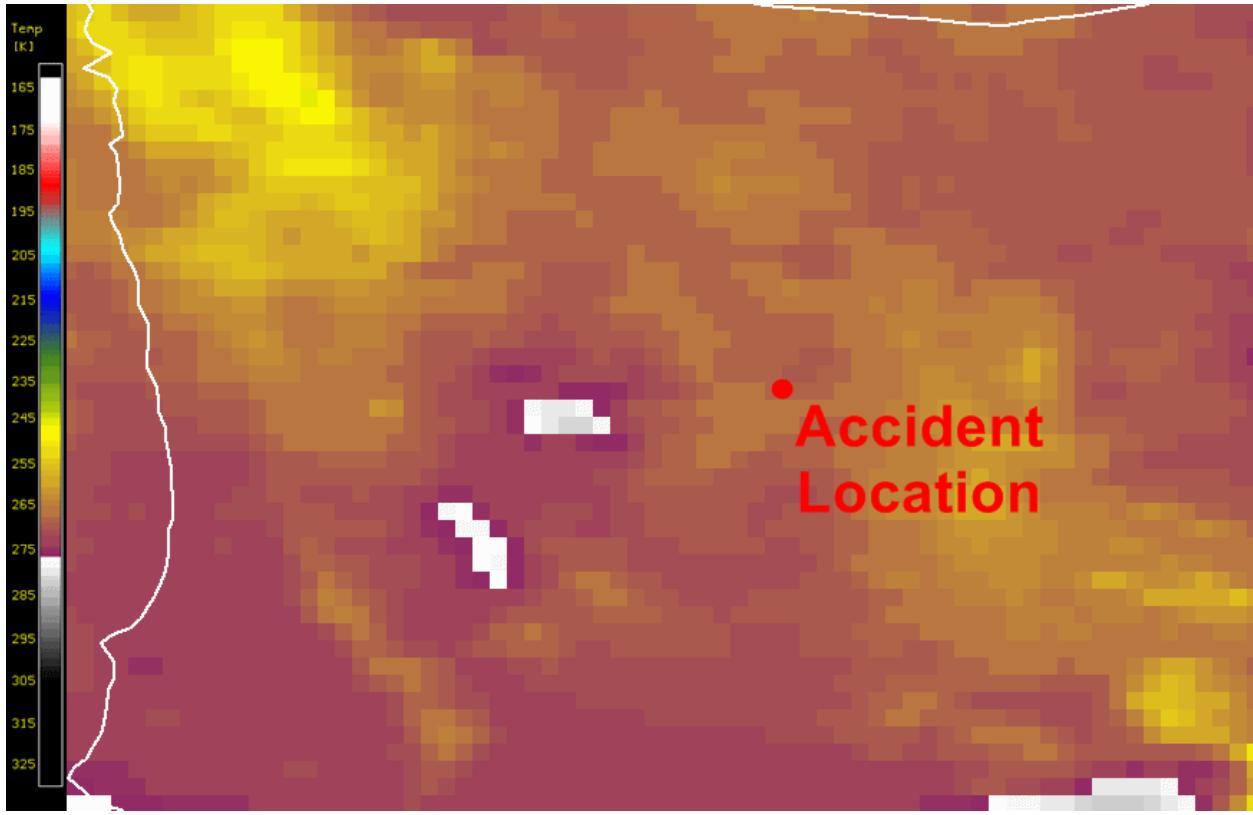
Figure 5 – GOES-15 10.7µm (infrared) color-enhanced imagery from 1700 PDT.

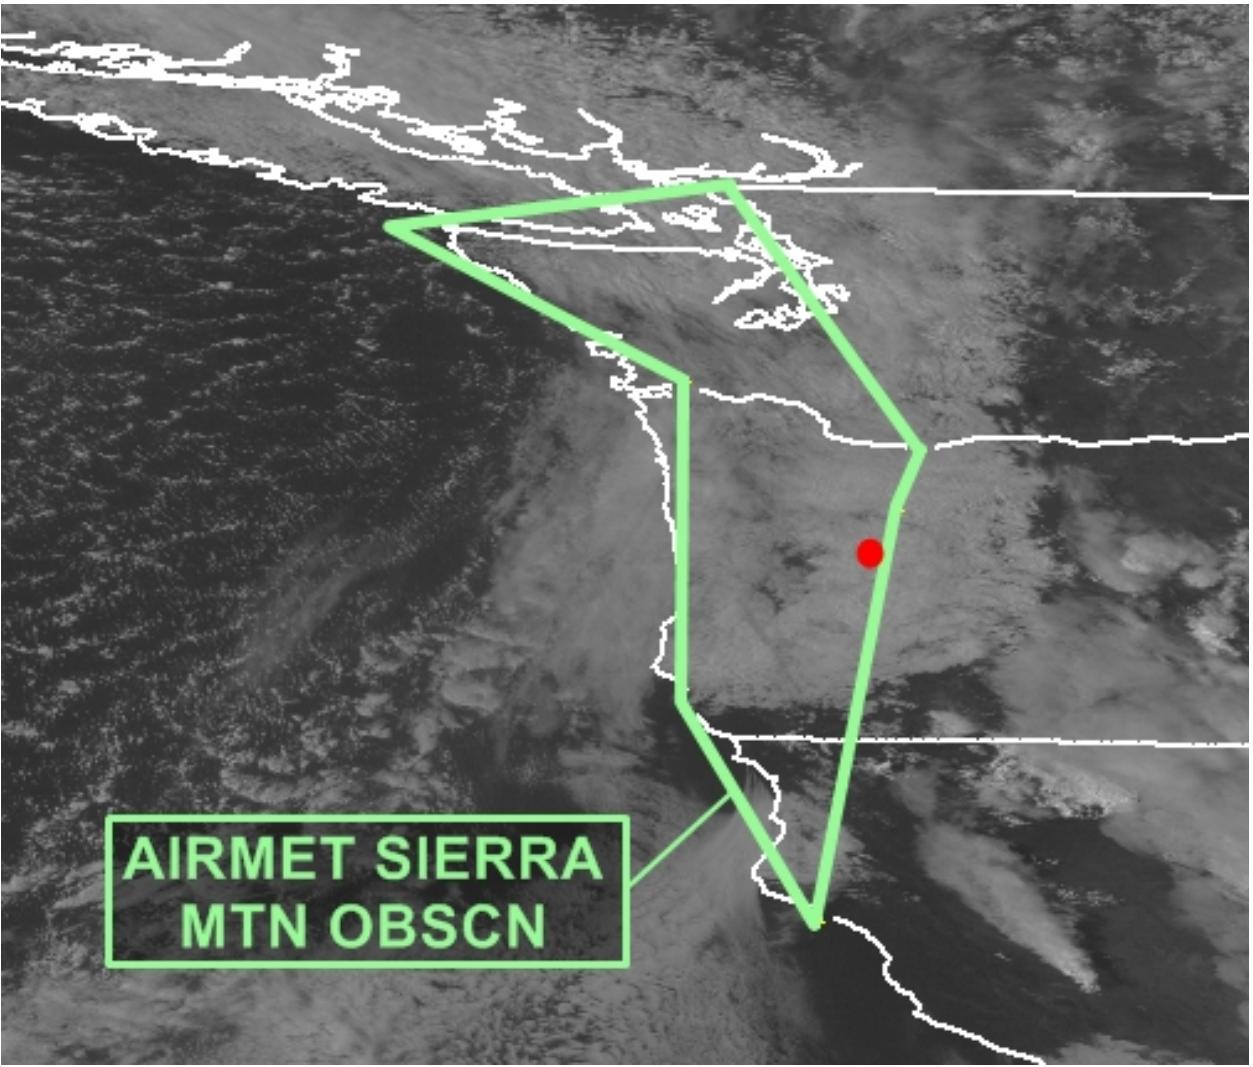
An Airmen's Meteorological Information (AIRMET) Sierra advisory for mountain obscuration (figure 6) was active for the accident location at the accident time. No other AIRMETs were active for the accident location at the accident time.

Figure 6 – AIRMET Sierra for mountain obscuration. Accident location denoted by the red dot.
