VEHICLE FACTORS ATTACHMENT

Eldorado Bus Specifications

HWY23MH004

SUBJECT: SAFETY RECALL (U.S., EXPORT) Bosch DiamondLife[™] Zero Offset Pin Slide Hydraulic Disc Brakes on Certain Bus Models Built 10/28/1997 through 6/3/2002

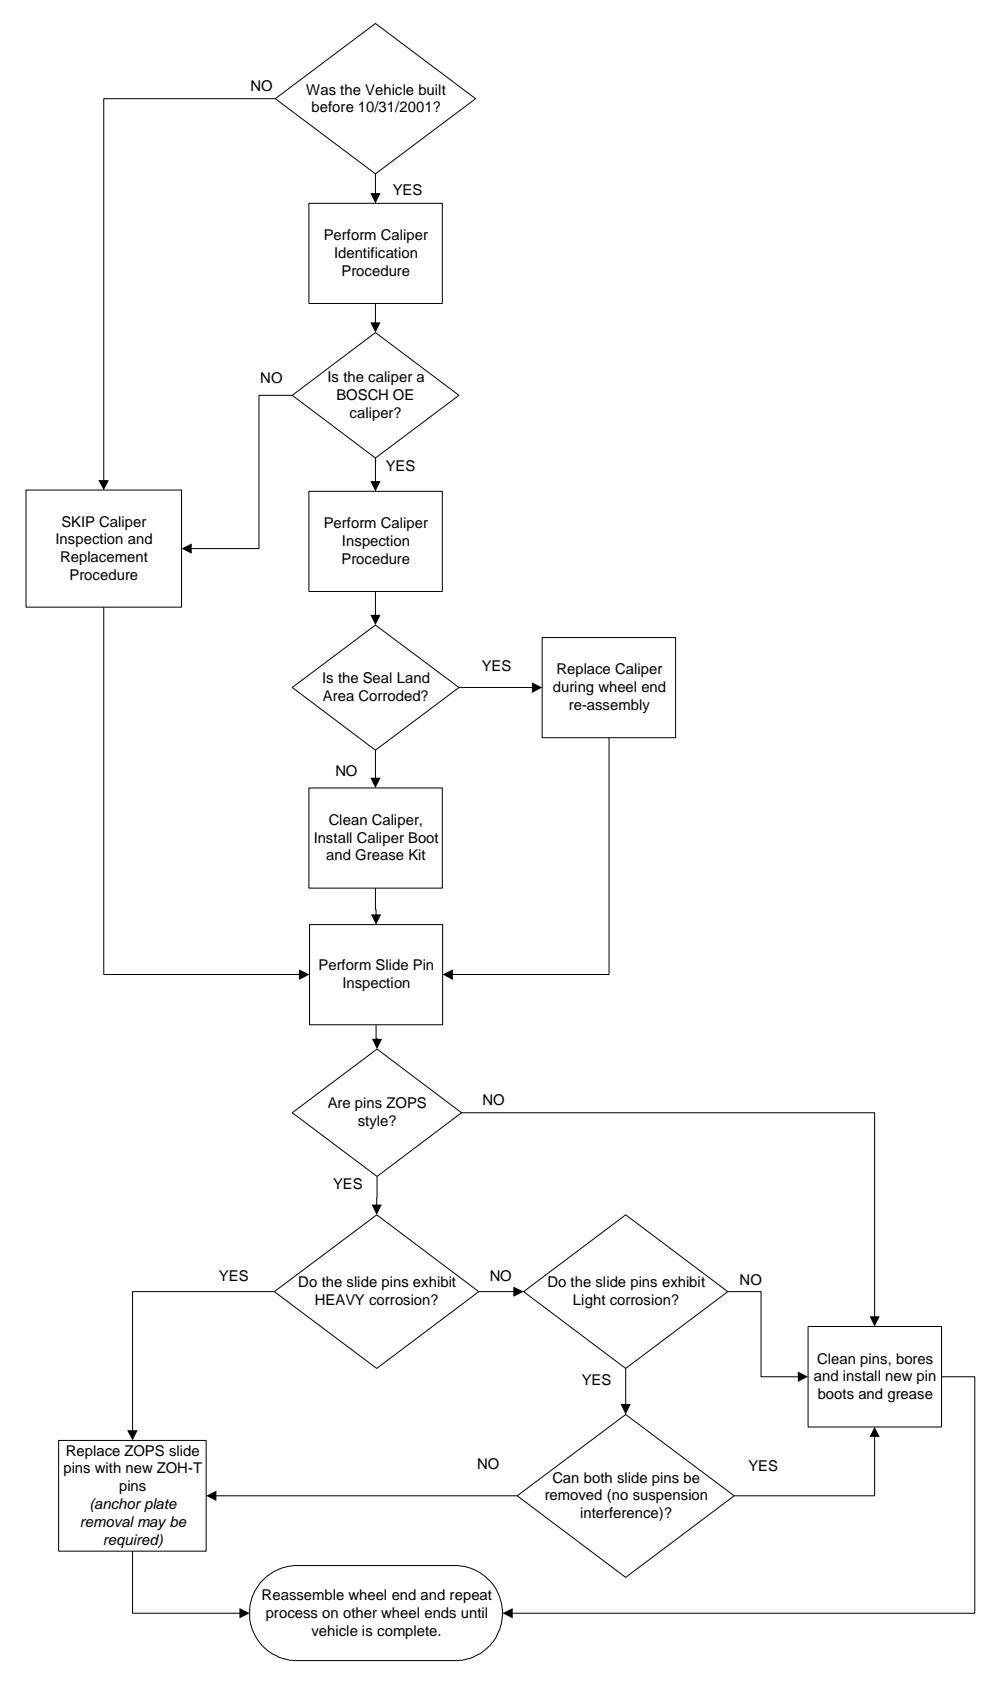
INSPECTION/DECISION PROCESS FLOW

The following page contains a simplified flow-chart that describes how the decision to replace or re-use brake components is to be made. Please use this for general information only, as more detailed instructions are contained in the body of the letter. Perform the following service on ALL vehicle wheel ends.

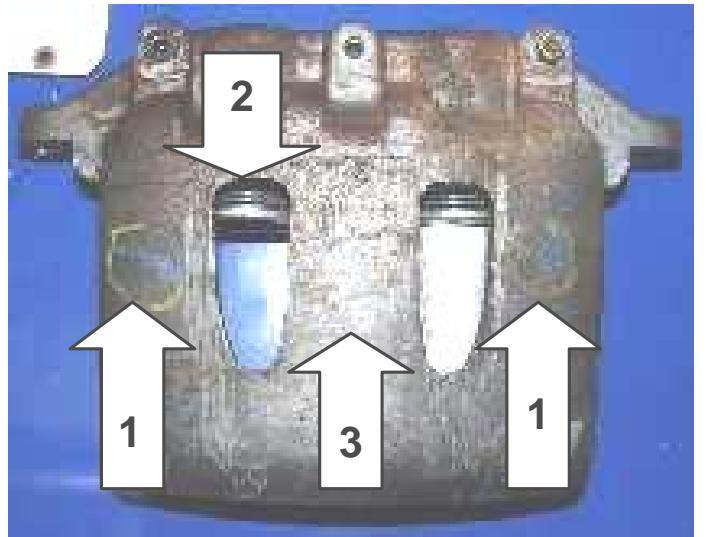
Figure 1 – Remanufactured Caliper Assembly

- 1. Remanufactured calipers will be identified. Typical locations for the "Reman" stamps are shown in figure 1, area 1.
- 2. Remanufactured calipers have light gray piston boots (Bosch OE boot is dark gray).
- 3. Remanufactured calipers typically are not plated (Bosch OE calipers have black plating).

2. Inspect and verify that the calipers are Bosch Original Equipment and not a remanufacture or non-Bosch product. **Refer to Figures 1 & 2.**

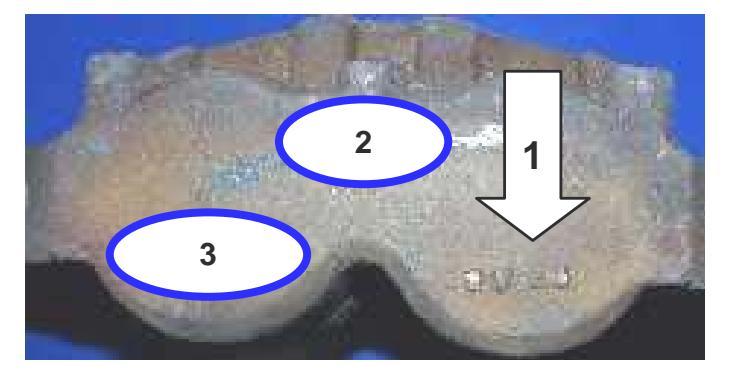
Figure 2 – Non-Bosch Product (clones or knock-off's)

- 1. Bosch OE calipers have nothing or only '66' or '73' cast into the housing in area 1.
- 2. Bosch OE calipers have "4153269" for 2x66mm or "4153222" for 2x73mm sizes) cast into the housing in area 2.
- Bosch OE calipers have a 4 digit code cast into the housing in area 3. Non-OE calipers DO NOT have this marking.

- 3. If the caliper *IS* a Bosch OEM caliper, proceed to step 5, *CALIPER INSPECTION PROCEDURE*.
- 4. If the caliper *IS NOT* a Bosch OEM caliper (if it is remanufactured or a non-Bosch product such as a clone or knock-off), proceed to step 29, *SLIDE PIN INSPECTION/REPLACEMENT PROCEDURE.*
 - NOTE: OE Service parts (such as piston boots, etc) are not interchangeable between the Bosch OE caliper and remanufactured or Non-Bosch calipers.

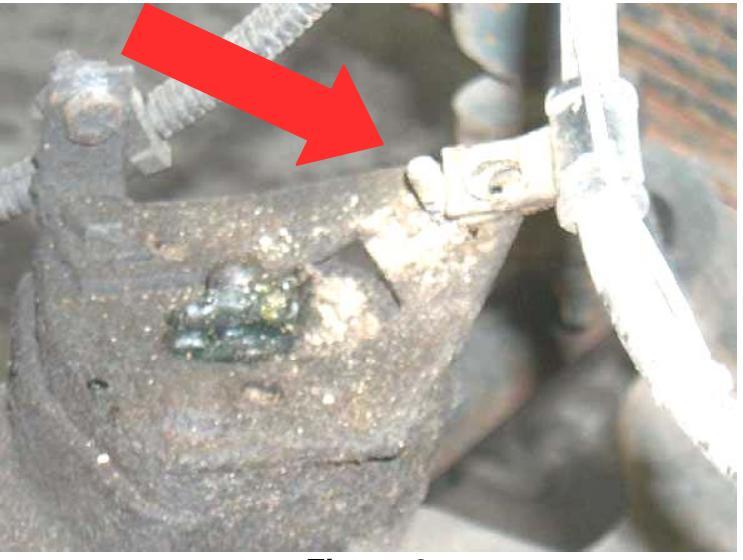
Figure 3

6. Remove any brake hose retaining fasteners as applicable. This allows the caliper to be rotated for piston boot inspection.

NOTE: Do not remove brake hose at the caliper inlet.

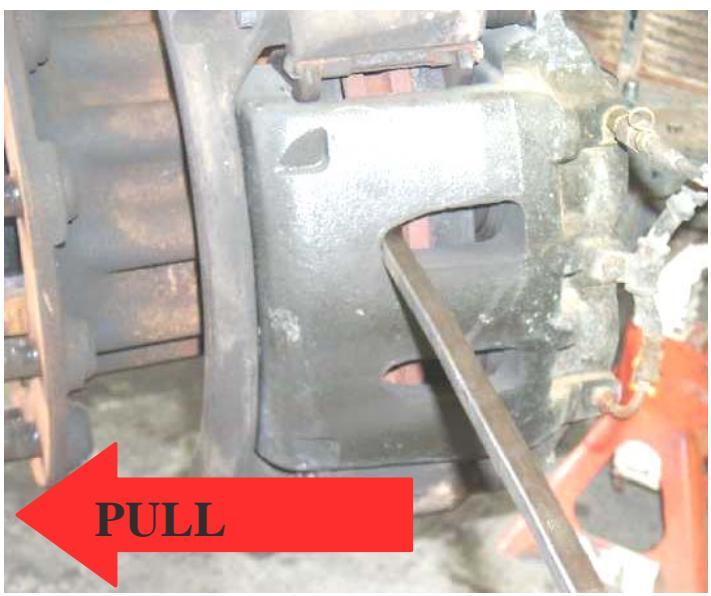
Figure 4

7. To retract pistons, place a suitable pry bar into one of the **rotor cooling fins** and pry caliper housing outboard (see arrow direction) until pistons are pushed back into housing.

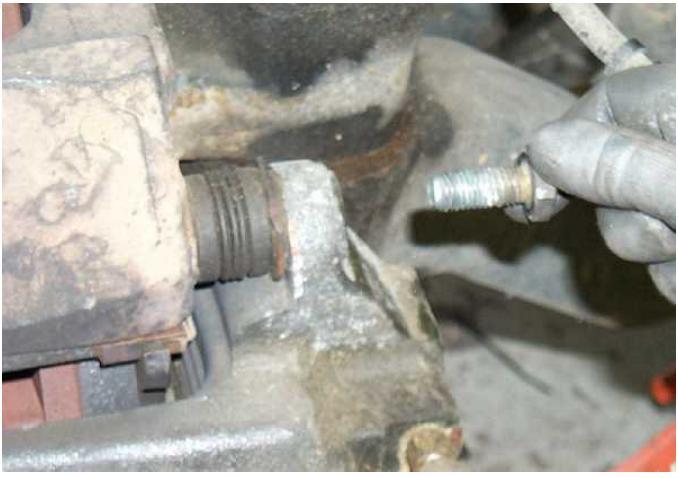
Figure 5

8. Remove upper (top) caliper mounting bolt securing the caliper to the anchor plate.

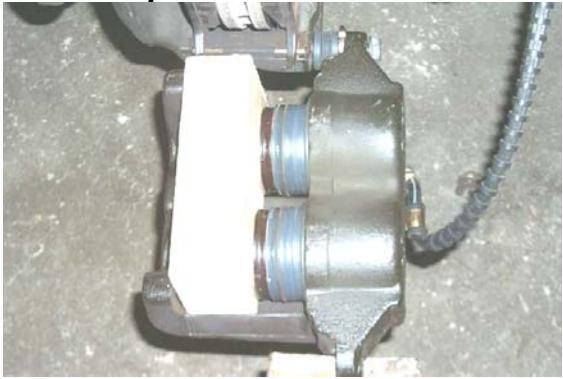
Figure 9

12. Place the spacer block provided in the generic tool kit into caliper housing between pistons and caliper legs. Depress brake pedal slowly and just enough to extend pistons to contact spacer.

NOTE: Use only block thickness indicated. Otherwise, pistons will extend too far and a high pressure brake fluid leak could occur resulting in personal injury.

If pistons are extended too far, DO NOT attempt to re-install pistons. Remove brake hose at the caliper, cap brake line and remove caliper assembly. Skip to step 29, SLIDE PIN INSPECTION REPLACEMENT PROCEDURE and in step 47 install a NEW caliper.

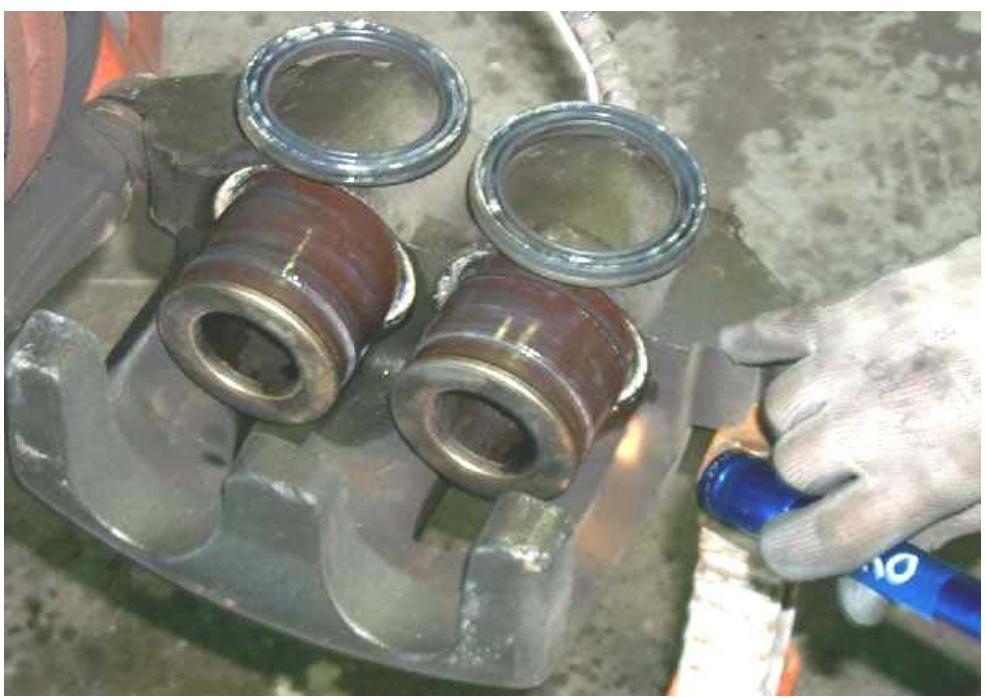
Figure 10

- 13. Remove both piston boots with a flat bladed screwdriver and discard.
- 14. Using shop light or flashlight, inspect caliper housing bore near piston area for corrosion. Inspect entire circumference around piston. Also inspect piston for any indication of deterioration such as cracks or crumbling.

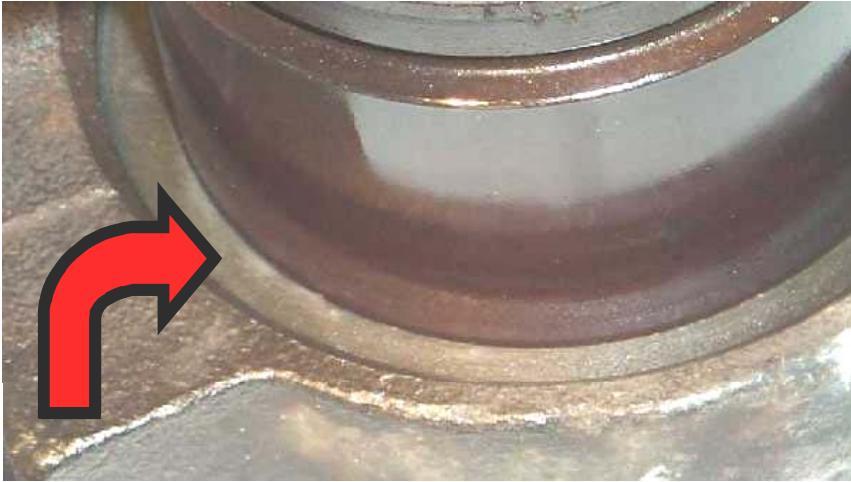
Figure 11 – No Corrosion

- 15. Inspect caliper housing for seal land corrosion.
- NOTE: The pistons are made from a phenolic material and are is naturally brown in color. This should not be confused with any corrosion color.

If there is NO CORROSION PRESENT, please continue on to step 16 – PISTON BOOT INSTALLATION PROCEDURE.

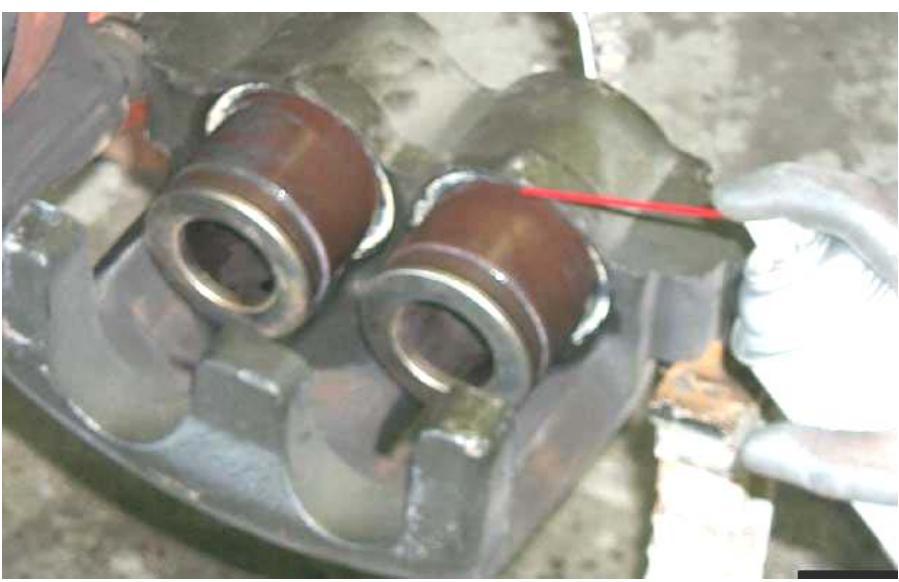
Figure 13

NO COMMERCIALLY AVAILABLE BRAKE CLEANERS ARE TO BE USED; OTHERWISE, PART COULD BE DAMAGED AND RESULT IN THE LOSS OF BRAKING.

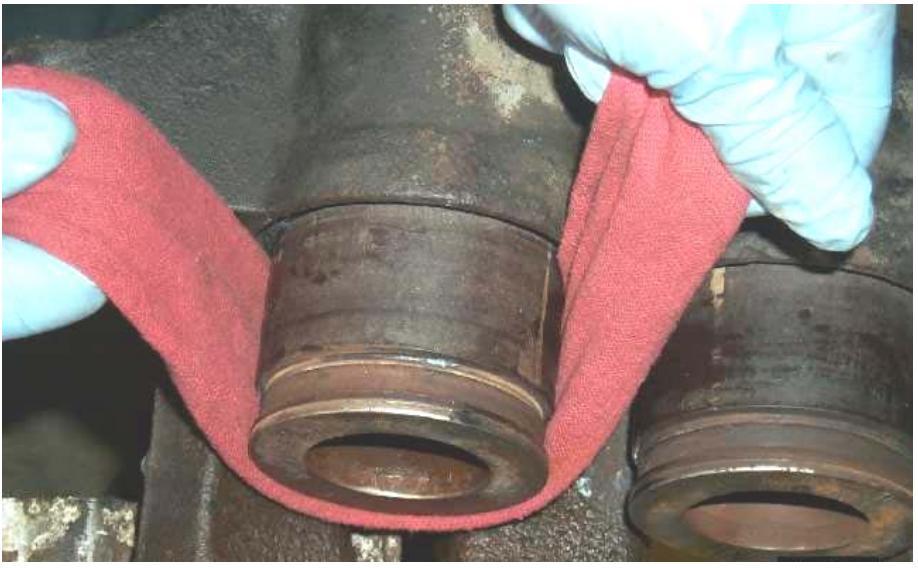
Figure 14

17. Use a clean, lint free shop cloth and wipe pistons and caliper housing bore area.

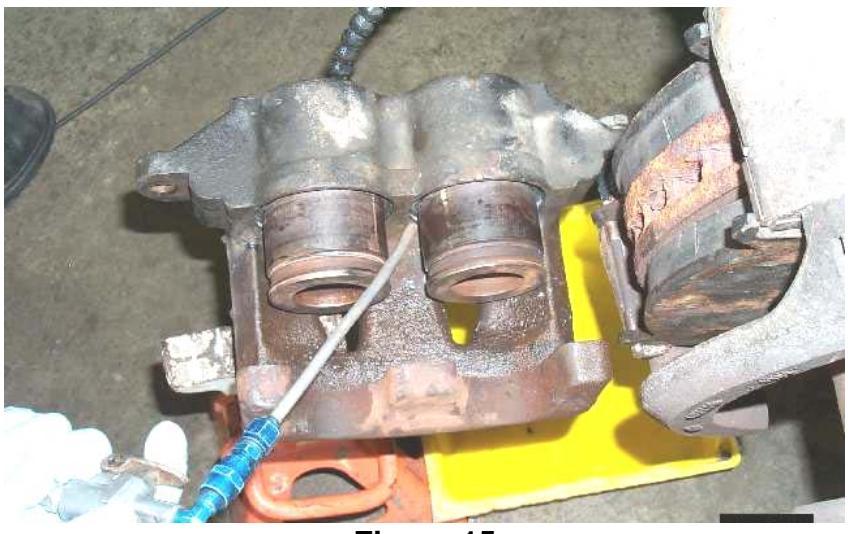
Figure 15

18. CAREFULLY air-dry pistons and caliper bore area with low pressure shop air.

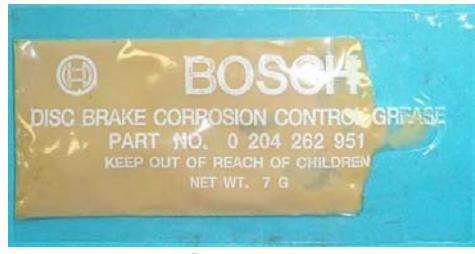
Figure 16

19. Using an acid brush from the piston boot replacement kit (8900127R91 for 66mm or 8900129R91 for 73mm), lubricate pistons and caliper housing bore area with Disc Brake Corrosion Control Grease.

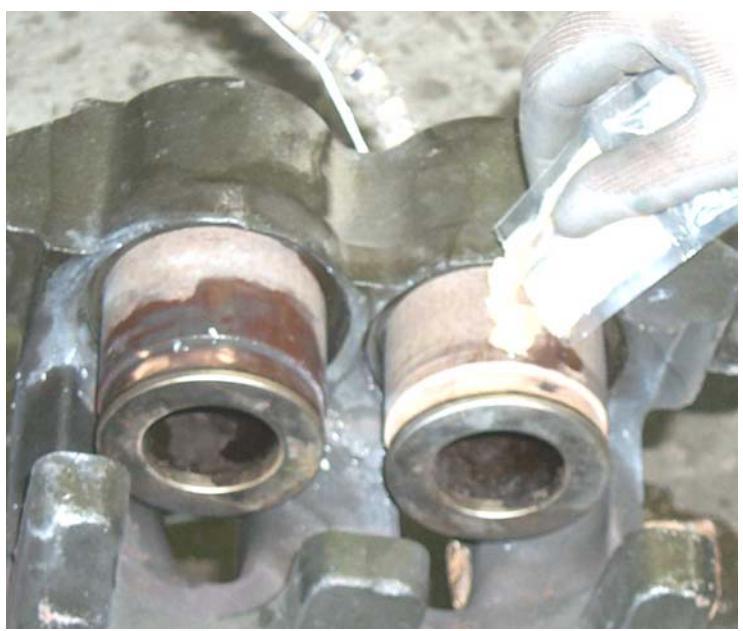
Figure 17

- 20. Place a small amount of Disc Brake Corrosion Control Grease onto the piston.
 - NOTE: One (1) packet is to be used for BOTH pistons and bores of one caliper.

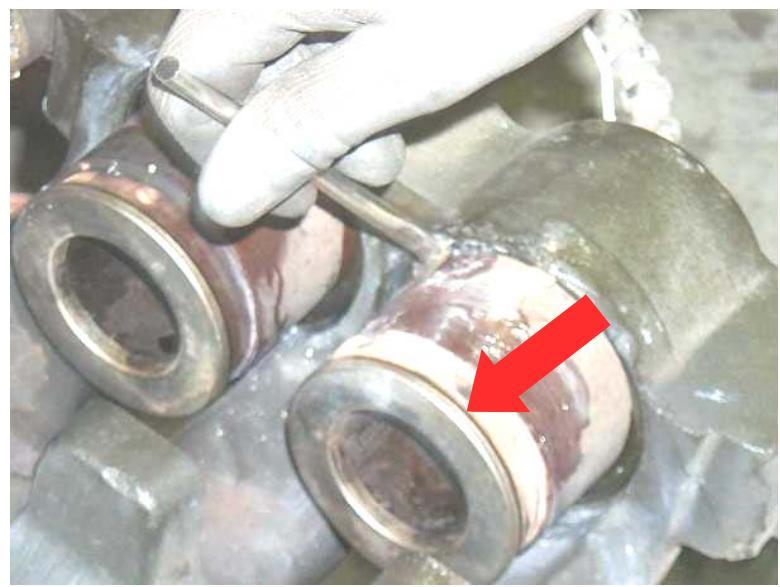
Figure 18

21. Start at the caliper housing opening as shown and work up the piston stopping at the piston boot groove. Spread grease uniformly. Use of a flashlight and/or dental mirror to ensure uniform distribution on underside (caliper top side) of each piston, may be required.

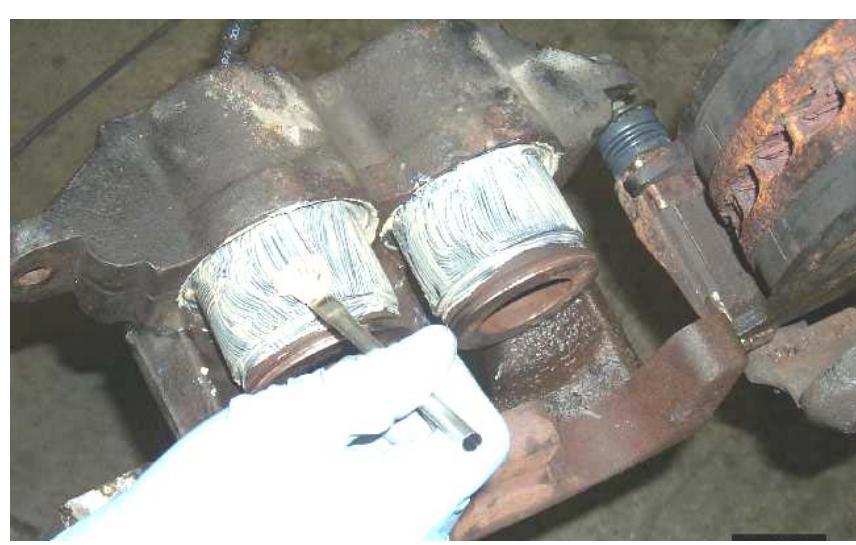
Figure 19

22. End at the piston boot groove, as shown.

NOTE: Use care while spreading grease to avoid getting any debris on newly greased surfaces.

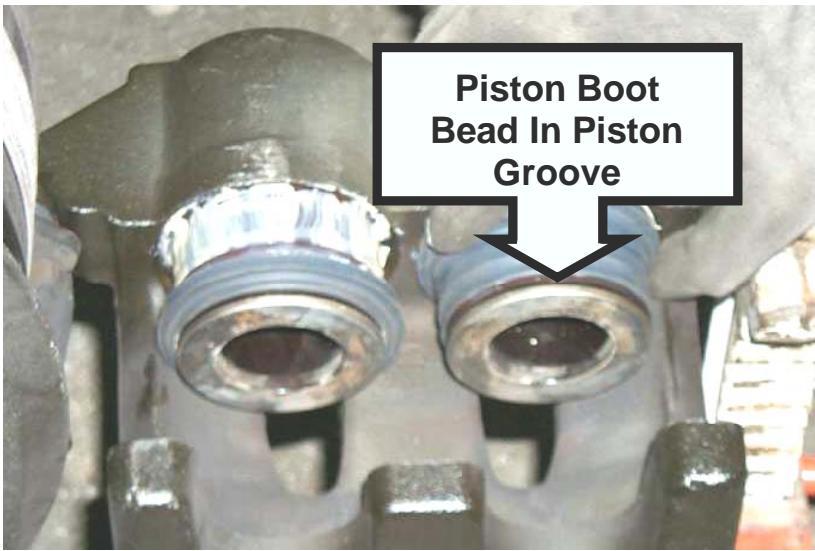
Figure 20

23. Inspect new piston boots provided in the piston boot replacement kit for cuts, tears or damage. If damaged, discard and use a new Piston Boot Kit. Carefully install new piston boots.

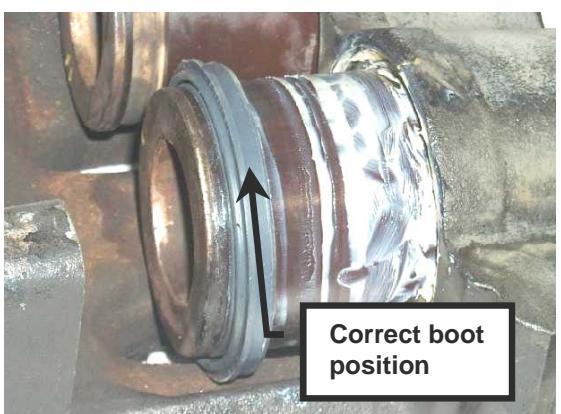
Figure 22

24. Carefully move the free end of the boot back to the bead end of the piston so that the boot folds up correctly. Rotate the piston boot to firmly seat in piston boot bead in groove.

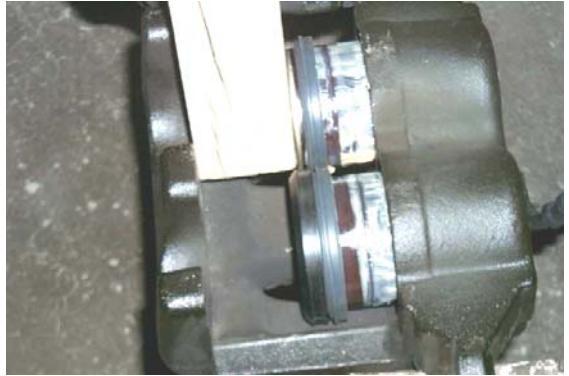
Figure 23

25. To reinstall the piston and seat piston boot into caliper, use the insertion tool from the generic tool kit.

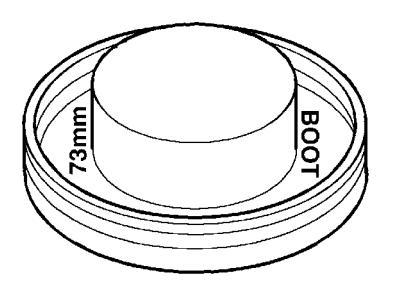
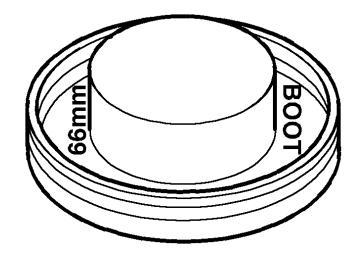
Figure 24

NOTE: Proper piston boot installation tool and tool orientation must be observed.

73mm Piston Boot Insertion Tool.

66mm Piston Boot Insertion Tool.

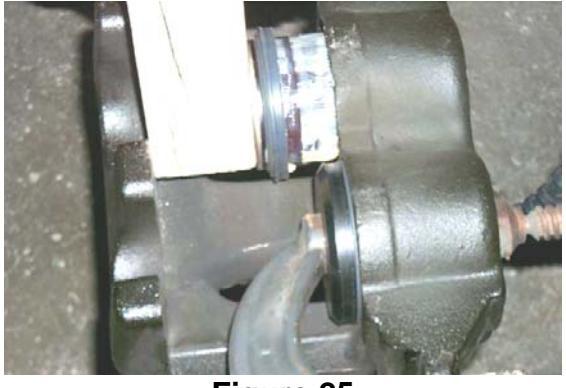
Figure 25

26. Insert spacer block in front of one piston to keep it in place. Center piston boot insertion tool onto opposite piston and boot. Slowly tighten C-clamp to insert this piston completely into housing.

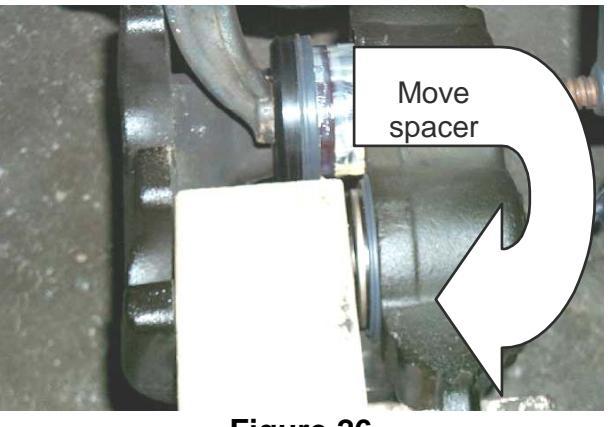
Figure 26

- 27. Move spacer block to the inserted piston position to keep the inserted piston from being pushed out when the second piston is being pushed into the bore.
- 28. Center piston boot insertion tool onto opposite piston and boot. Slowly tighten C-clamp to insert the 2nd piston completely into housing.

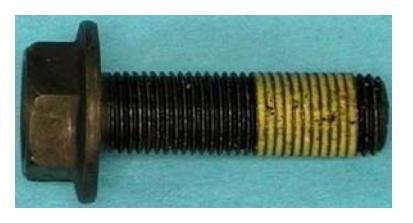
Figure 28

31. If the bolt is fine thread as shown, proceed to step 40.

ZOH-T Bolt: flange head, dark in color, fine thread, may have thread patch as shown (M12x1.25x40).

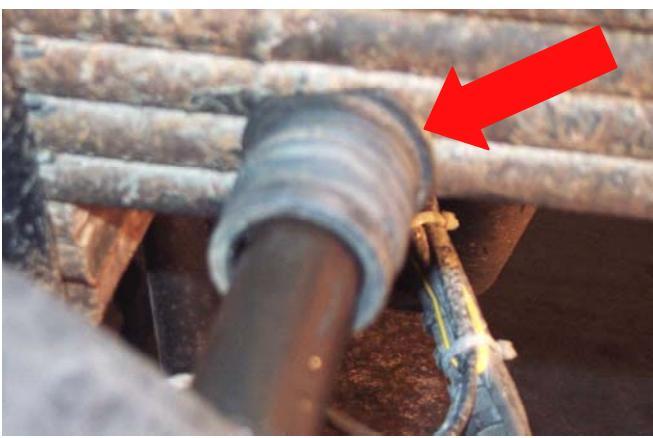
Figure 29

34. On some rear axle applications, one of the caliper slide pins cannot be removed without removal of the anchor plate. DO NOT REMOVE ANCHOR PLATE AT THIS TIME.

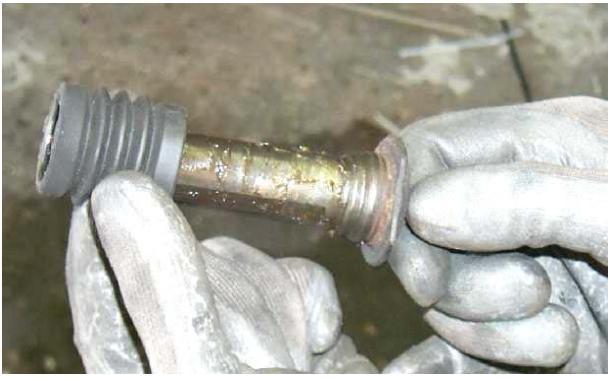
Figure 30

- 35. Inspection of REAR axle guide pin which *cannot* be readily removed from the anchor plate (NOTE: For REAR axle guide pins which can be removed, continue to step 46).
 - a. Pull the caliper guide pin out as far as possible and cut off boot.
 - b. Use clean cloth dampened with isopropyl or denatured alcohol to clean pin and air dry with low pressure shop air.

- c. Inspect caliper guide pin for corrosion using Figure 32.
- 36. For all caliper guide pins that can be removed, remove and discard guide pin boots.

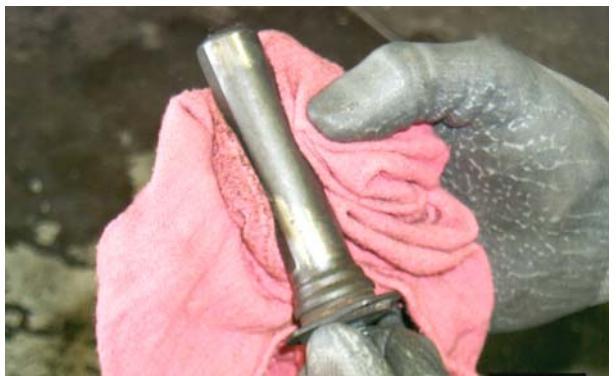
Figure 31

37. Using isopropyl or denatured alcohol, clean and wipe pins dry with clean shop cloth. See warning in step 16.

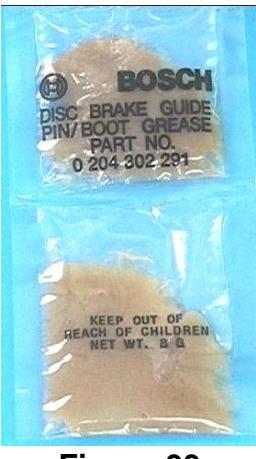
Figure 33

39. Disc Brake Guide Pin/Boot Grease for the anchor plate pin bore, caliper slide pin and pin boot, is contained in a two chamber packet. One chamber of the grease packet is used for each anchor plate bore/guide pin/pin boot combination.

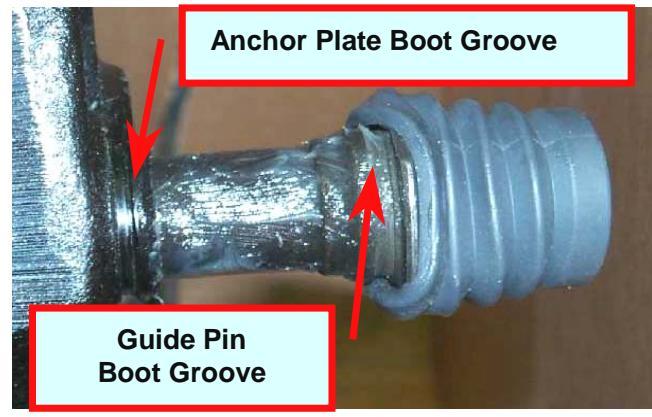
Figure 34

- 40. For **REAR AXLE** guide pins which **cannot** be removed due to suspension interference AND **do not** exhibit corrosion:
 - a. Lubricate guide pin in anchor plate bore.
 - b. Carefully install new boot over pin flange and seat boot into groove.
 - c. Push guide pin into anchor plate bore and seat boot onto anchor plate boot groove.

NOTE: Verify that boot was NOT torn during installation.

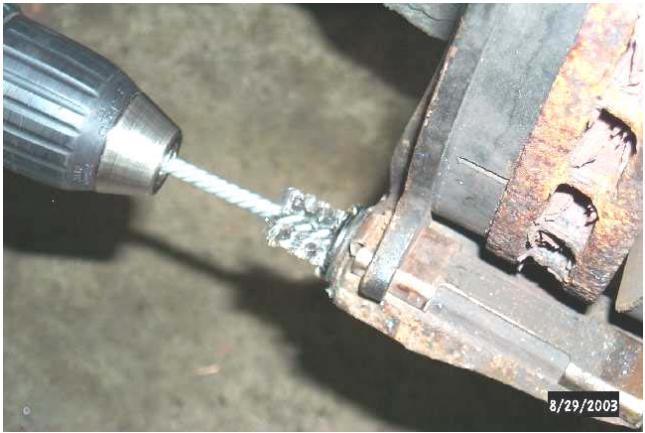
Figure 35

41. Cleaning and lubrication of anchor plate bores. Using round wire brush found in generic tool kit and isopropyl or denatured alcohol, wire brush both upper and lower anchor plate pin bores. Clean out any remaining loose residue with a clean shop cloth or swab. Carefully, air dry pin bores.

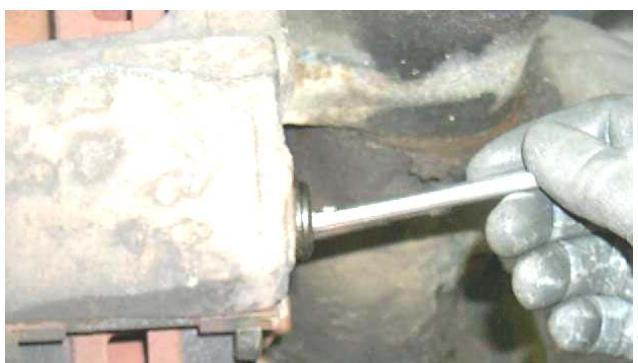
Figure 36a – Anchor Plate Bore

42. Only for pins removed from anchor plate bores, use the acid brush from the guide pin boot replacement kit, carefully grease anchor plate bore, caliper mounting pins, and pin boot beads with Disc Brake Guide Pin / Boot grease.

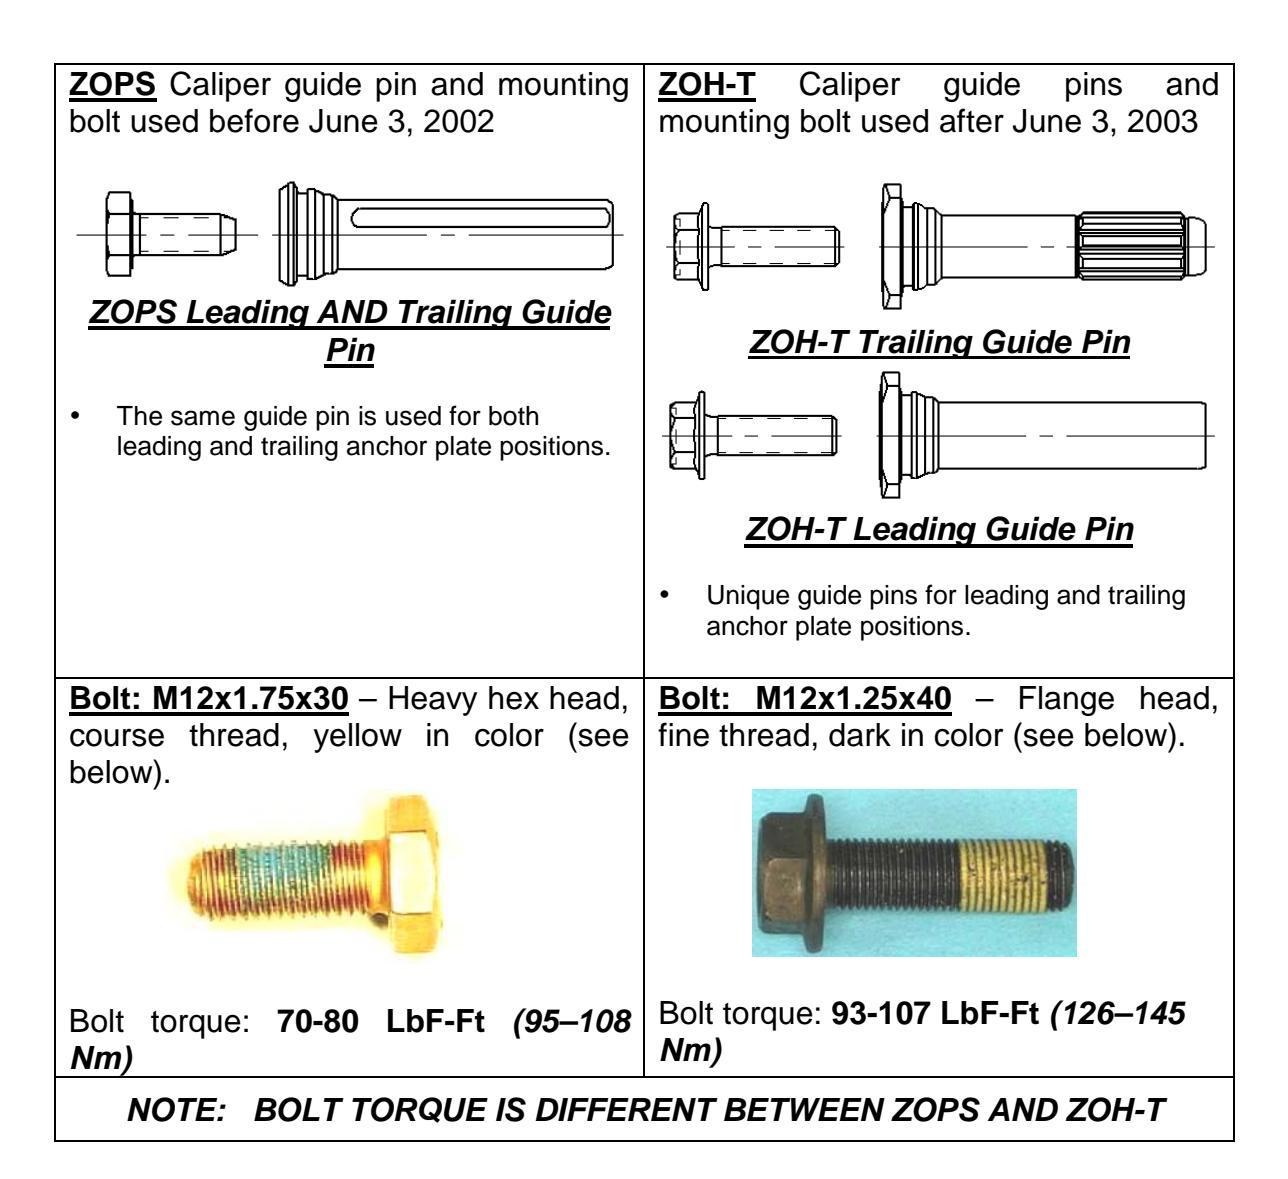
Figure 38 -- ZOPS and ZOH-T Caliper Guide Pins & Mounting Bolts

After re-inserting guide pins and boots, clean pin flange face and internal threads with clean cloth and denatured or isopropyl alcohol. Air dry.

- 49. Torque the LEADING bolt completely to torque value indicated in Figure 38.
 - a. For ZOPS (early design) bolt & pin, use a medium to large flat blade screwdriver under the pin flange to keep it parallel to the caliper abutment during bolt tightening.
 - b. For ZOH-T (later design) bolt & pin, screwdriver is not required.

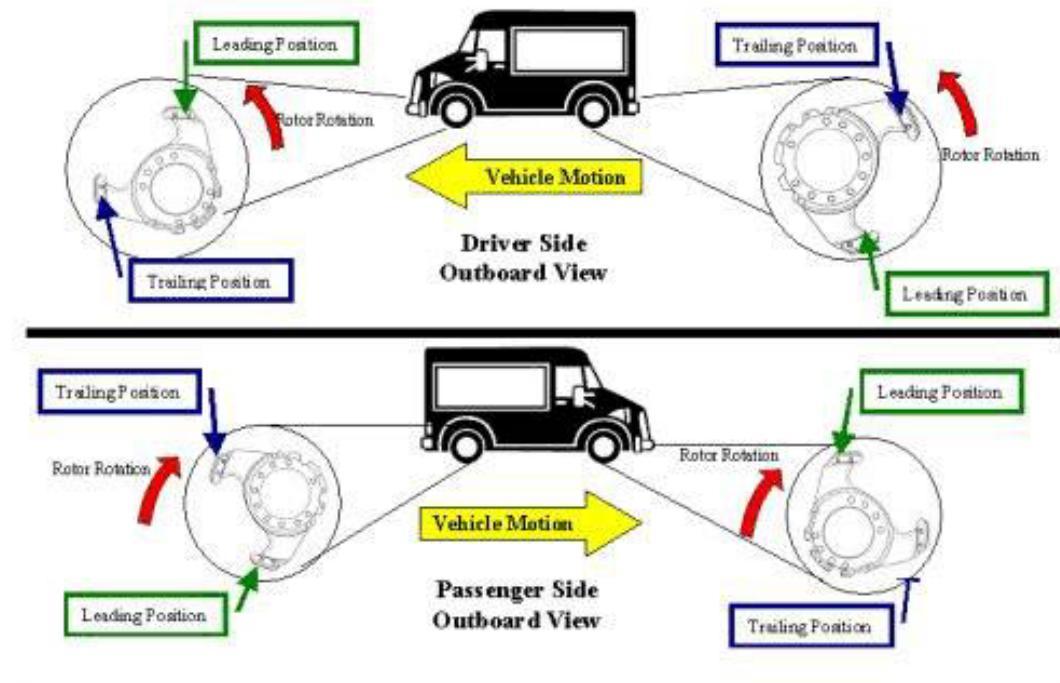
Figure 39

- 44. Definition of leading and trailing positions:
 - a. Rotor rotation is for a vehicle moving forward.
 - b. View rotor from outside of vehicle.

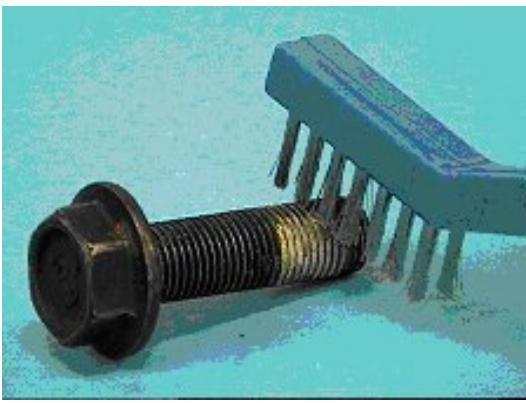
Figure 40

45. <u>**Re-using caliper mounting bolts**</u>. When re-using the caliper mounting bolts, wire brush the lower half of both caliper mounting bolts and clean with isopropoyl or denatured alcohol and air dry.

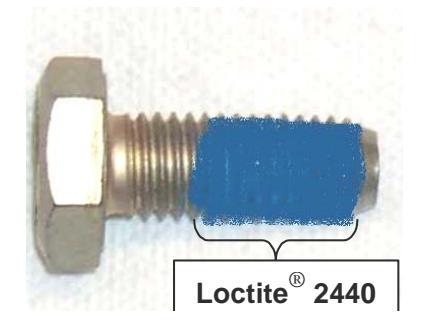
Figure 41

- 46. On the lower half of each bolt, apply liquid Loctite[®] 2440 around the circumference of the bolt.
 - NOTE: This procedure does not apply when using new bolts in guide pin replacement kit because a Loctite[®] thread patch is already applied.

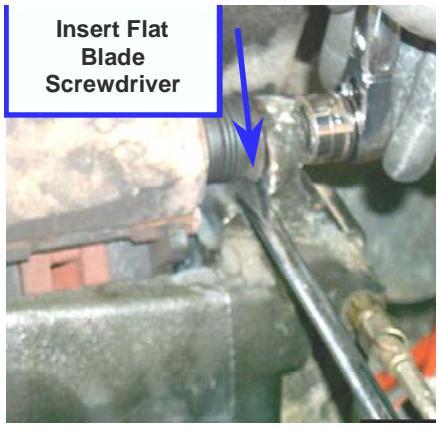
Figure 42

CAUTION: Do Not Allow Screwdriver To Puncture Boot.

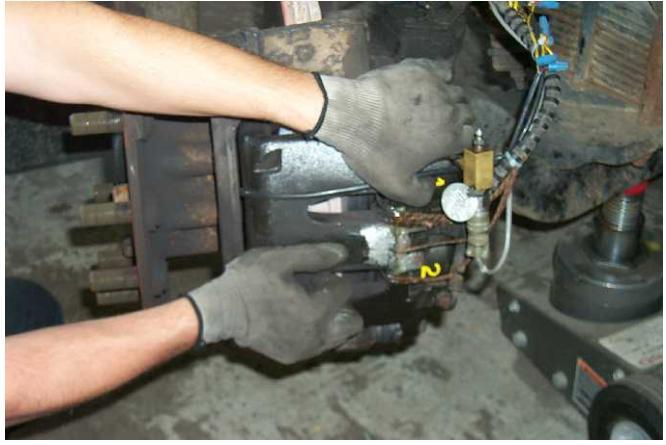
Figure 43

- 53. **For ZOPS Style Pins:** Check that the caliper slides on guide pins. Place hands on the caliper as shown, push / pull caliper and check that the caliper assembly slides on the guide pins.
 - a. If the ZOPS caliper assembly slides on guide pins STOP. Inspection and repair procedure for this wheel end is complete.

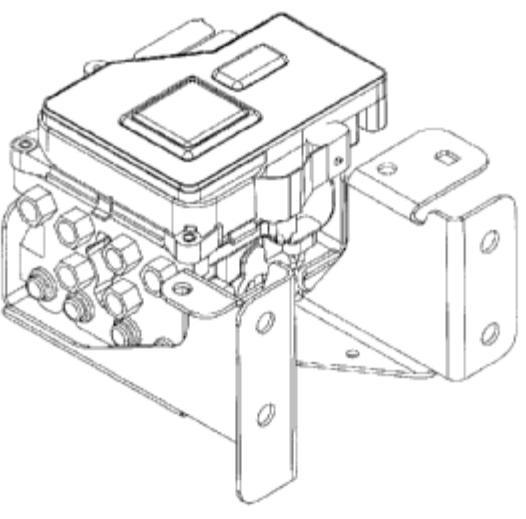
Figure 1

- 1. Disconnect the negative battery terminal.
- 2. Locate the EHCU assembly on the driver's side frame rail.

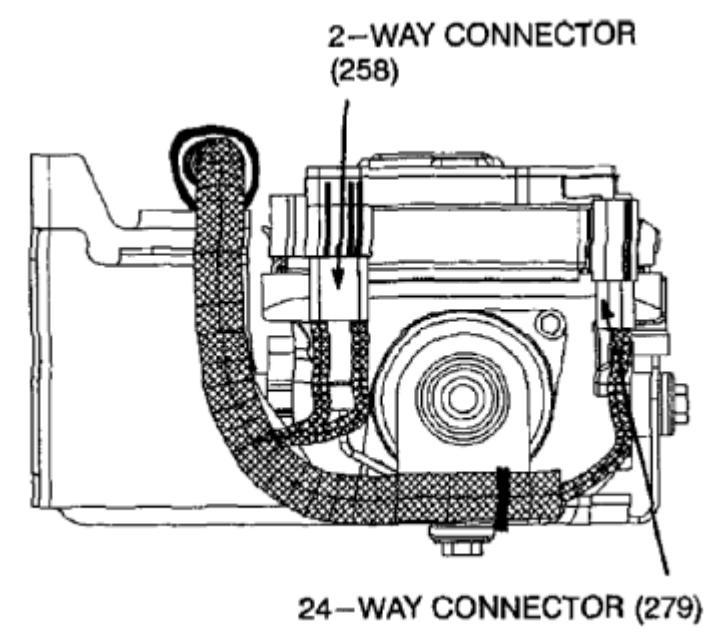
Figure 2 -- View from Rear of Vehicle

- 3. Remove dirt from the EHCU assembly with a dry soft brush or cloth. Blow loose particles and dust away with low-pressure shop air. **Do not use water or chemical cleaners.**
- 4. Disconnect the 2-way and 24-way connectors from the ECU.

IMPORTANT: Avoid touching the pins of the electrical connectors on the ECU. Damage could occur, due to electrostatic discharge.

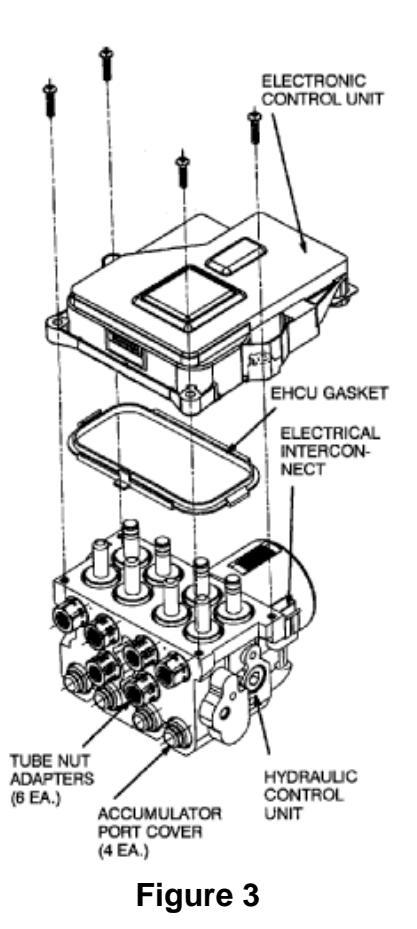
- 5. Disconnect the 2-way connector from the electrical interconnect between the ECU and HCU (it is located on the side of the EHCU that was next to the frame rail).
- 6. With a small hammer, lightly tap the four T-25 Torx® bolts which fasten the ECU to the HCU. Remove the bolts cautiously, so as to ensure they are not broken during removal.
 - a. If bolts cannot be removed due to corrosion, or stripped heads, or if they become broken off, replace entire EHCU assembly. This is the only condition in which EHCU assembly replacement will be necessary.
 - Refer to Master Service Manual for proper EHCU removal and re-installation instructions.
 - IMPORTANT: Do not pry on the ECU or HCU with a mechanical aid. Excessive force will cause damage to the units.

7. Carefully remove the ECU from the HCU. A light amount of force may be required. Ensure no dirt falls into the HCU.
