Report Author: Michael Huhn (IIC)

1. Event Summary

Location: Newport, Oregon Date: December 23, 2017 Aircraft: AirCam Registration: N959M NTSB Number: WPR18LA055

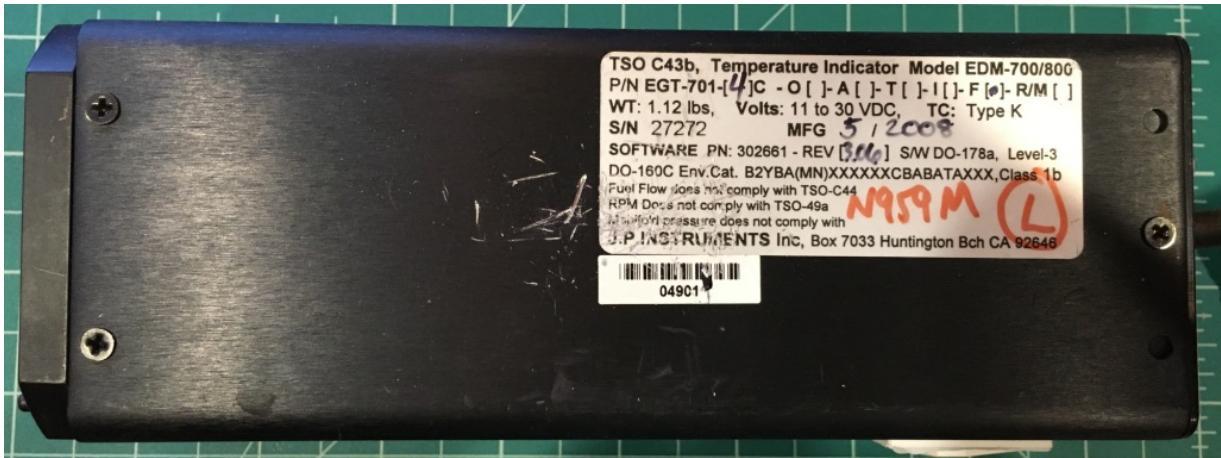
Figure 1 - JPI EDM 700 (Left Engine)

The device appeared to be undamaged, but when functionally checked some of the LED display bars on the instrument face were inoperative. This did not preclude download of the data. The device memory contained 36 power cycles; each power cycle typically, but not always, represents a discrete flight. The first power cycle was auto-assigned by the device as #983, dated 8/4/2017. The last power cycle (the accident flight) was #1018, dated 12/23/2017.

The accident flight duration, as determined by the device, was 1.83 hours, and began at a device time of 20:56:48. Parameter plots are presented in Section 6 of this report.

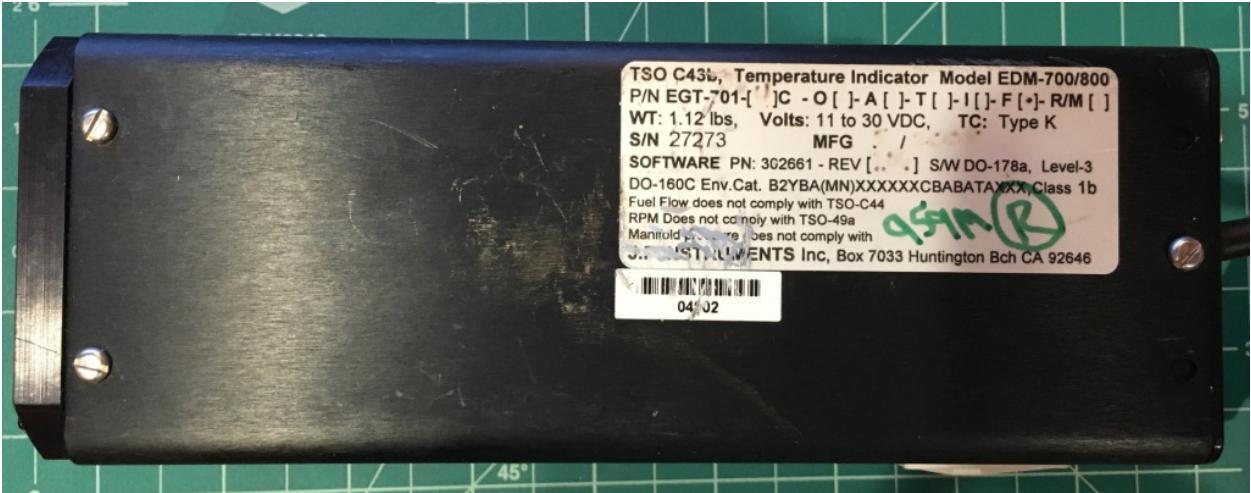
Figure 2 - JPI EDM 700 (Right Engine)

The device appeared to be undamaged, but when functionally checked some of the LED display bars on the instrument face were inoperative. This did not preclude download of the data. The device memory contained 37 power cycles; The first power cycle was #984, dated 8/4/2017. The last power cycle (the accident flight) was #1020, dated 12/23/2017.

The accident flight duration, as determined by the device, was 1.83 hours, and began at a device time of 21:46:04. Parameter plots are presented in Section 6 of this report.

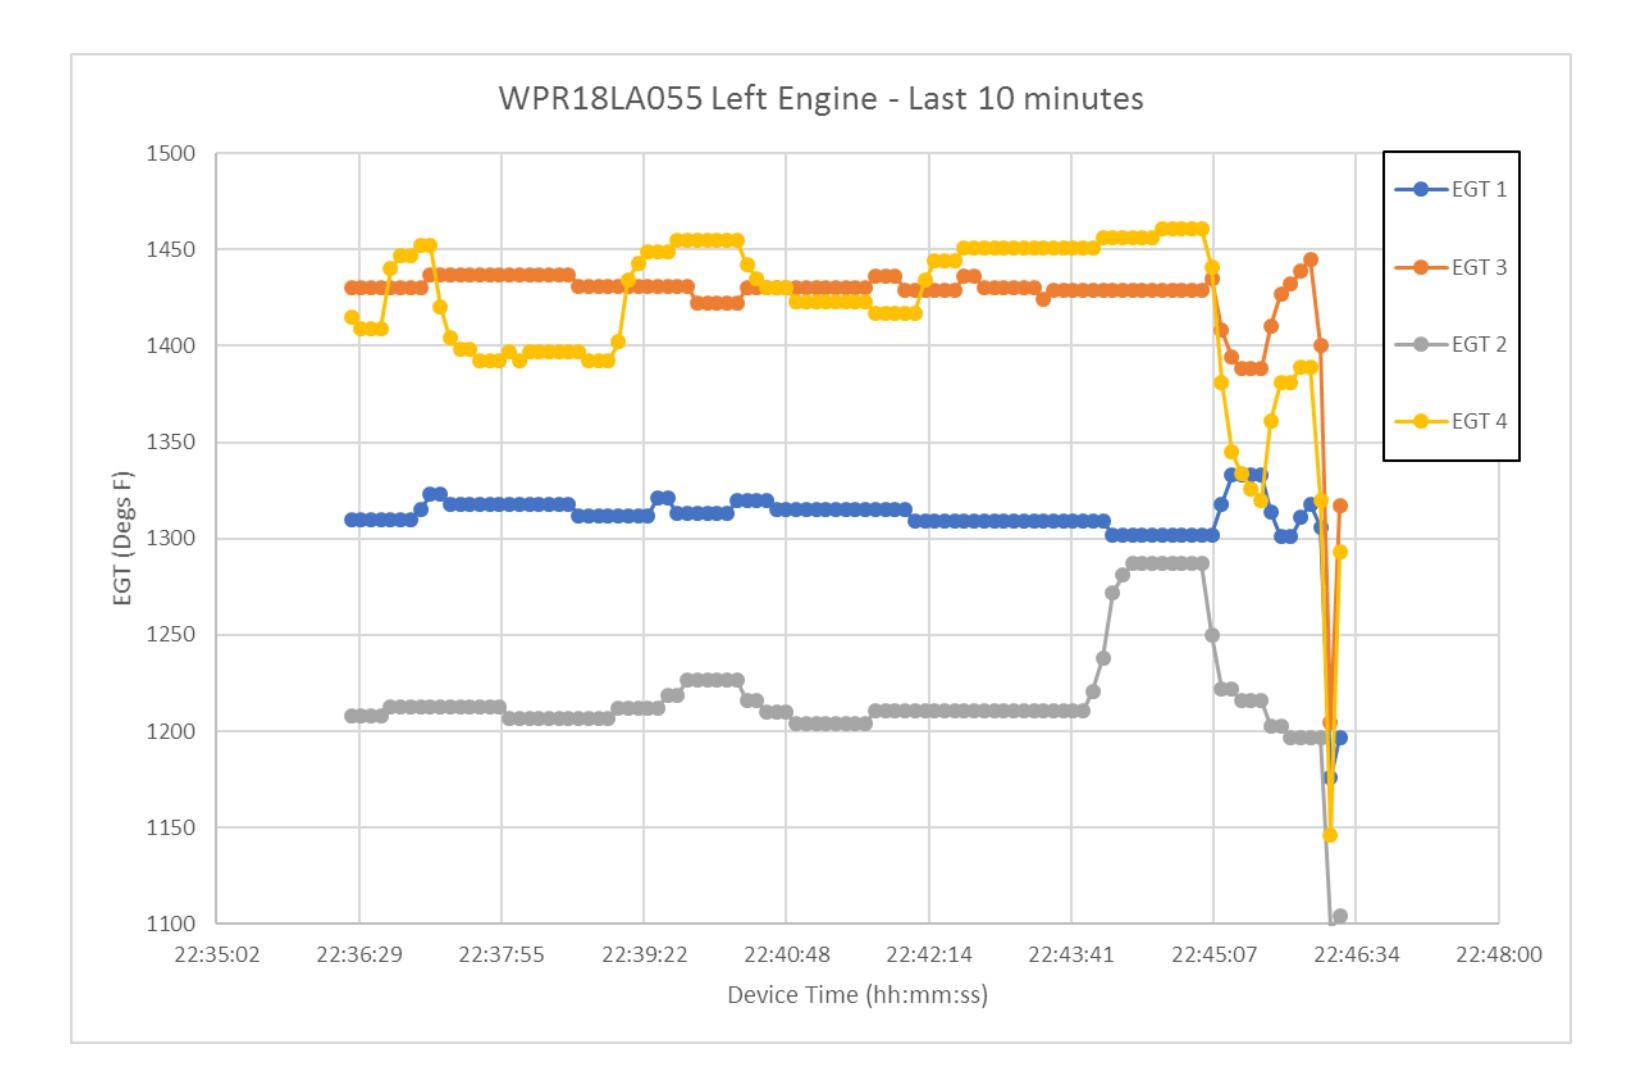
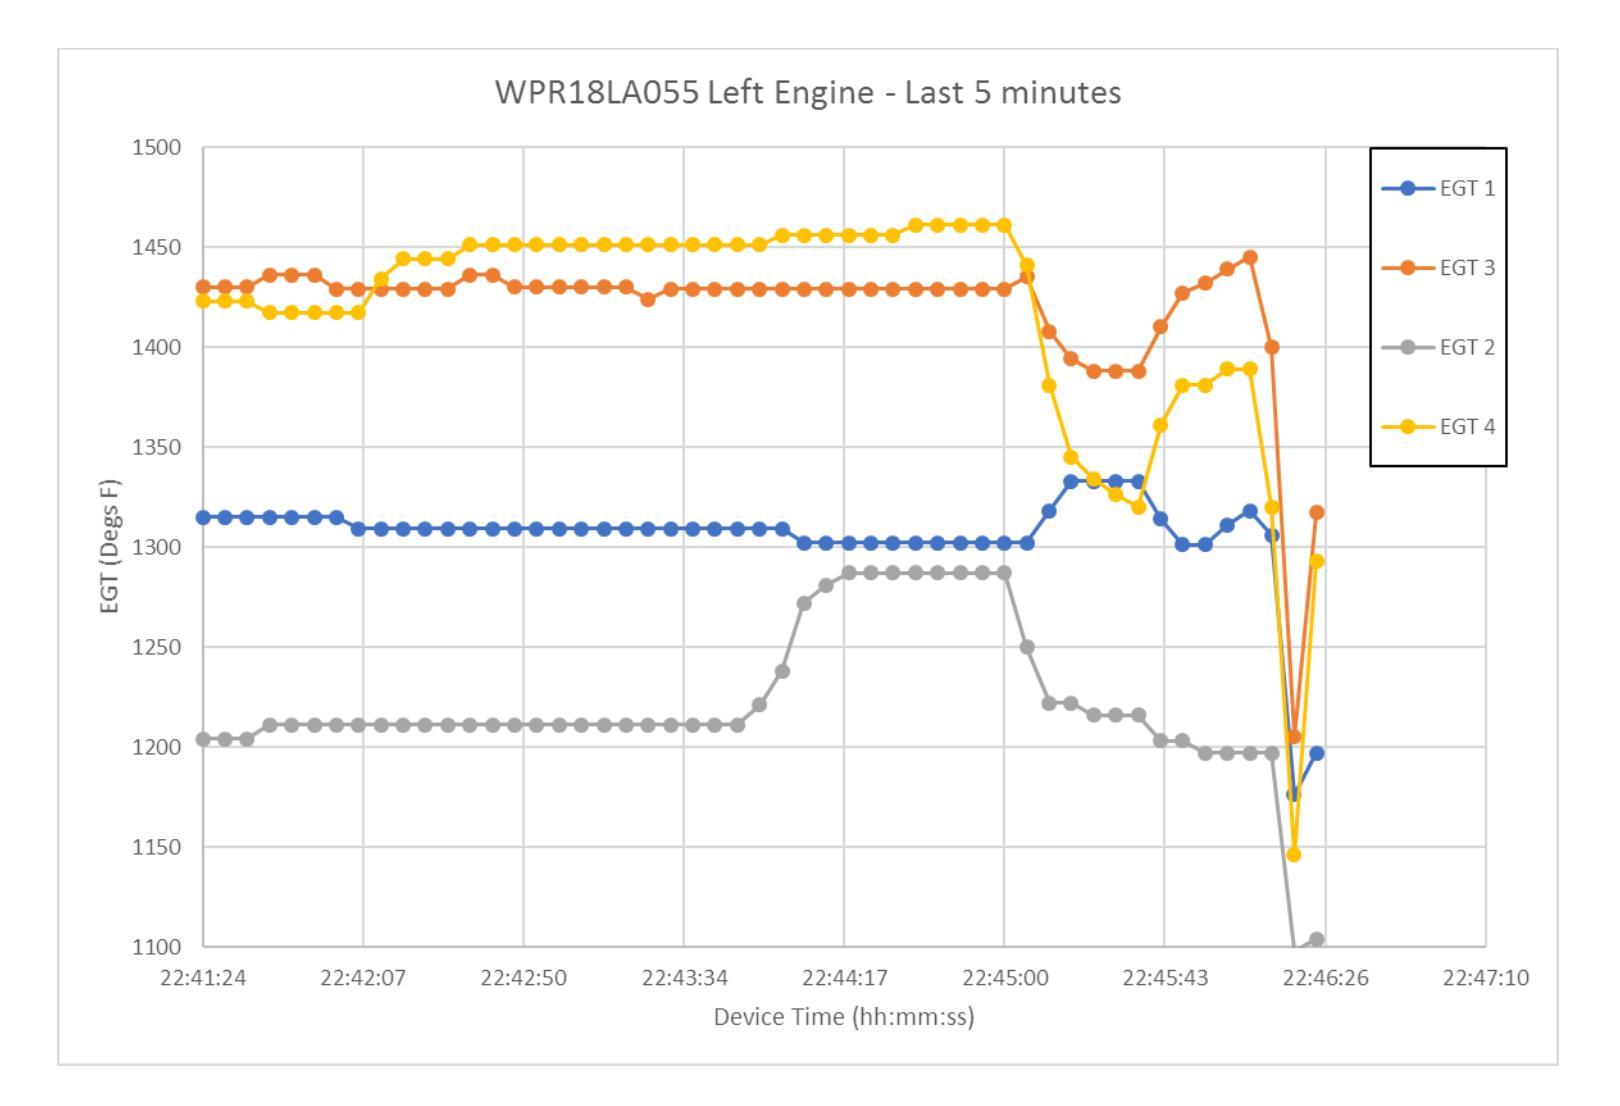
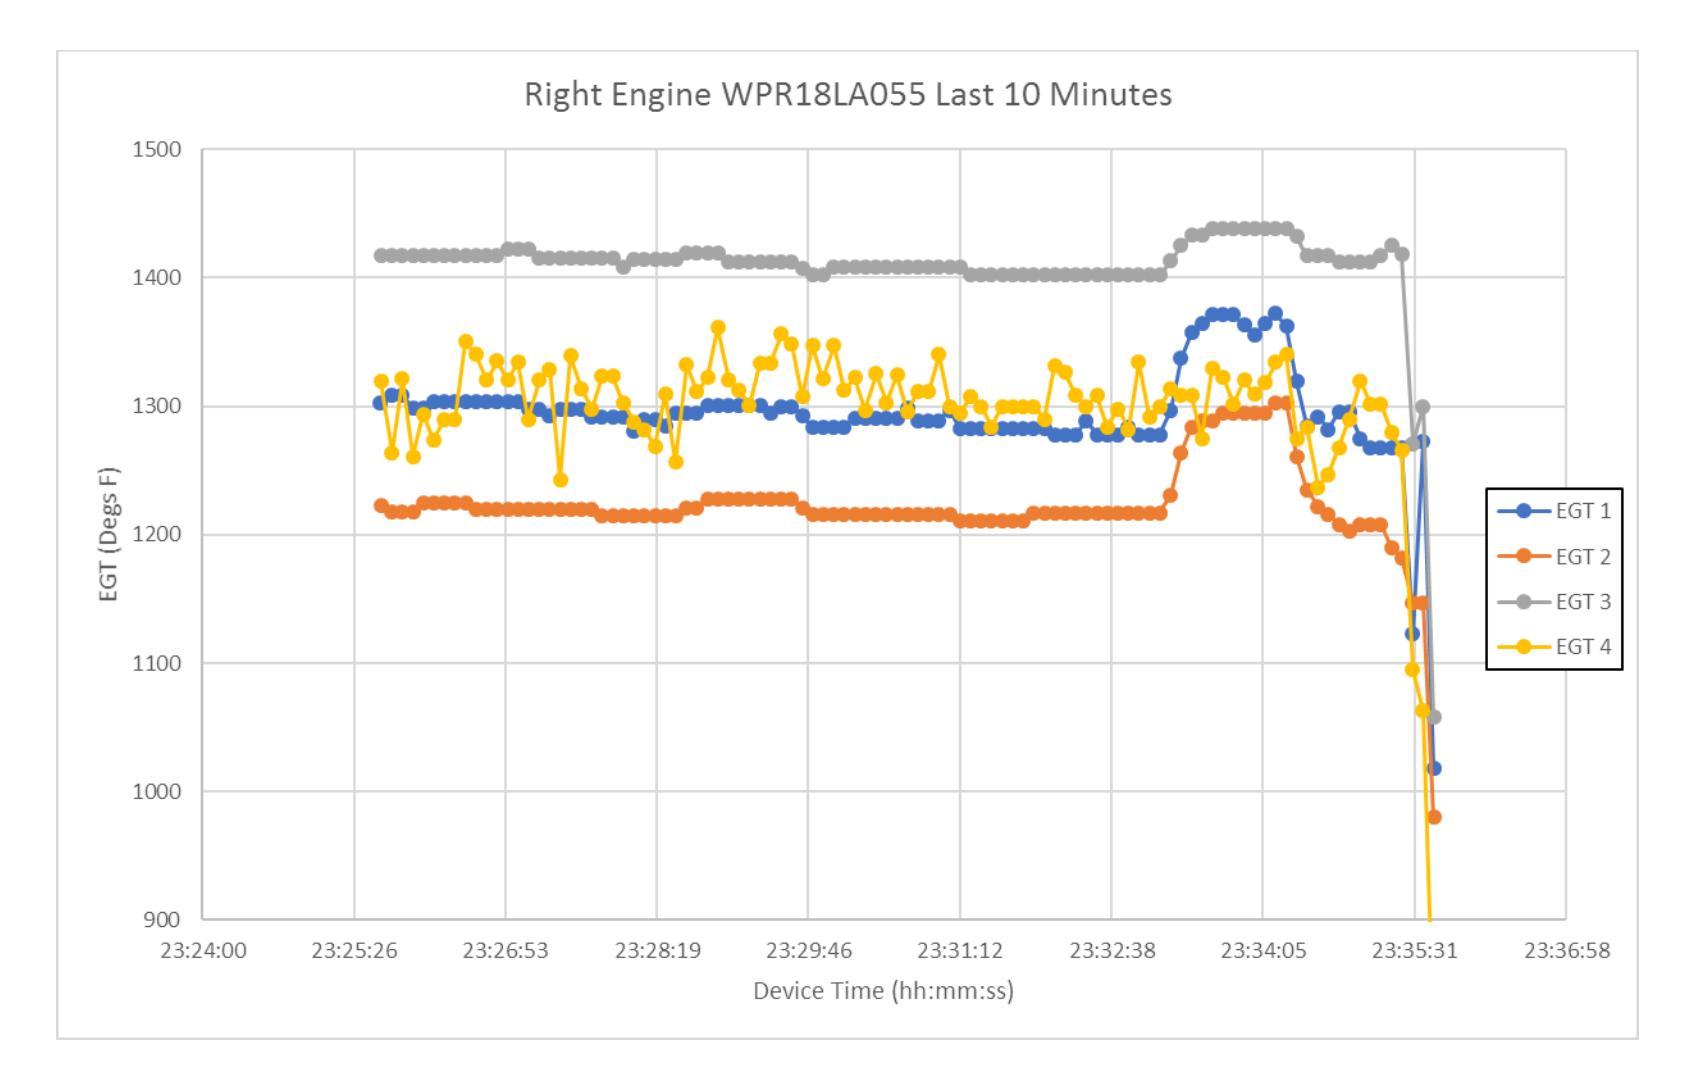
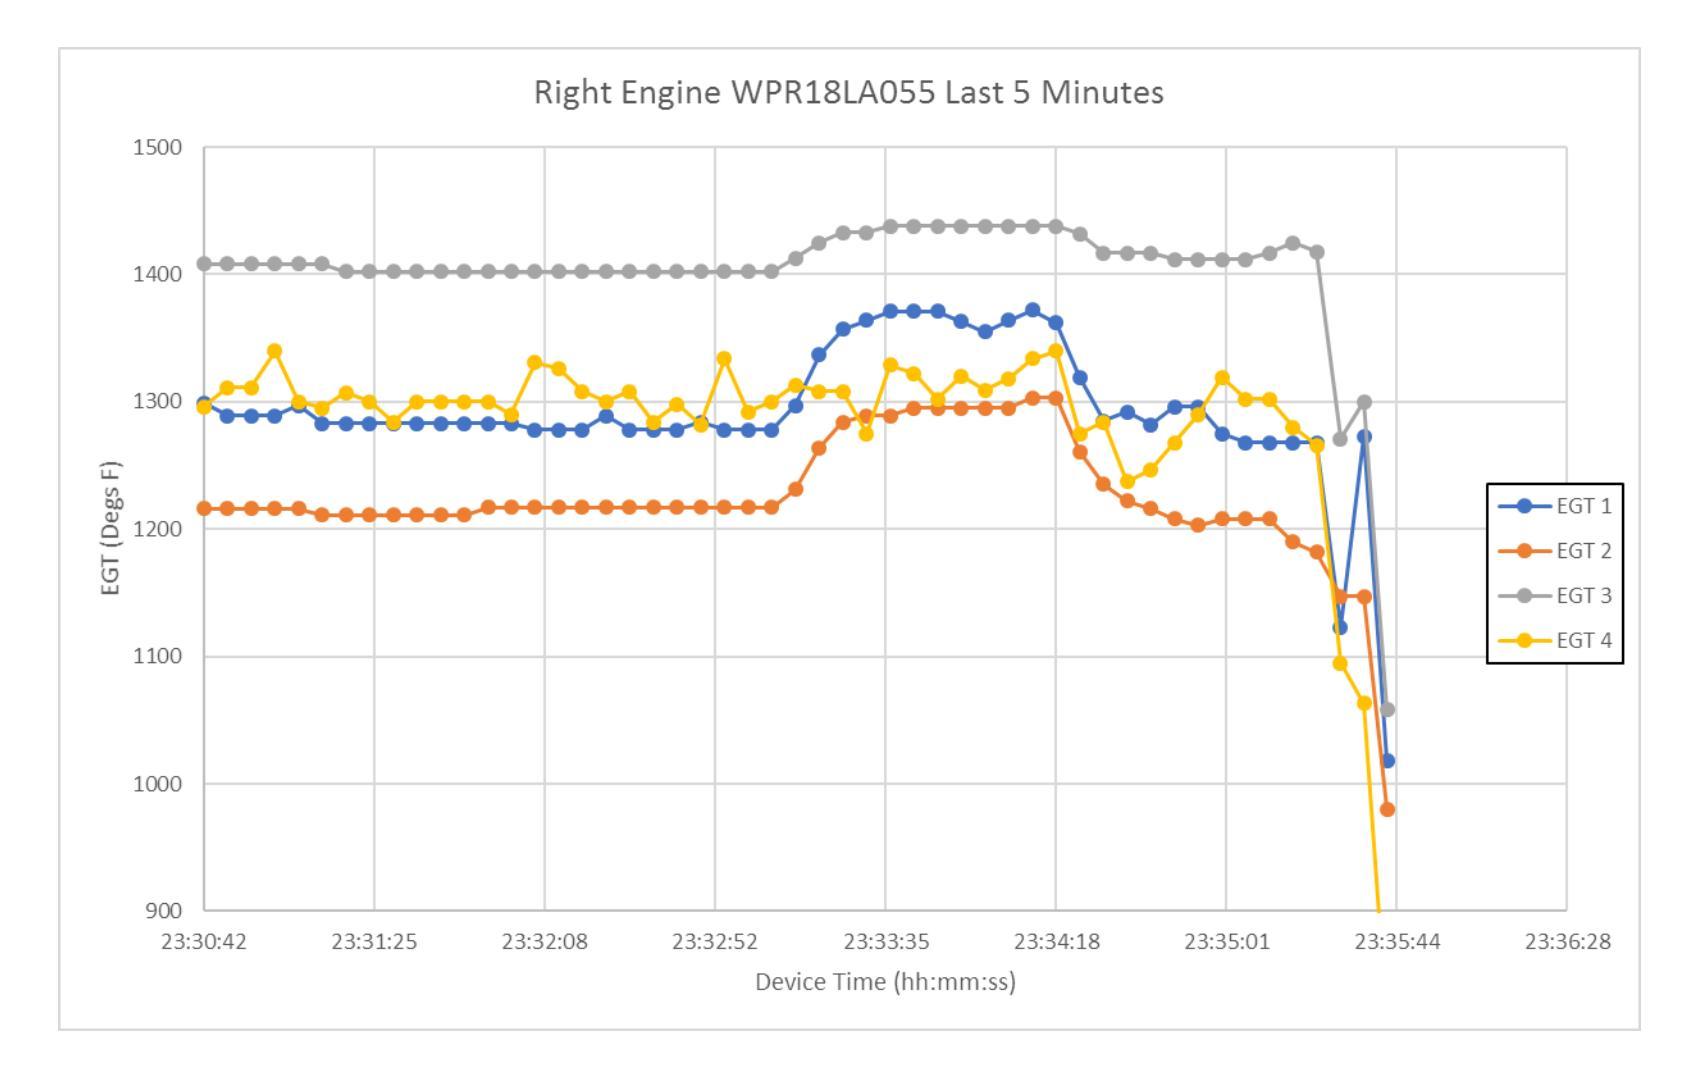
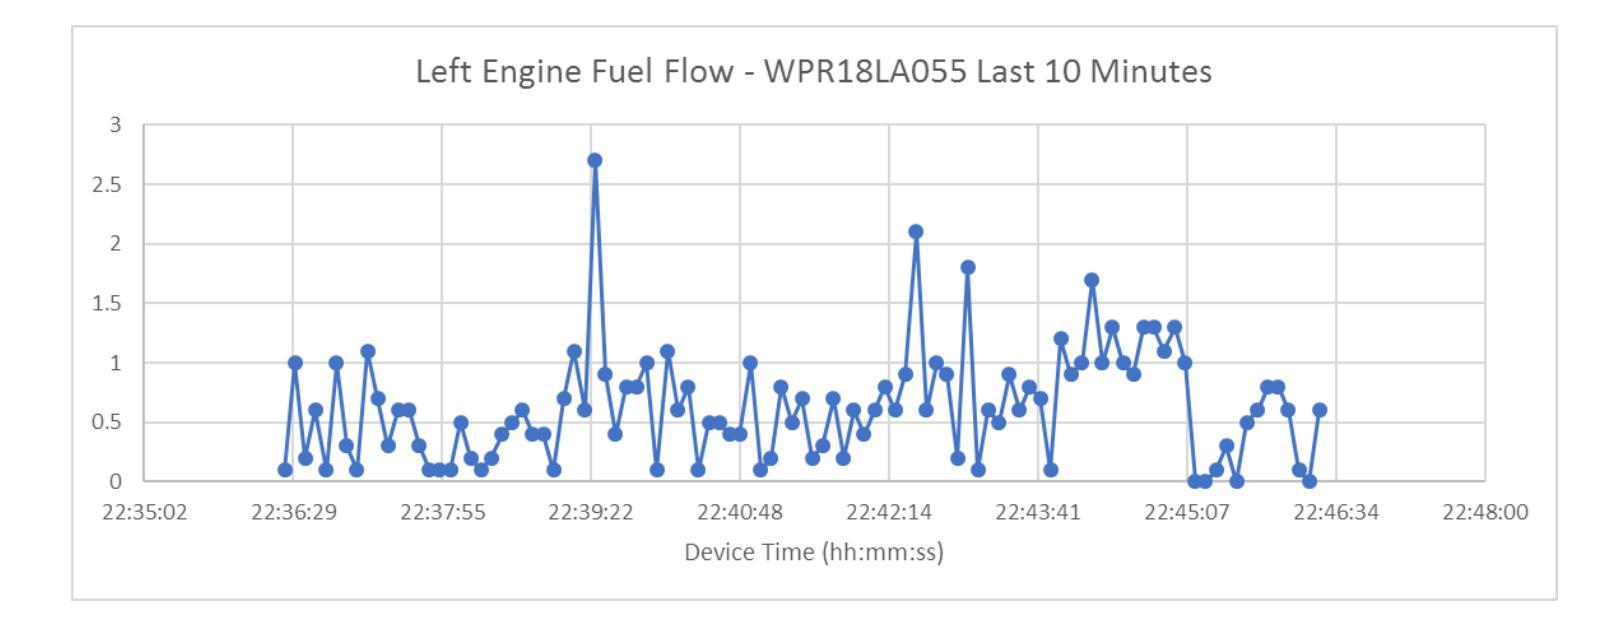
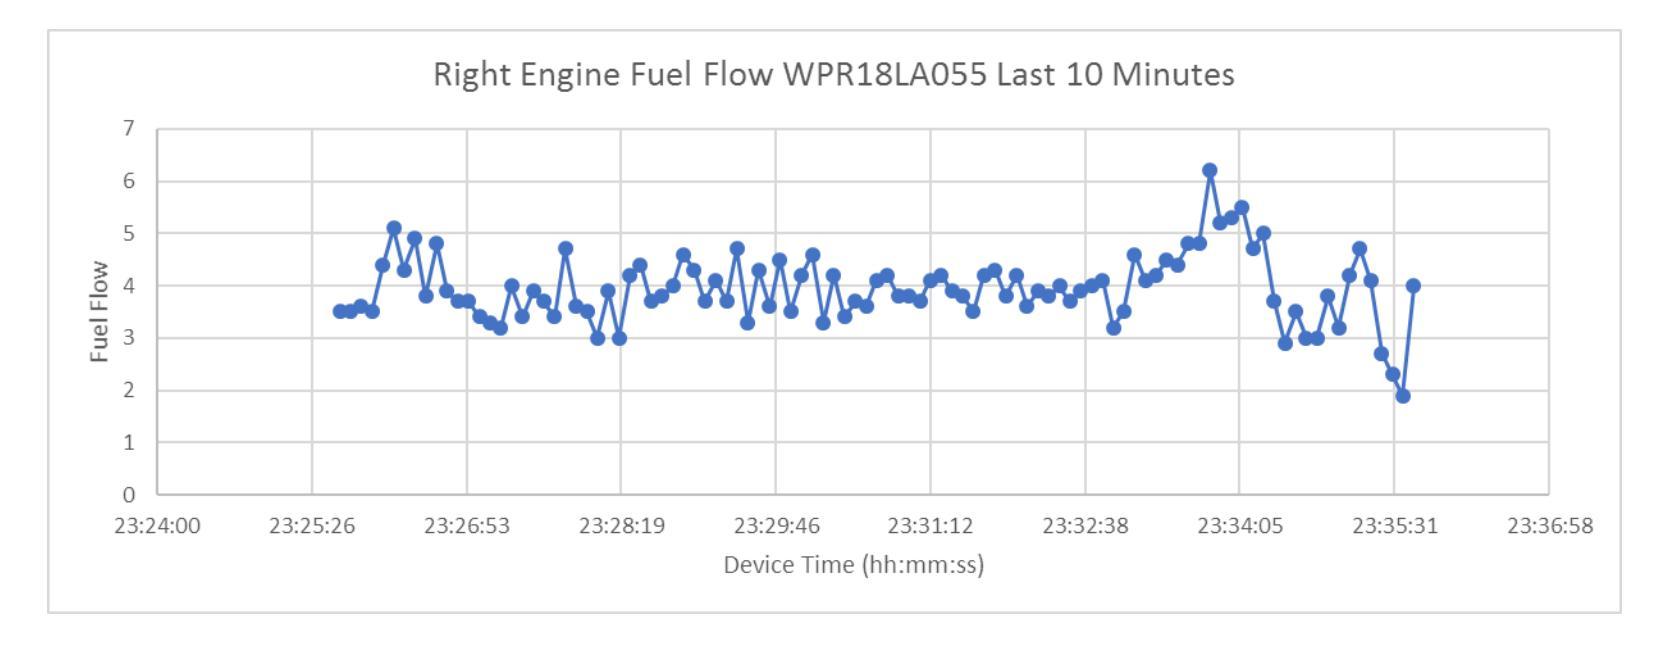
6. Data Plots- See following pages

Both devices were successfully downloaded, using the JPI EZTrends software version 2.2.21.75. Both devices contained data from the accident flight. Data sample rate was 10 samples/minute. Recorded parameters included exhaust gas and cylinder head temperatures (EGT & CHT) for each of the four cylinders, fuel flow, fuel used, and battery voltage. None of these parameters provide a direct measure of engine rpm or power.
