National Transportation Safety Board

CEN22FA424

GPS AND TRANSPONDER DEVICES

Specialist's Factual Report

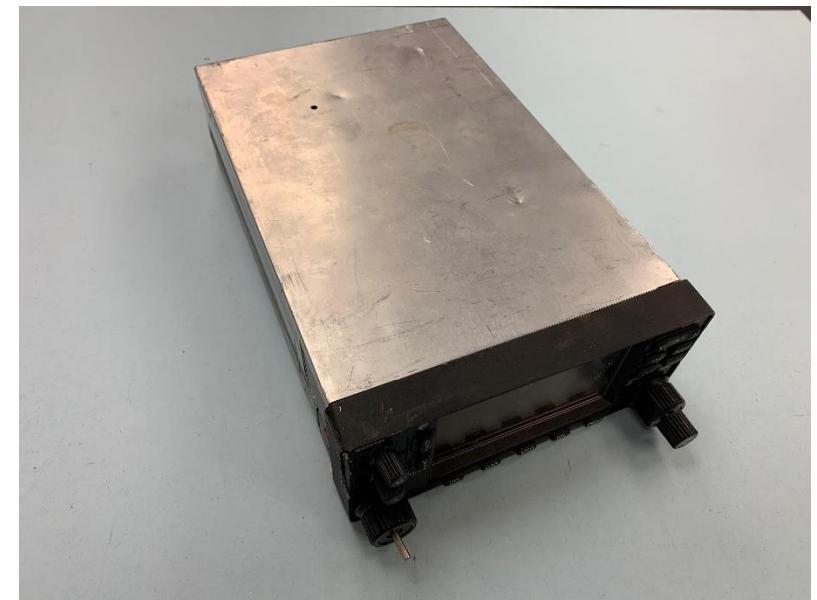
The device was lightly damaged in the event. The only evidence of damage was some broken plastic in the outer case that holds the screen and a missing left cursor knob. The device was installed into a third-party bench top power supply that was designed to operate the device outside of an aircraft's panel. The power supply has two settings, normal mode and simulation mode. Normal mode was used to power the device in the benchtop power supply. Normal mode provides grounding to certain pins that enable factory configuration pages to be accessed, as if the unit was installed in an aircraft. Alternatively, when set to simulation mode, these pins remain ungrounded.

Figure 1. Photo of Garmin GNS-430W, as received.

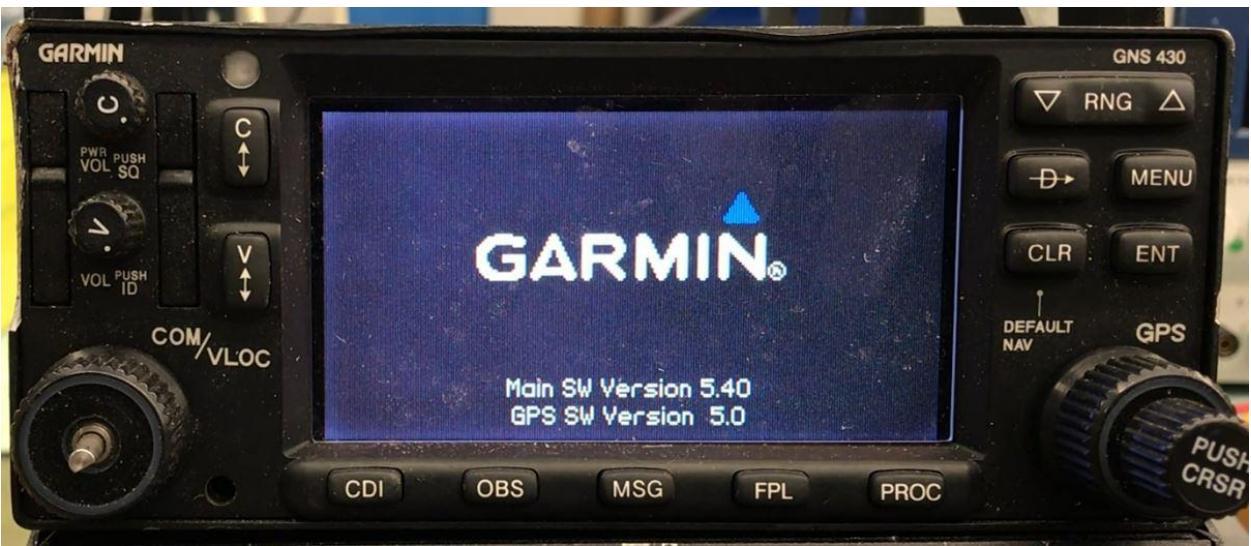
Figure 2 is the device's power splash screen. Nothing anomalous was noted by the group.

Figure 2. Photo of Garmin GNS-430W power splash screen.

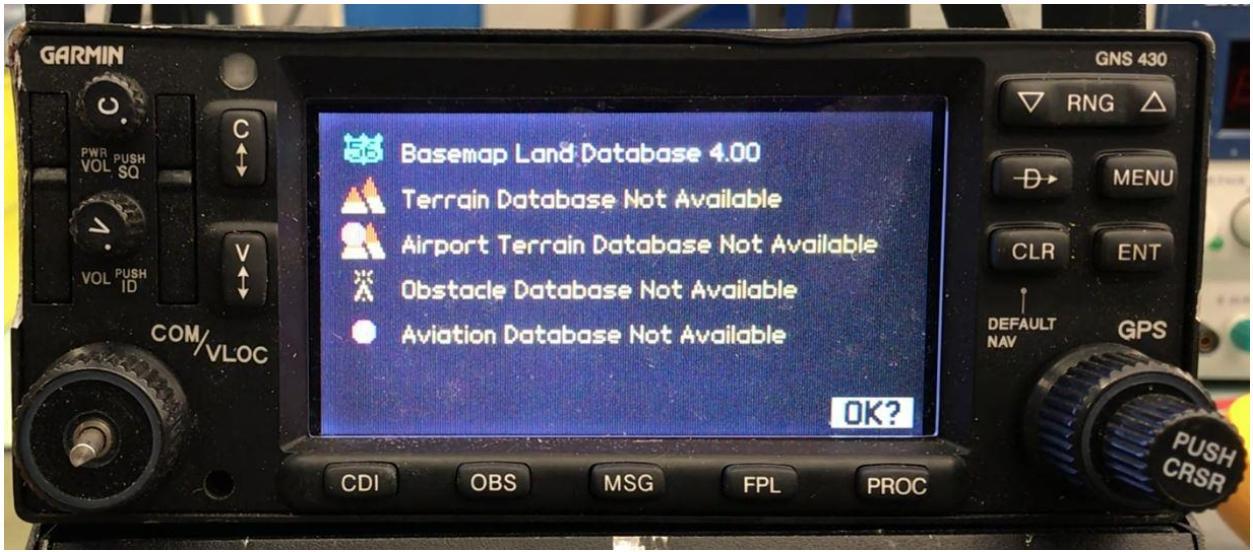
Figure 3 is the device's database information page. Nothing anomalous was noted by the group.

Figure 3. Photo of Garmin GNS-430W database information page.

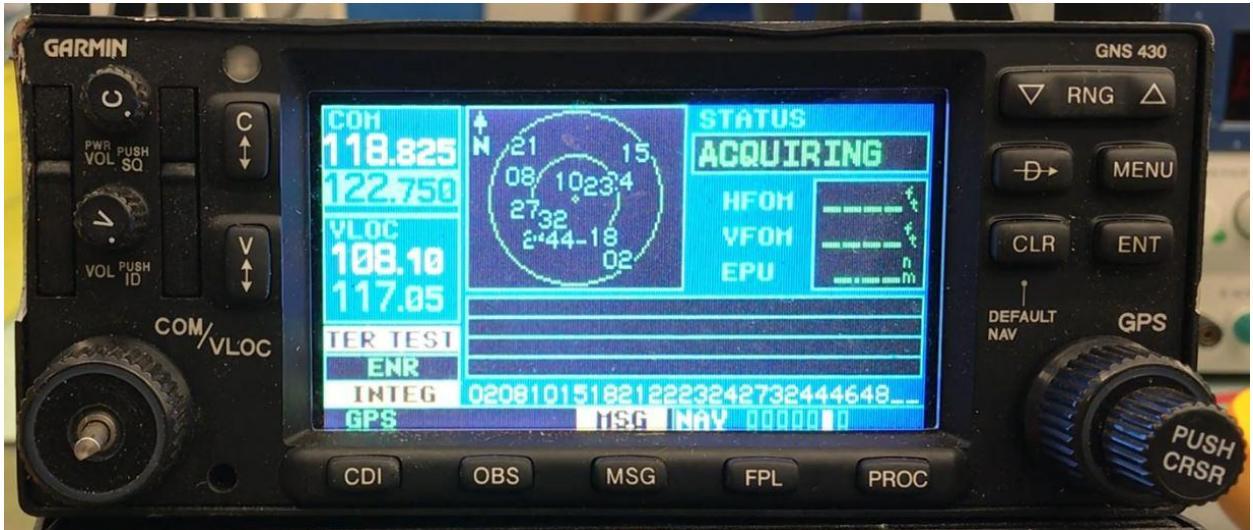
Figure 4 is satellite status page. On the left, the active and standby communications and navigation frequencies are shown. The active communication frequency was set to 118.825 MHz. The standby communication frequency was set to 122.750 MHz. The active VHF radio navigational communication frequency was set to 108.10 MHz. The standby VHF radio navigational communication frequency was set to 117.05 MHz. The unit displayed a message that stated the unit's terrain test had failed. This is an expected result as the device was not computing a GPS position as the test was conducted indoors and the unit was not connected to a GPS antenna. The unit also failed a GPS integrity test for the same reason.

Figure 4. Photo of Garmin GNS-430W satellite status page with active communication and navigation frequencies.

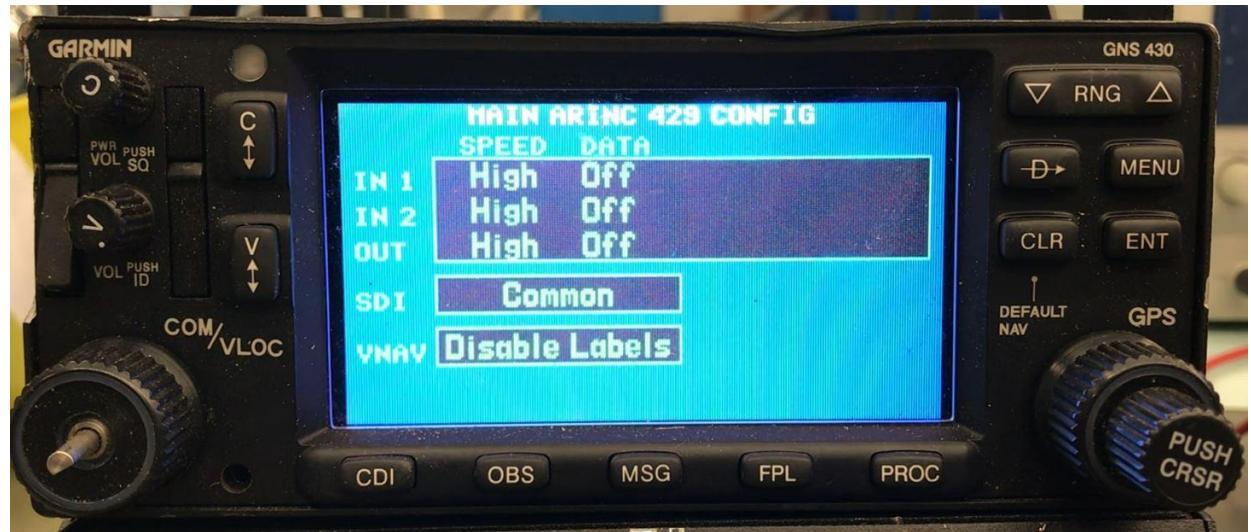
Figure 5 is the ARINC 429 configuration page. The unit showed that all ARINC 429 channels were configured to "Off" for input and output data.

Figure 5. Photo of Garmin GNS-430W ARINC 429 configuration page.

The device can be configured to transmit WAAS GPS position information to connected devices via either ARINC-429 or RS-232 protocols. In order to do this, the GNS- 430W must be properly connected to the receiving source, in this case, the Garmin GTX-330. Figure 5 shows the ARINC-429 output source was set to off. Additionally, figure 6 shows the RS-232 outputs were set to "off" for all channels. The device was not configured to provide position data to the connected device.

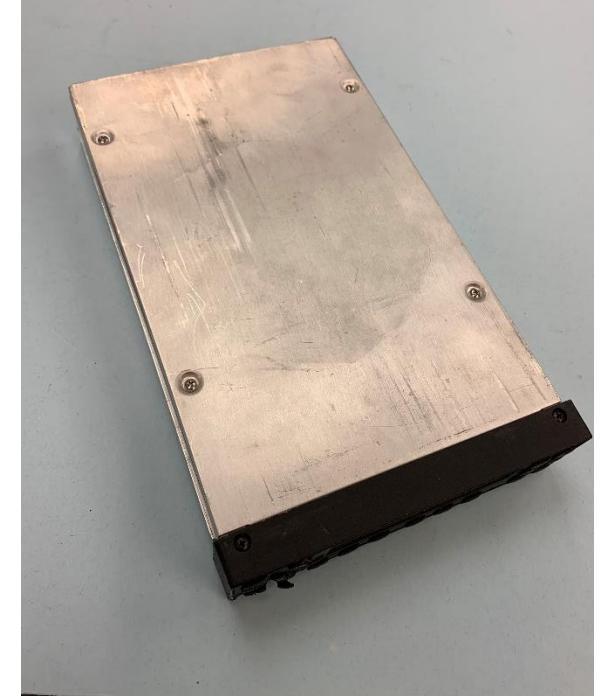
The device was lightly damaged in the event. The device is shown in figure 7. The only evidence of damage was some broken plastic in the left front face of the

display housing. The damage in the left portion of the display housing affected some of the device's buttons. Before powering the device, the extent of the damage to the buttons was unknown. The device appeared otherwise operable.

Figure 7. Photo of Garmin GTX-330, as received.

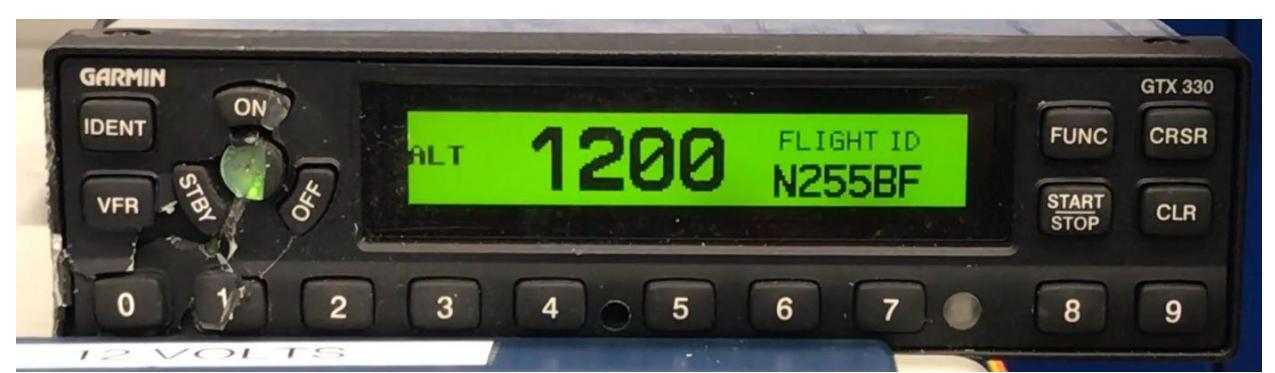
Figure 8 shows the unit was initially booted and was in altitude mode "ALT" with a transponder code of "1200."

Figure 8. Photo of Garmin GTX-330 when initially booted in the laboratory.

The device was then repowered normally to simulate normal operation. Because the device was previously set to configuration mode, the device now powered in standby mode, which was the expected response. Recall in figure 8 which showed the device initially started in ALT mode, which would have likely been representative of the mode the transponder was in during the time of the accident.

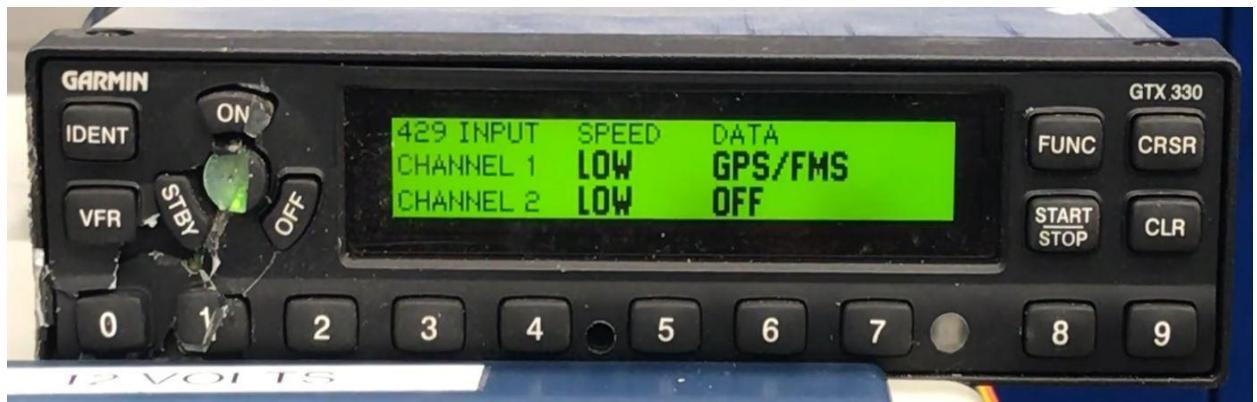
Figure 9 is the ARINC 429 input configuration screen for channels 1 and 2. The configuration shows the unit could accept data on ARINC 429 channel 1 if it were provided input from a GPS source such as the Garmin GNS-430W. The source device, however, would have to be configured to send this data. Recall that figure 5 shows the GNS-430W was not configured to output ARINC 429 data.

Figure 9. Photo of Garmin GTX-330 channel 1 and 2 ARINC-429 Input configuration screen.

The Garmin GTX-330 can be configured to receive WAAS GPS data from an approved and compatible WAAS device. The GTX-330 must be properly connected to the WAAS GPS source, in this case, the Garmin GNS-430W. Figures 9 and 10 show the ARINC-429 input configuration for the GTX-330. Channel 1 was set to "GPS/FMS", channel 2 was set to "off" and channel 3 was set to "off." Figure 12 shows the RS-232 input configuration screen. Both channel 1 and channel 2 were set to "remote" which indicated they could receive a remote WAAS GPS source via RS-232. Recall that in figure 6, the RS-232 output configuration from the GNS-430 was set to "off."

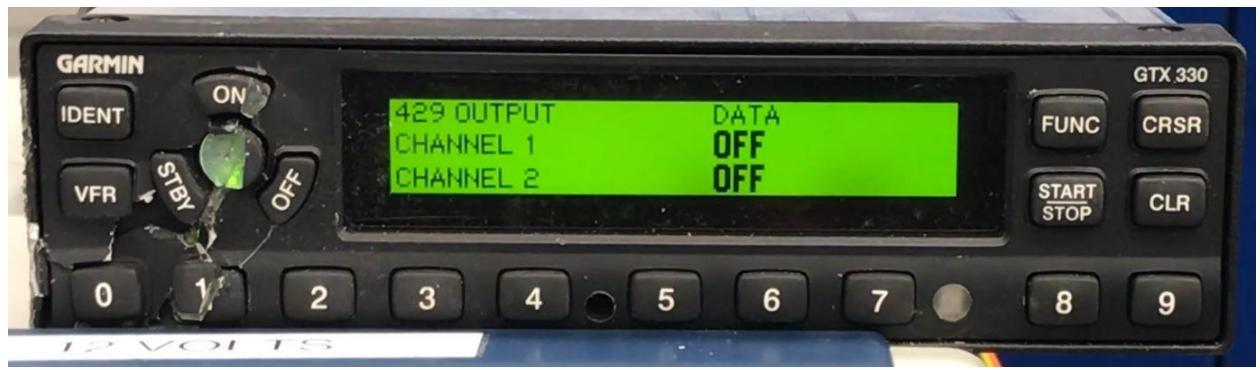
Figure 11 is the ARINC 429 output configuration screen. Nether channel 1 or channel 2 was configured to output ARINC 429 data.

Figure 11. Photo of Garmin GTX-330 channel 1 and 2 ARINC-429 Output configuration screen.

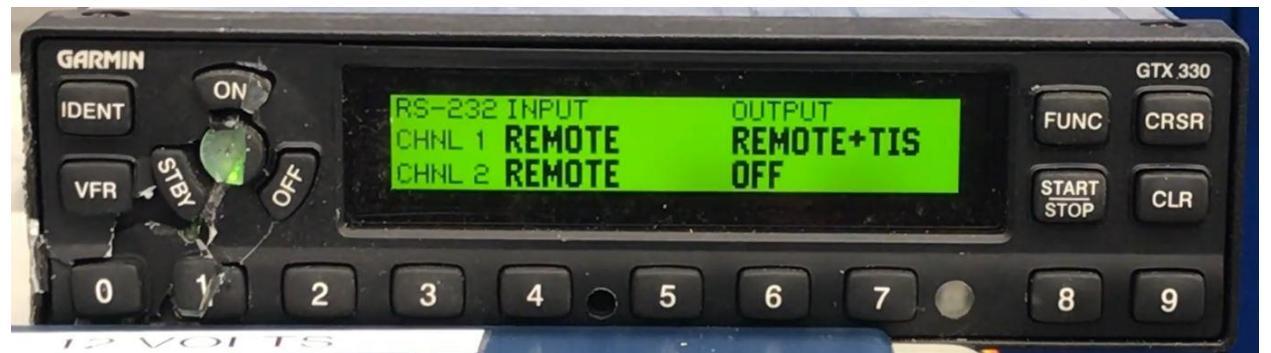
Figure 12 is the RS-232 input and output configuration screen. The configuration shows RS-232 was set to "remote" for channels 1 and channel 2 input. This would allow the GTX-330 to accept RS-232 data from a position source such as the GNS-430W, if the device was so configured. Recall from figure 6 that the GNS-430W was not configured to output RS-232 data.

Figure 12. Photo of Garmin GTX-330 channel 3 ARINC-429 Output configuration screen.

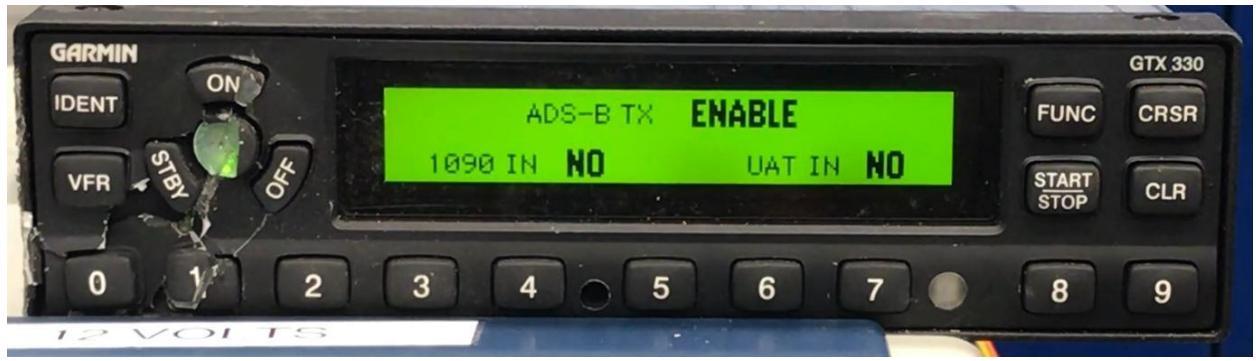
Figure 13 is ADS-B configuration page. The unit was set to transmit ADS-B with the value set to "ENABLE." With the unit configured this way, with no position source information, a Garmin representative stated the device would show a "NO ADSB" in the upper left corner of the screen when the unit was set to transmit ADS-B data in "ALT" mode. Note from figure 8, that the transponder was set to "ALT" mode with a transponder code of "1200" when booted in the lab.

Figure 13. Photo of Garmin GTX-330 ADS-B transmission configuration screen.

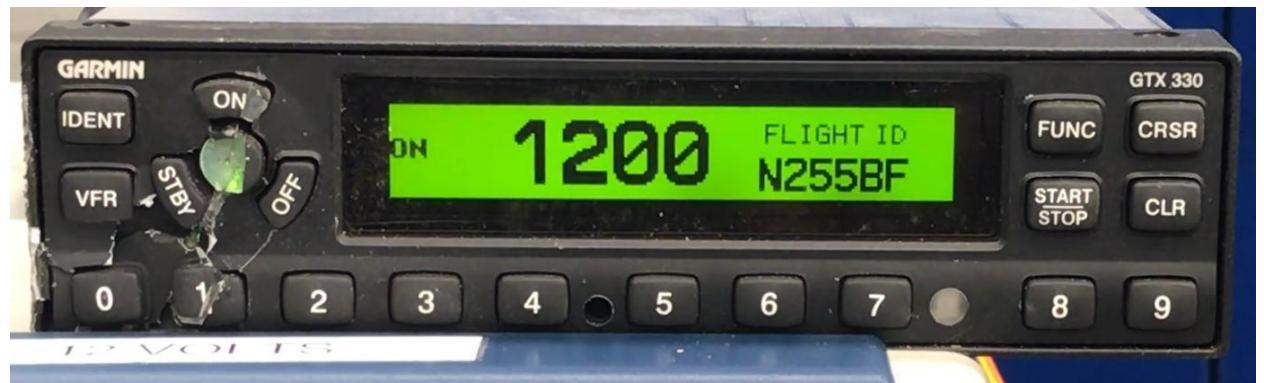
With the device repowered, the device was set to transmit data. Note that a dummy load of 50 ohms had been attached to the signal output port to attenuate any potential signal and to protect the device's internal components. Figure 14 shows the unit operating in "ON" mode. Note that the "ALT" button was broken, so ALT mode could not be selected at this time.

Figure 14. Photo of Garmin GTX-330 in "ON" mode.

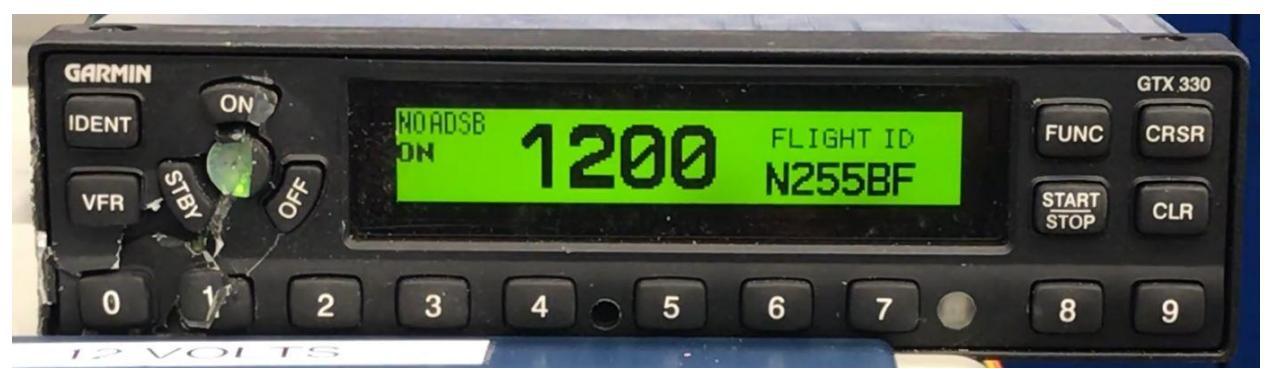
After approximately 150 seconds, the device then displayed a message "NO ADSB" in the upper left hand of the unit's display. This is the expected response. This condition is shown in figure 15.

Figure 15. Photo of Garmin GTX-330 in "ON" mode after approximately 150 seconds now displaying a "NO ADSB" message.

The GTX-330 was then powered on the bench and put into transmission mode. After approximately 150 seconds, the device displayed a "NO ADSB" message.

In summary, the Garmin GTX-330 was set to receive an ARINC 429 GPS/FMS input on channel 1 and a remote RS-232 input on channels 1 and 2, however, a review of the GNS-430W ARINC 429 and RS-232 output configuration showed these output channels were set to "off." When powered, the device displayed a "NO ADSB" message on the display screen.
